# Aviation Investigation Final Report

| <b>Location:</b> | Harrison, Michigan | <b>Accident Number:</b> | CEN22FA029 |
| <b>Date &amp; Time:</b> | November 5, 2021, 09:37 Local | <b>Registration:</b> | N16TG |
| <b>Aircraft:</b> | Vans RV | <b>Aircraft Damage:</b> | Destroyed |

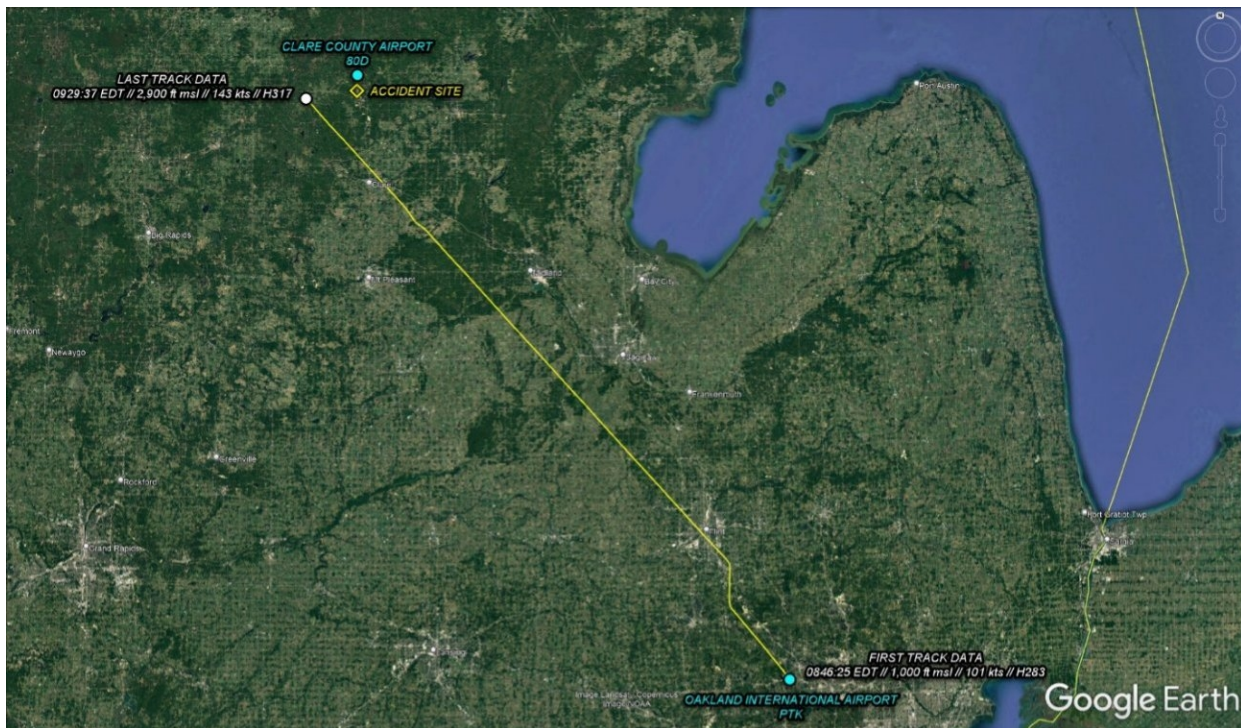
ADS-B data indicated that the airplane departed runway 27L at Oakland International Airport (PTK), Pontiac, Michigan at 0846. After departure the airplane made a climbing right turn and flew northwest for about 12 nm, then turned north for about 5 nm, then back to a northwest heading. The airplane reached a cruise altitude of about 3,000 ft mean sea level and remained on the northwest heading until track data was lost about 0905. The last ADS-B position was about 56 nm and 143° from the accident site. Discrete radar beacon returns showed that the airplane continued a straight-line course for another 60 nm after the loss of ADS-B data. The radar data showed that the airplane was in straight and level flight before the end of the data. The accident site was located about 1 nm south of the approach end of runway 36 at the Clare County Airport (80D), Harrison, Michigan.

Figure 1. Plot of ADS-B track data for the entire flight.

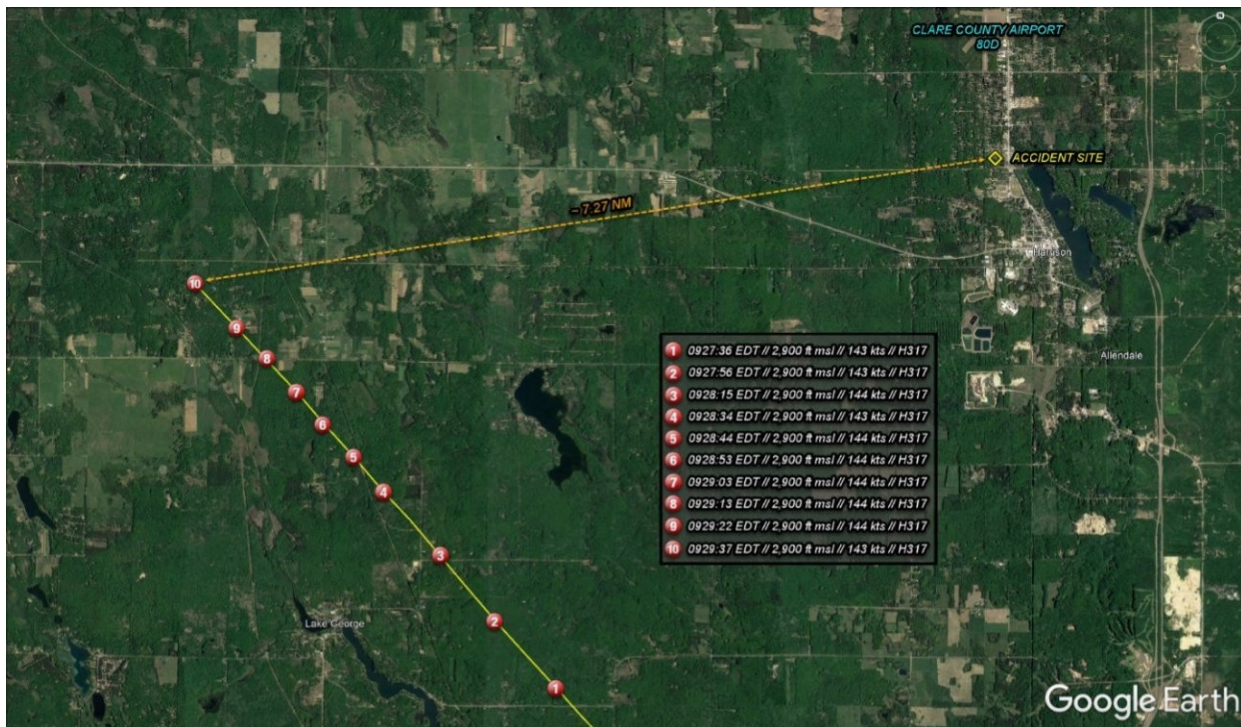
The accident site was located about 7.3 nautical miles (nm) to the east of the last recorded track and about 1 nm south of the approach end of an airport runway. The location of the accident site suggests that the pilot had diverted from his original course and was attempting to land at the nearby airport. The loss of automatic dependent surveillance-broadcast (ADS-B) flight track data and discrete radar beacon returns indicated an interruption of transmission of the data from the airplane.

Additionally, the distance from the final radar return to the accident site was not consistent with the achievable glide ratio of the airplane, suggesting that the engine did not lose power at the point where the final discrete beacon return was received. Therefore, the reason the airplane was diverting to the alternate airport could not be determined. The impact signatures indicated that the pilot likely failed to maintain the proper airspeed, leading to an exceedance

Figure 2. Plot of the final portion of the accident flight.

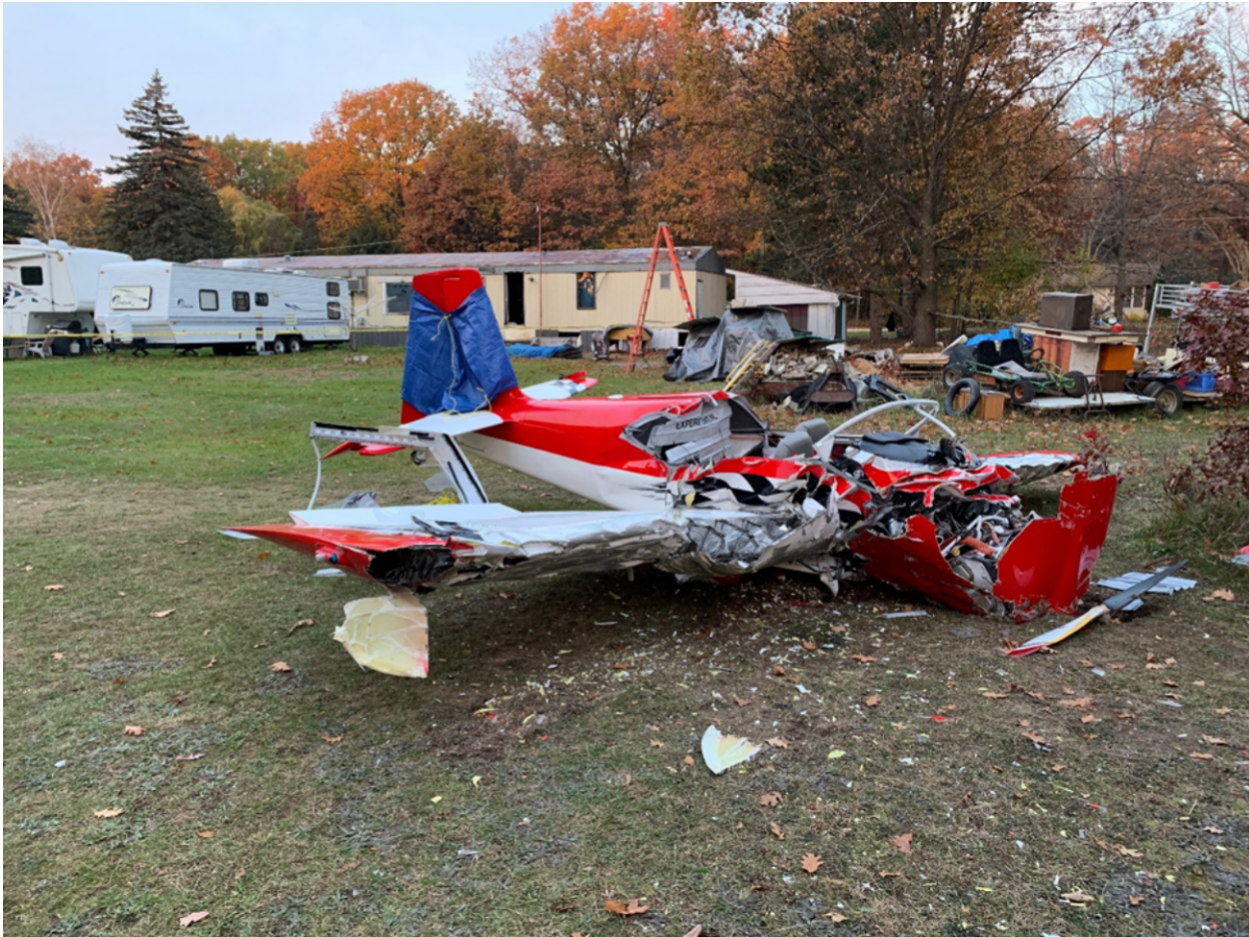
The airplane impacted the back yard of a residence. Impact signatures indicated that the airplane struck the ground about 45° nose low. The initial impact point was located directly

beneath the airplane. The airplane remained predominately intact with all major airframe components still connected. The engine was partially attached to the fuselage. The three-blade wood core propeller was attached to the engine. One blade was broken off near the blade root. None of the propeller blades were splintered and they were predominately intact, consistent with low or no engine power at impact.

Figure 3. Airplane at accident scene.
