Aviation Investigation Final Report

Location:	Randsburg, California	Accident Number:	WPR22FA033
Date & Time:	November 12, 2021, 14:13 Local	Registration:	N984LD
Aircraft:	Zenith STOL CH701	Aircraft Damage:	Destroyed
Defining Event:	Aerodynamic stall/spin	Injuries:	2 Fatal
Flight Conducted Under:	Part 91: General aviation - Personal

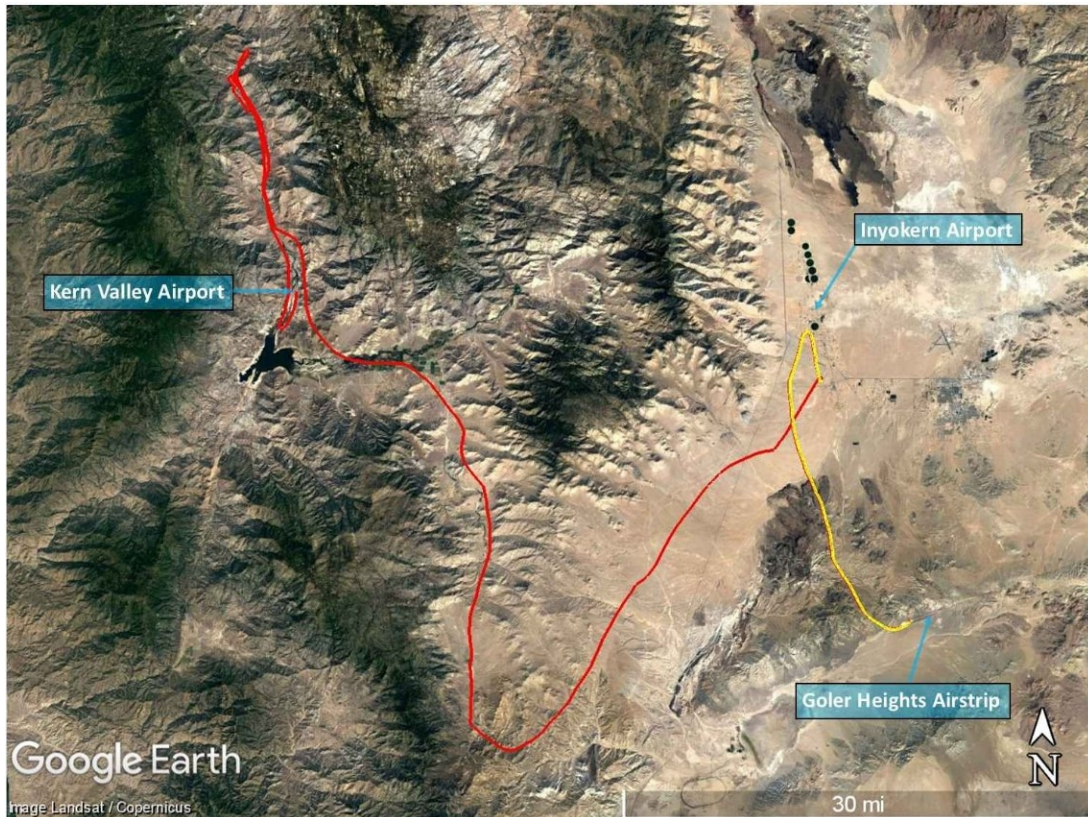
Figure 1 – Flight track. Morning of accident (red), accident flight track (yellow).

Data from an onboard Appareo Stratus 3 unit showed that the airplane initially departed from Kern Valley Airport (L05), Kernville, California, at 1134 on the day of the accident, and flew 15 miles north along the Kern River Valley. It then turned around and flew a 65-mile meandering track to the south, before heading northeast and landing at Inyokern Airport (IYK), Inyokern, California, at 1311 (see figure 1). Fuel receipts indicated that at 1331, the pilot purchased 7 gallons of 100 low-lead aviation gasoline.

The airplane departed from IYK on the accident flight at 1349 and climbed to an altitude of about 3,100 ft msl (650 ft above ground level [agl]). The airplane then began a left turn to the southwest in the general direction of Goler Heights, and for the next 18 minutes, gradually climbed to about 5,000 ft msl while maintaining a groundspeed between 55 and 65 kts.

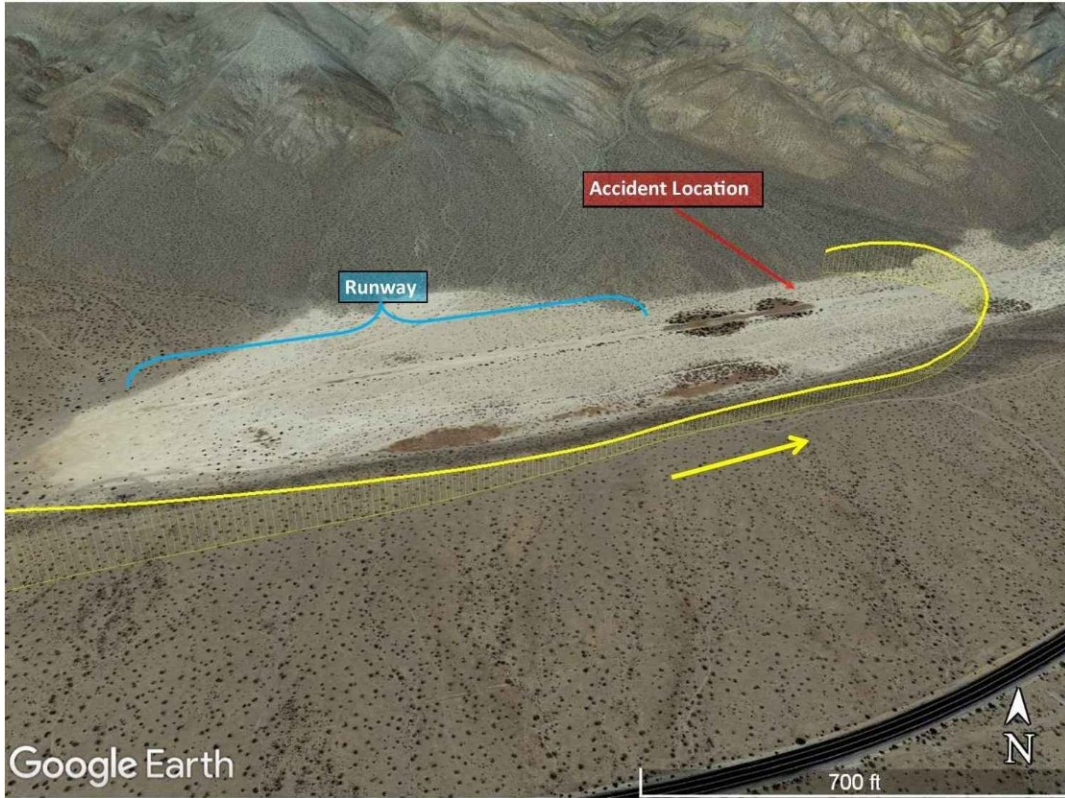
Figure 3 –Descent path into traffic pattern.

By the time the airplane had reached the downwind leg, it was about 800 ft laterally from the runway and had slowed to a groundspeed of 47 kts. The airplane continued on the downwind leg along the ridgeline about 50 ft agl (125 ft above the runway), as the speed decreased to 40 kts. Shortly after the airplane passed the landing threshold, it began a 25° left turn consistent with the first stage of a base turn. As the runway centerline approached, the airplane's turn began to tighten, and its groundspeed began to increase to 65 kts, as it overshot the runway centerline and continued toward rising terrain. The airplane's last position was recorded five seconds later, by which time the airplane had reached the runway heading, but had overshot the centerline by 300 ft. The wreckage was located about 150 ft beyond, and 100 ft below the last recorded position (see figures 3 and 4).

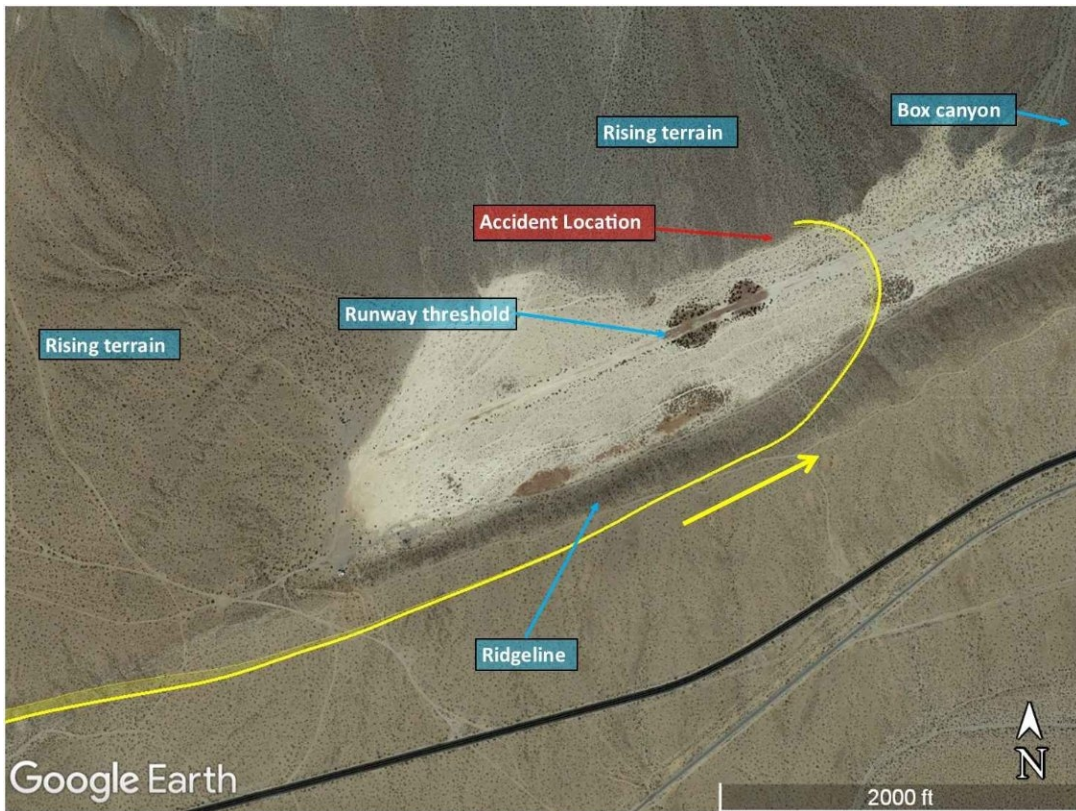
Figure 4 –Plan view of flight track.

The airplane's bank angle increased to between 60° and 90° as it turned from base to final, and the airplane then rapidly descended, consistent with an aerodynamic stall. The airplane impacted the ground about 700 ft short of the runway threshold and about 300 ft right of the runway centerline.
