Aviation Investigation Final Report

Location:	Randsburg, California	Accident Number:	WPR22FA033
Date & Time:	November 12, 2021, 14:13 Local	Registration:	N984LD
Aircraft:	Zenith STOL CH701	Aircraft Damage:	Destroyed
Defining Event:	Aerodynamic stall/spin	Injuries:	2 Fatal
Flight Conducted Under:	Part 91: General aviation - Personal

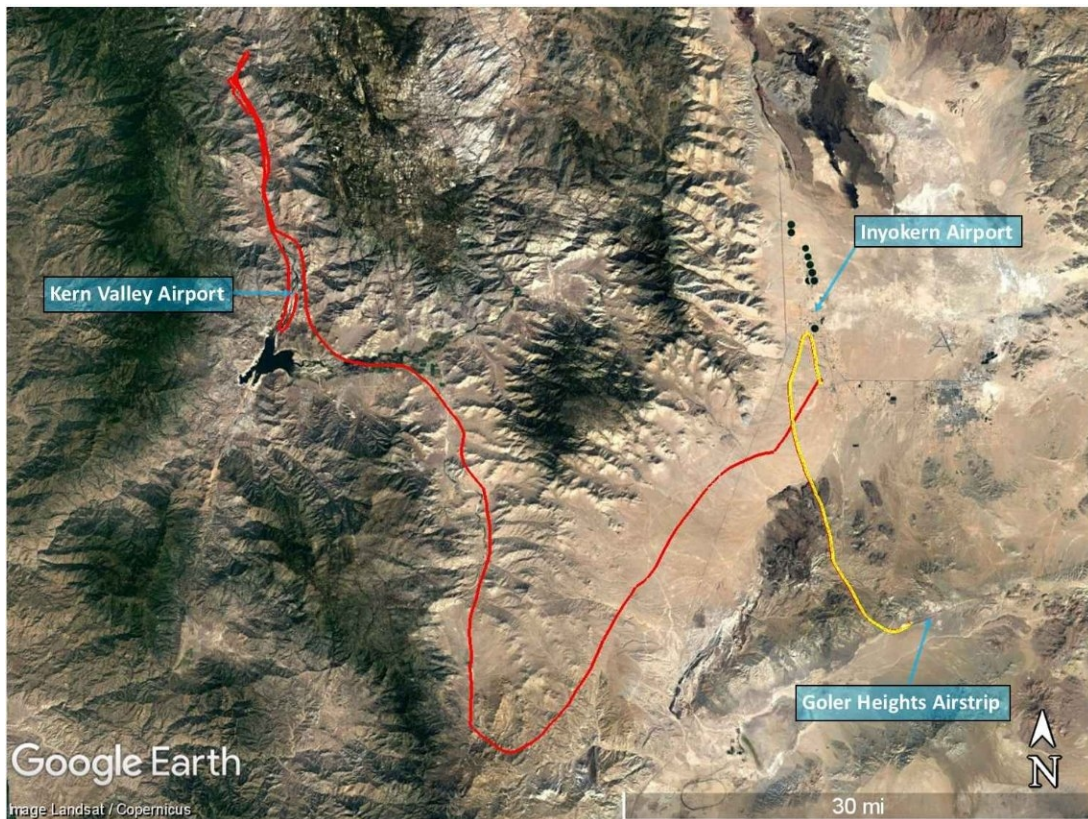
Data from an onboard Appareo Stratus 3 unit showed that the airplane initially departed from Kern Valley Airport (L05), Kernville, California, at 1134 on the day of the accident, and flew 15 miles north along the Kern River Valley. It then turned around and flew a 65-mile meandering track to the south, before heading northeast and landing at Inyokern Airport (IYK), Inyokern, California, at 1311 (see figure 1). Fuel receipts indicated that at 1331, the pilot purchased 7 gallons of 100 low-lead aviation gasoline.

Figure 1 – Flight track. Morning of accident (red), accident flight track (yellow).

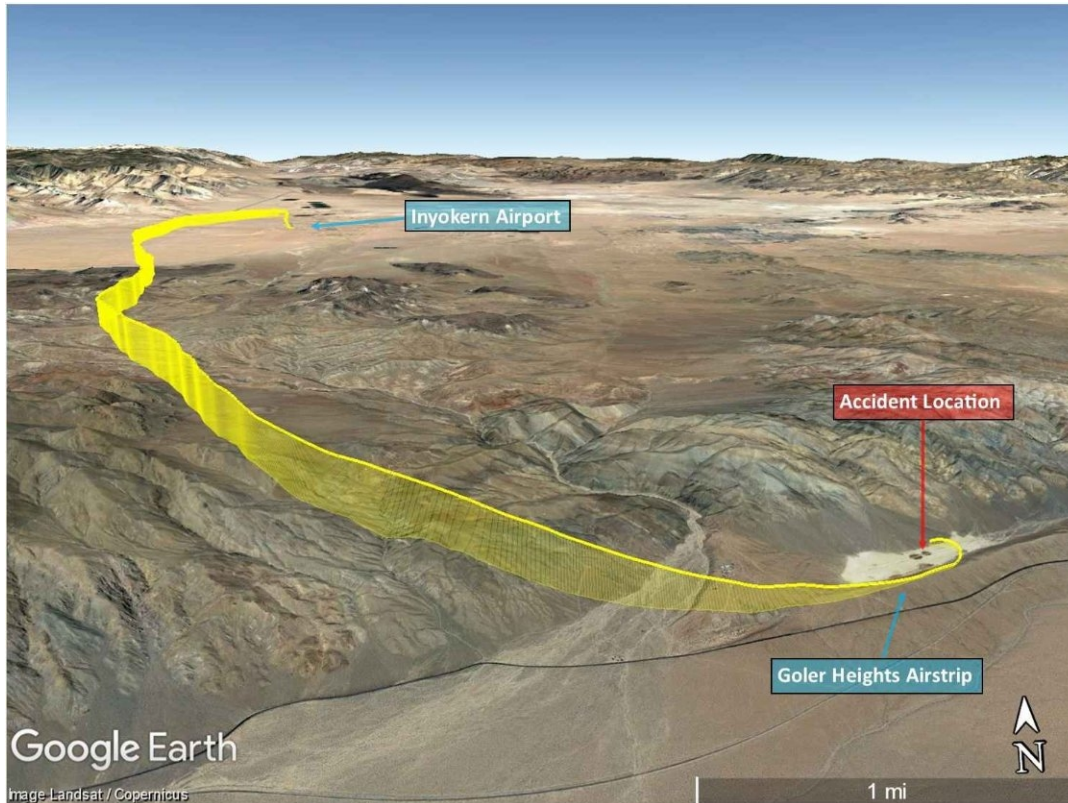
At 1409, the airplane had passed over the Red Rock Canyon State Park Mountain Range and was about 3 miles northwest of, and 2,500 ft above the airstrip. Over the next 2 ½ minutes, the airplane began a descending left turn until it reached the parallel ridgeline of the left downwind leg. The airplane maintained a groundspeed of about 60 knots during the decent, with descent rates varying between about 500 and 1,450 ft per minute (see figure 2).

Figure 2 – Accident flight track

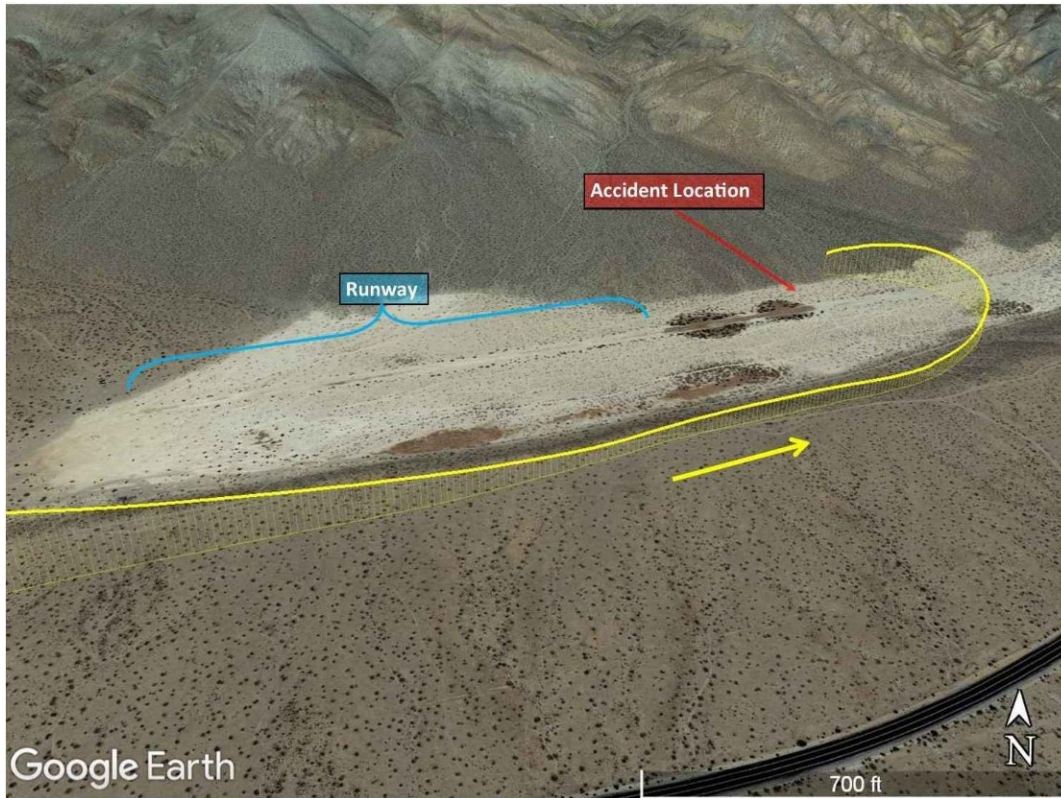
By the time the airplane had reached the downwind leg, it was about 800 ft laterally from the runway and had slowed to a groundspeed of 47 kts. The airplane continued on the downwind leg along the ridgeline about 50 ft agl (125 ft above the runway), as the speed decreased to 40 kts. Shortly after the airplane passed the landing threshold, it began a 25° left turn consistent with the first stage of a base turn. As the runway centerline approached, the airplane's turn began to tighten, and its groundspeed began to increase to 65 kts, as it overshot the runway centerline and continued toward rising terrain. The airplane's last position was recorded five seconds later, by which time the airplane had reached the runway heading, but had overshot the centerline by 300 ft. The wreckage was located about 150 ft beyond, and 100 ft below the last recorded position (see figures 3 and 4).

Figure 3 –Descent path into traffic pattern.

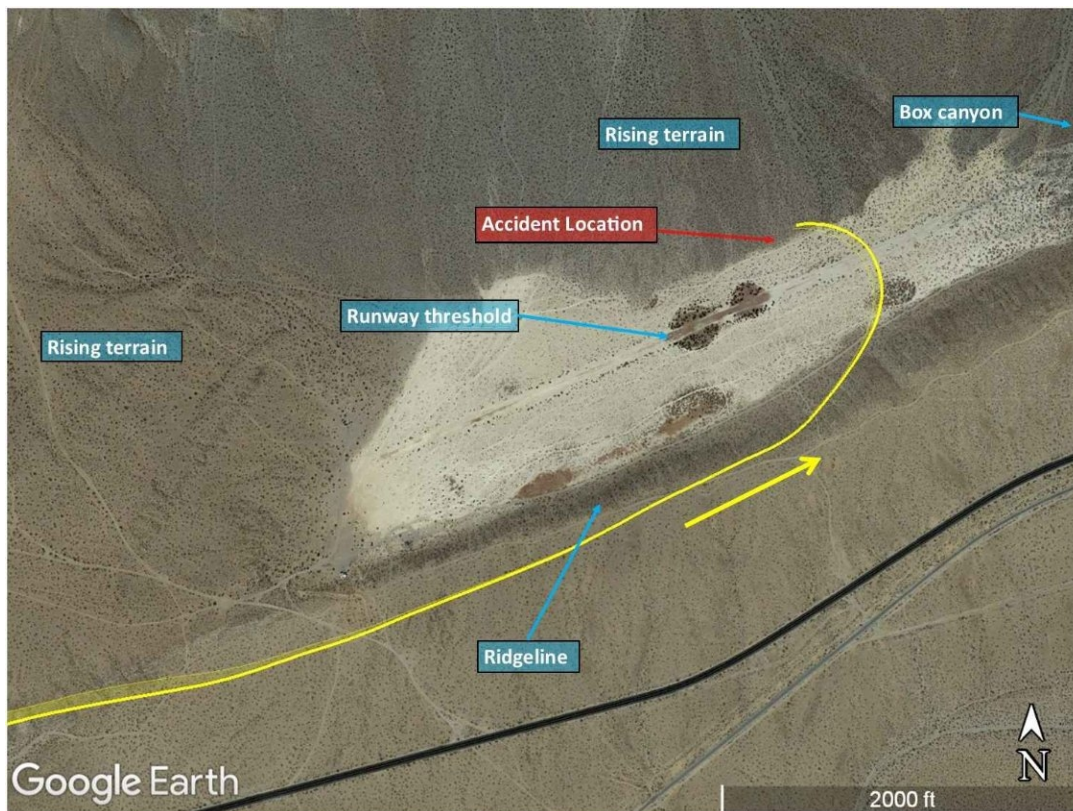
Figure 4 –Plan view of flight track.
