# Aviation Investigation Final Report

<b>Location:</b>	Beaver Island, Michigan	<b>Accident Number:</b>	CEN22FA031
<b>Date &amp; Time:</b>	November 13, 2021, 13:49 Local	<b>Registration:</b>	N866JA
<b>Aircraft:</b>	BRITTEN-NORMAN BN-2A	<b>Aircraft Damage:</b>	Substantial
<b>Defining Event:</b>	Aerodynamic stall/spin	<b>Injuries:</b>	4 Fatal, 1 Serious
<b>Flight Conducted Under:</b>	Part 135: Air taxi & commuter - Non-scheduled

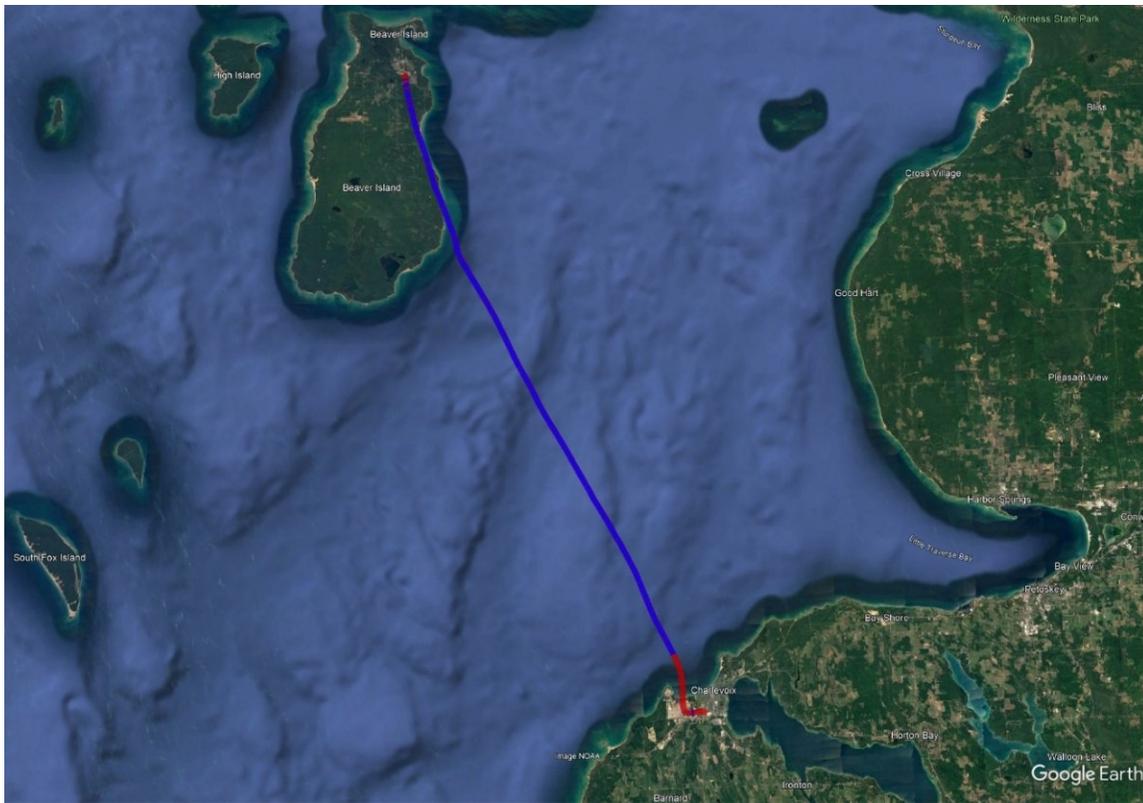
The ADS-B data showed that the airplane departed Charlevoix Municipal Airport (CVX), Charlevoix, Michigan, at 1332. After departing CVX, the airplane turned north and proceeded directly toward Welke Airport (6Y8), Beaver Island, Michigan. The enroute portion of the flight was conducted about 1,500 ft above mean sea level (msl), and the airplane remained at this altitude until it was about 3 nautical miles (nm) from 6Y8. At this point, the airplane descended and maneuvered toward a straight-in approach to runway 35 at 6Y8. The ADS-B data ended about 0.24 nm south of the accident site.

Figure 1: Overview of the accident flight. ADS-B flight track depicted in blue, GPS flight track depicted in red.

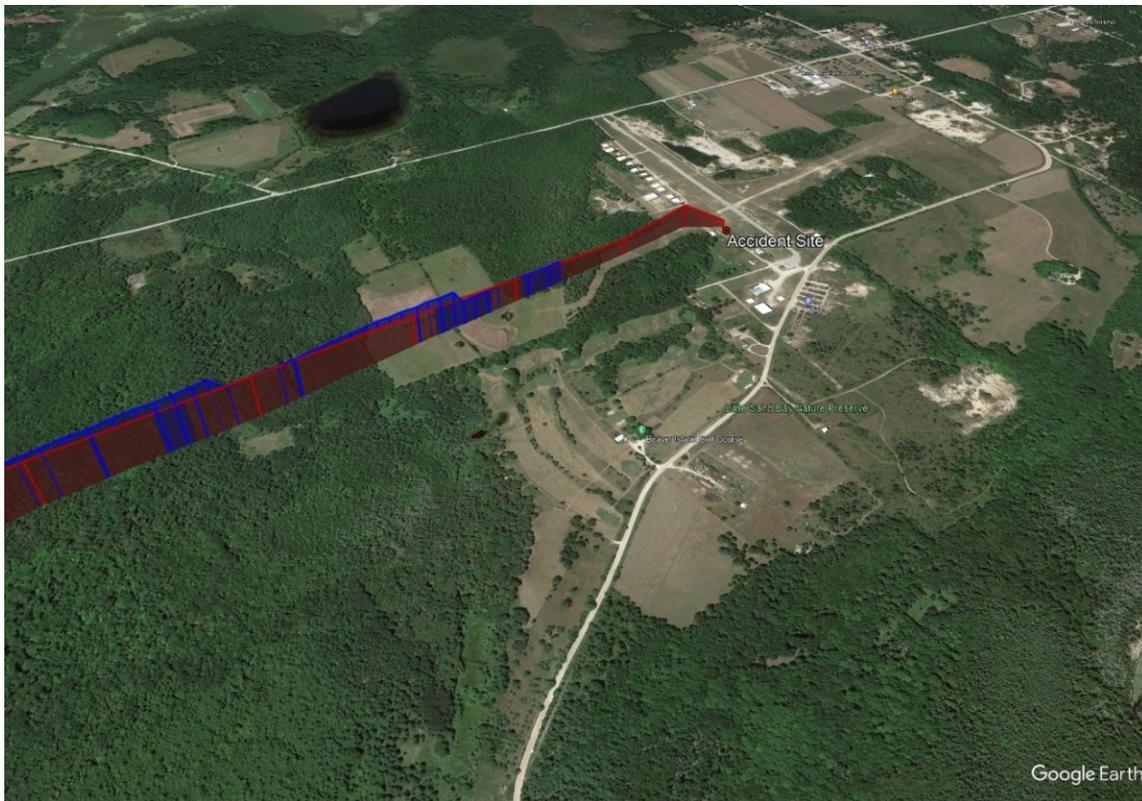
The track data from a handheld GPS that was used in the airplane coincided with the ADS-B data but recorded additional data that ended at the accident site.

*Figure 2: Plot of ADS-B and GPS flight track data for the final portion of the accident flight. ADS-B data depicted in blue. GPS data depicted in red.*

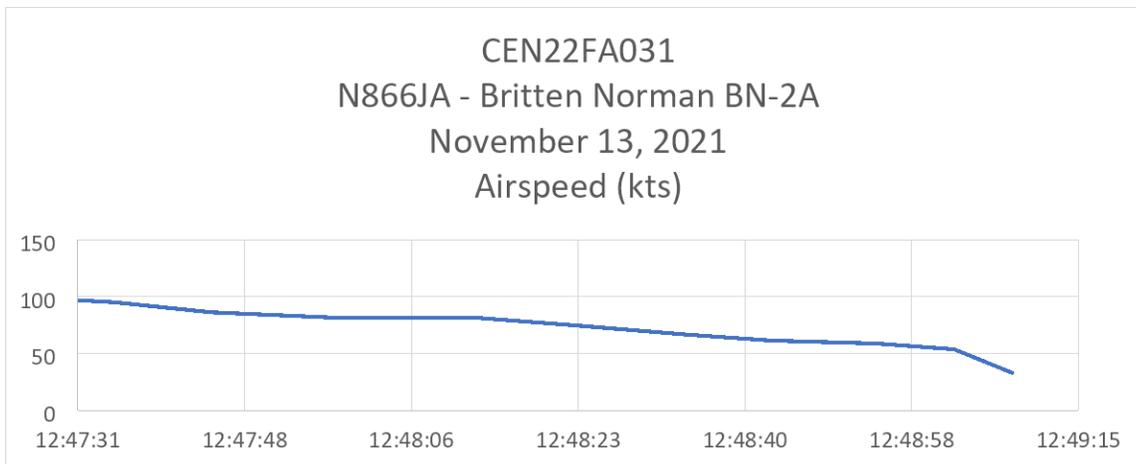
The GPS recorded position, heading, altitude, and ground speed among other data. The airplane's airspeed was calculated from the GPS groundspeed considering the recorded winds at the Beaver Island Airport (SJX), located about 2 nm southwest of the accident site. When the airplane was 1,200 ft from the runway threshold, the calculated airspeed was 58 knots, and when 600 ft from the threshold the airspeed was 54 knots. The final recorded data point coincided with the wreckage location and the recorded airspeed was 33 knots. Figure 3 depicts the plotted airspeed during the final portion of the accident flight.

Figure 3. Airspeed during the final portion of the flight.

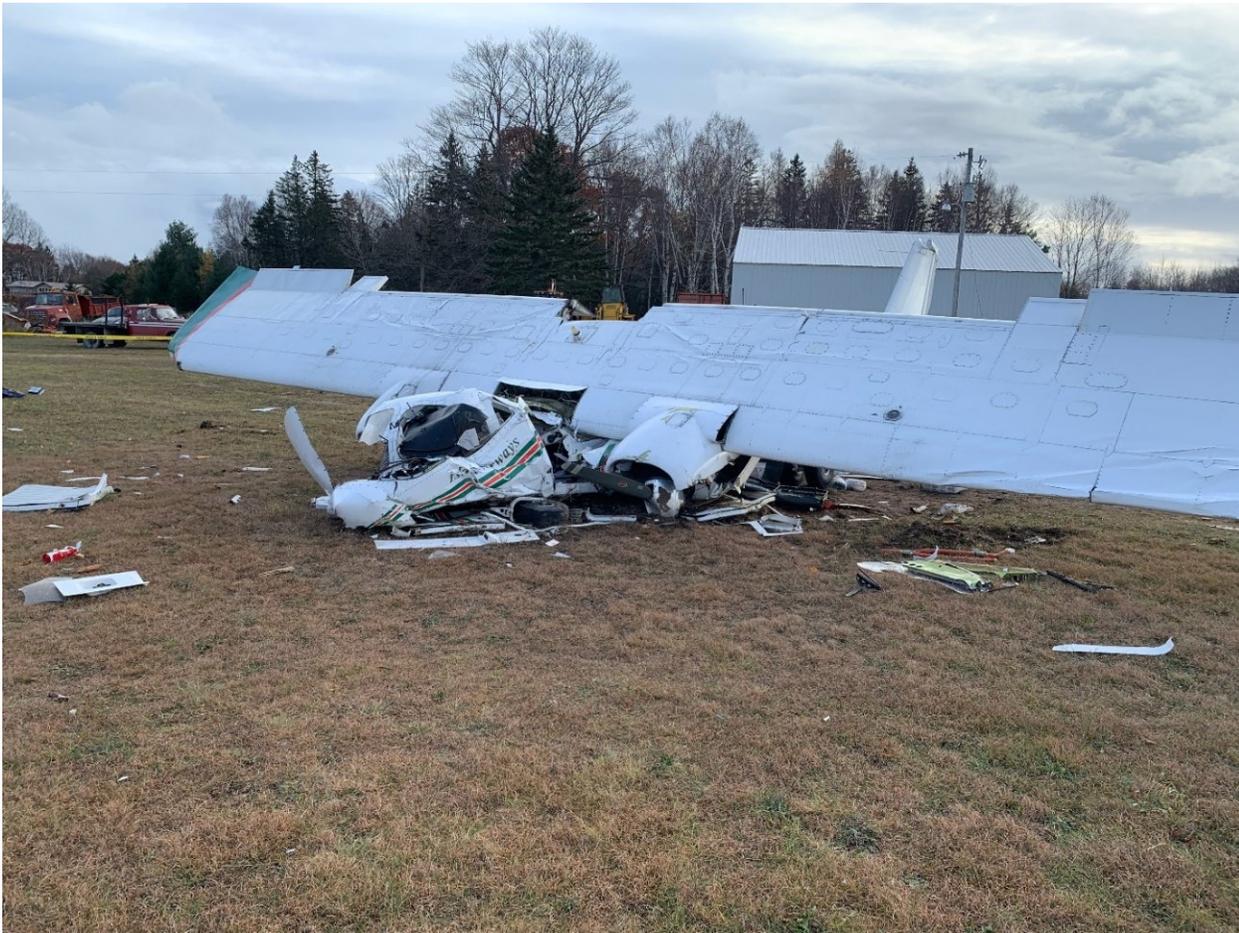
The airplane impacted the ground about 110 ft east of the extended centerline of runway 35, and 320 ft south of the runway threshold. The turf runway was 3,500 ft long and had a displaced threshold just beyond its intersection with paved runway 9/27. Impact signatures indicated that the airplane struck the ground in a left-wing-low, nose-low attitude. The front of the fuselage was crushed upward and aft.

*Figure 4. Overall view of the airplane wreckage at the accident site.*
