Aviation Investigation Final Report

Location:	Statesboro, Georgia	Accident Number:	ERA22FA083
Date & Time:	December 7, 2021, 21:24 Local	Registration:	N5776B
Aircraft:	Cessna 182	Aircraft Damage:	Destroyed
Defining Event:	VFR encounter with IMC	Injuries:	1 Fatal
Flight Conducted Under:	Part 91: General aviation - Personal

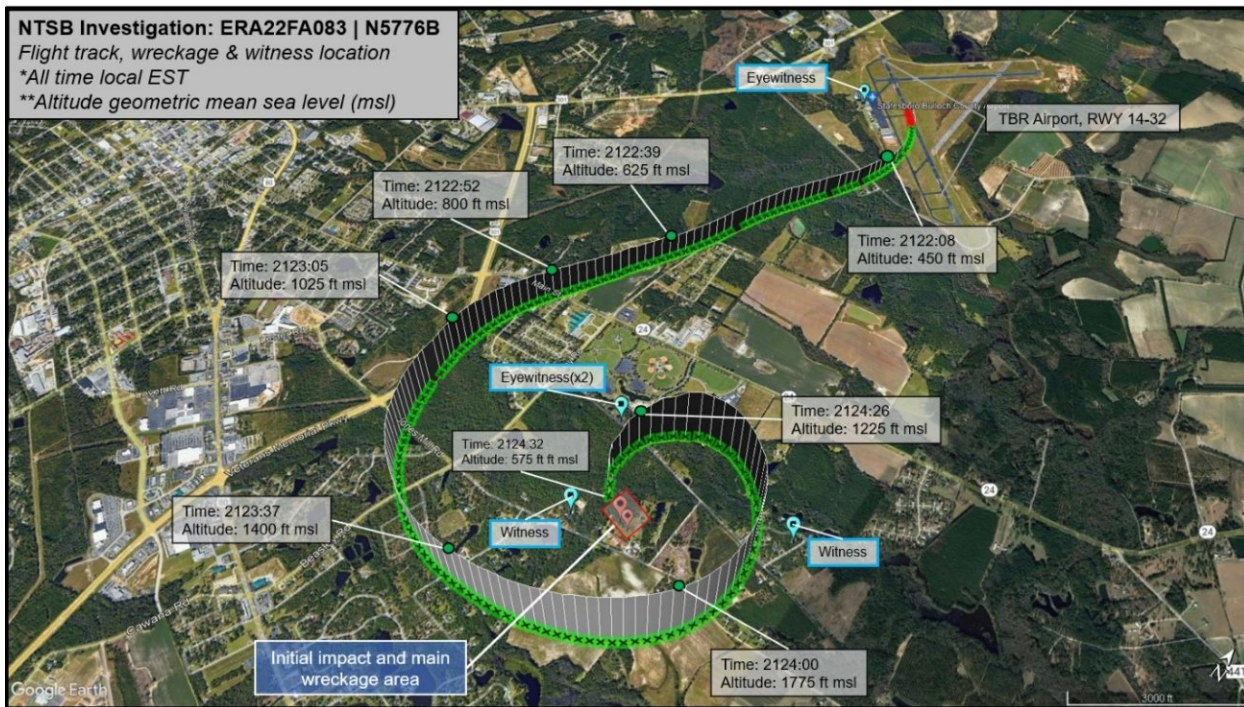
Review of automatic dependent surveillance-broadcast (ADS-B) data found that the airplane departed runway 14 at 2121. Shortly after takeoff, the flight track turned south, climbed to about 1,000 ft msl, which was about 800 ft agl, and then about 1.8 nautical miles south of TBR, the airplane entered a left turn. The airplane continued in a left 360° tightening turn where a maximum altitude of about 1,800 ft msl was reached, which was subsequently followed by a rapid descent.

The final position recorded at 2124:32 was about 0.1-miles from the accident site and showed the airplane headed east at an altitude of 575 ft msl (about 375 ft agl). Figure 1 displays the ADS-B flight track, main wreckage area, and witness locations.

Figure 1: Overview of the flight track, wreckage, and witness locations.

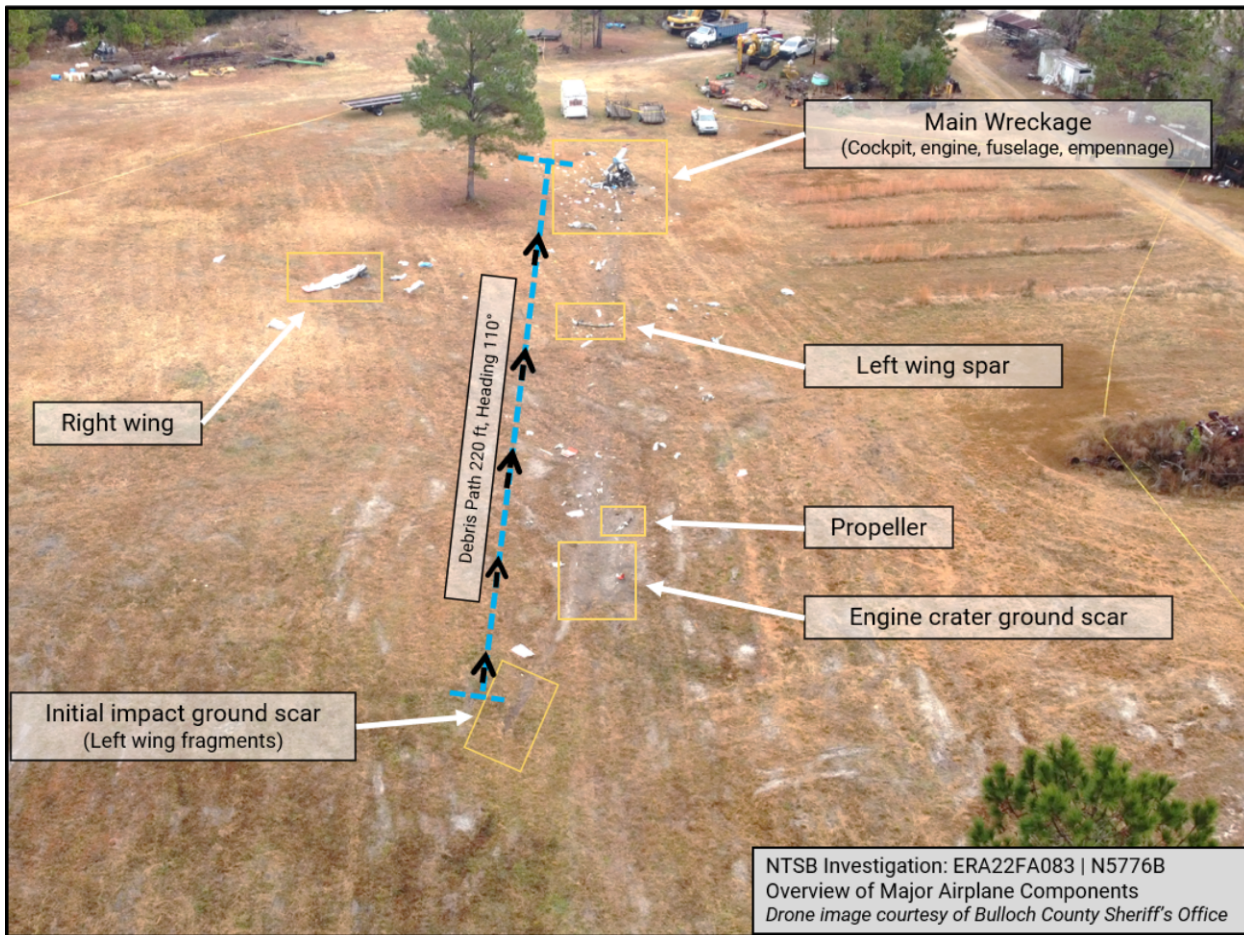
The wreckage was highly fragmented and was oriented on a debris path of about 110° magnetic. The initial impact ground scar was located about 220 ft from the main wreckage final resting location, and the elevation was about 175 ft msl. Figure 2 provides an overview of the major components of the airplane located at the accident site.

Figure 2: Overview of the major airplane components as located in the debris path.

All major components of the airplane were located in the debris path. The left-wing tip and additional left-wing fragments were located in the initial impact scar, which was consistent with the airplane impacting terrain in a descending left bank. There was no evidence of an in-flight fire; however, the wreckage was thermally damaged during a postcrash fire.
