Aviation Investigation Final Report

Location:	Steamboat Springs, Colorado	Accident Number:	CEN22FA069
Date & Time:	December 10, 2021, 18:09 Local	Registration:	N744Z
Aircraft:	Piper PA46-500TP	Aircraft Damage:	Substantial
Defining Event:	Controlled flight into terr/obj (CFIT)	Injuries:	1 Fatal
Flight Conducted Under:	Part 91: General aviation - Personal

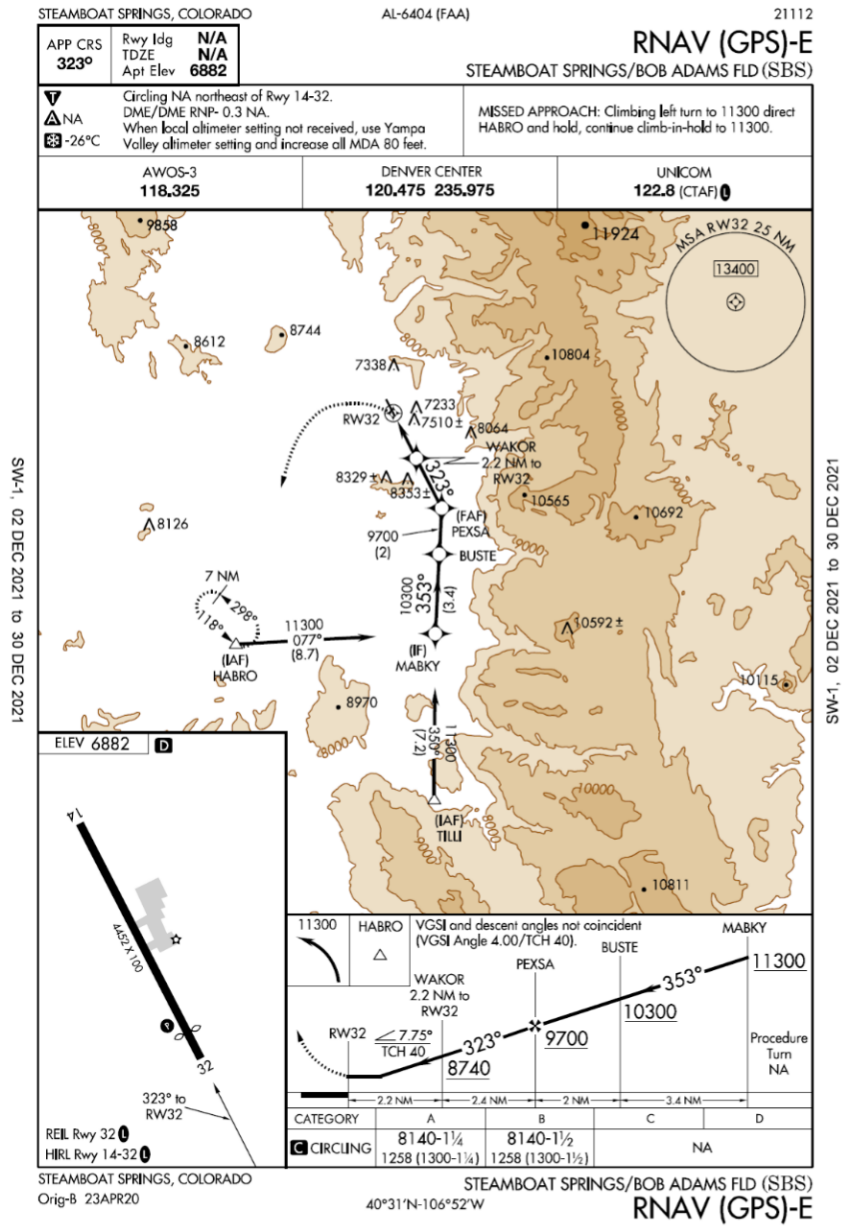
Figure 1: Published Instrument Approach Procedure

For terrain clearance, the procedure required the airplane to cross the final approach fix PEXSA at or above 9,700 ft mean sea level (msl) and WAKOR, the next waypoint located 2.2 nm from runway 32 threshold, at or above 8,740 ft msl. The ADS-B data showed that the accident airplane crossed PEXSA about 9,100 ft msl and WAKOR about 8,200 ft msl respectively.

The procedure allowed for a descent to the minimum descent altitude of 8,140 ft msl or 1,258 ft above ground level after passing WAKOR. The missed approach point for the procedure was

the runway 32 approach end, and then required a climbing left turn to 11,300 ft msl and indicated the pilot should proceed direct to the HABRO waypoint to enter a holding pattern. Immediately after passing WAKOR, the airplane made a left turn as shown in figure 2 and descended to an altitude of about 7,850 ft msl. The airplane subsequently began to climb, and the last ADS-B data point recorded at 1808:49 indicated an altitude of about 8,125 ft msl and was located about 3.5 miles north of the accident site.

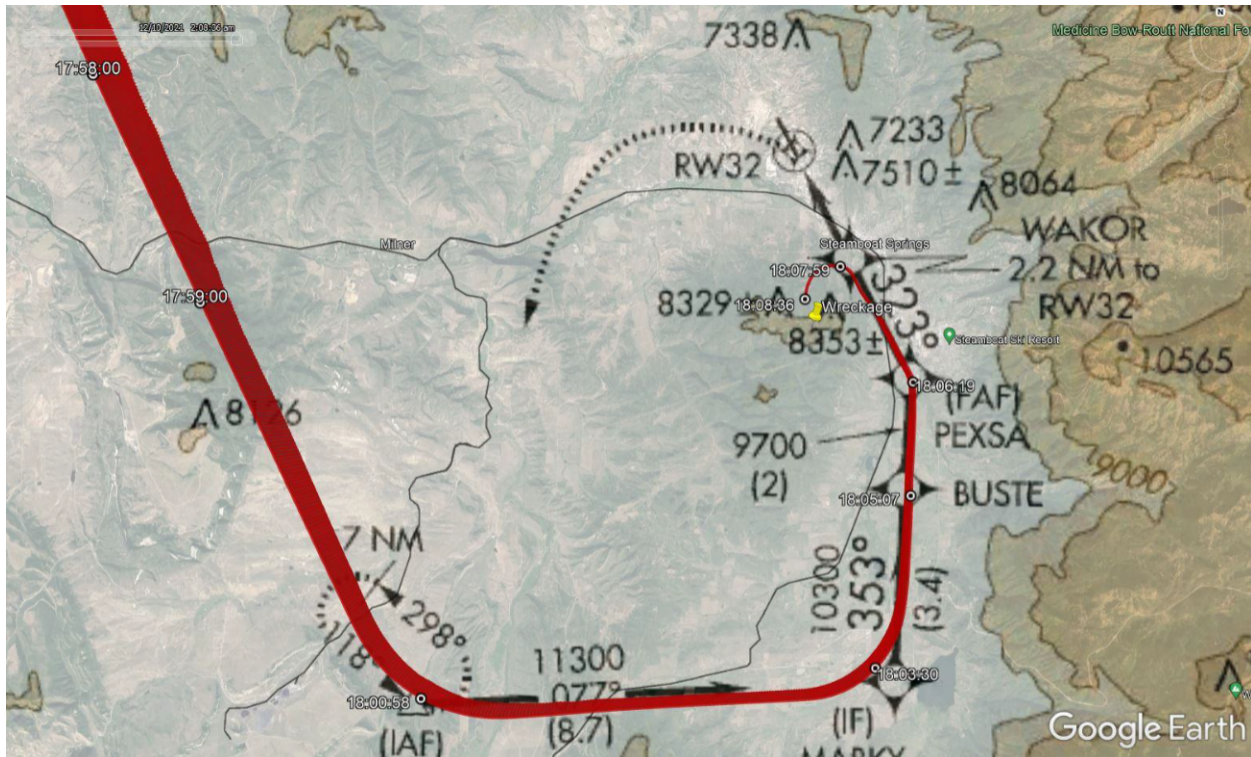
Figure 2: A Google Earth plot showing the accident aiplane's ground track in the vicinity of the KSBS terminal area. An FAA published approach plate for the RNAV (GPS)-E approach has been overlaid with a 50% opacity. A yellow pin has been added indicating the position of the wreckage.
