Aviation Investigation Final Report

Location:	Steamboat Springs, Colorado	Accident Number:	CEN22FA069
Date & Time:	December 10, 2021, 18:09 Local	Registration:	N744Z
Aircraft:	Piper PA46-500TP	Aircraft Damage:	Substantial
Defining Event:	Controlled flight into terr/obj (CFIT)	Injuries:	1 Fatal
Flight Conducted Under:	Part 91: General aviation - Personal

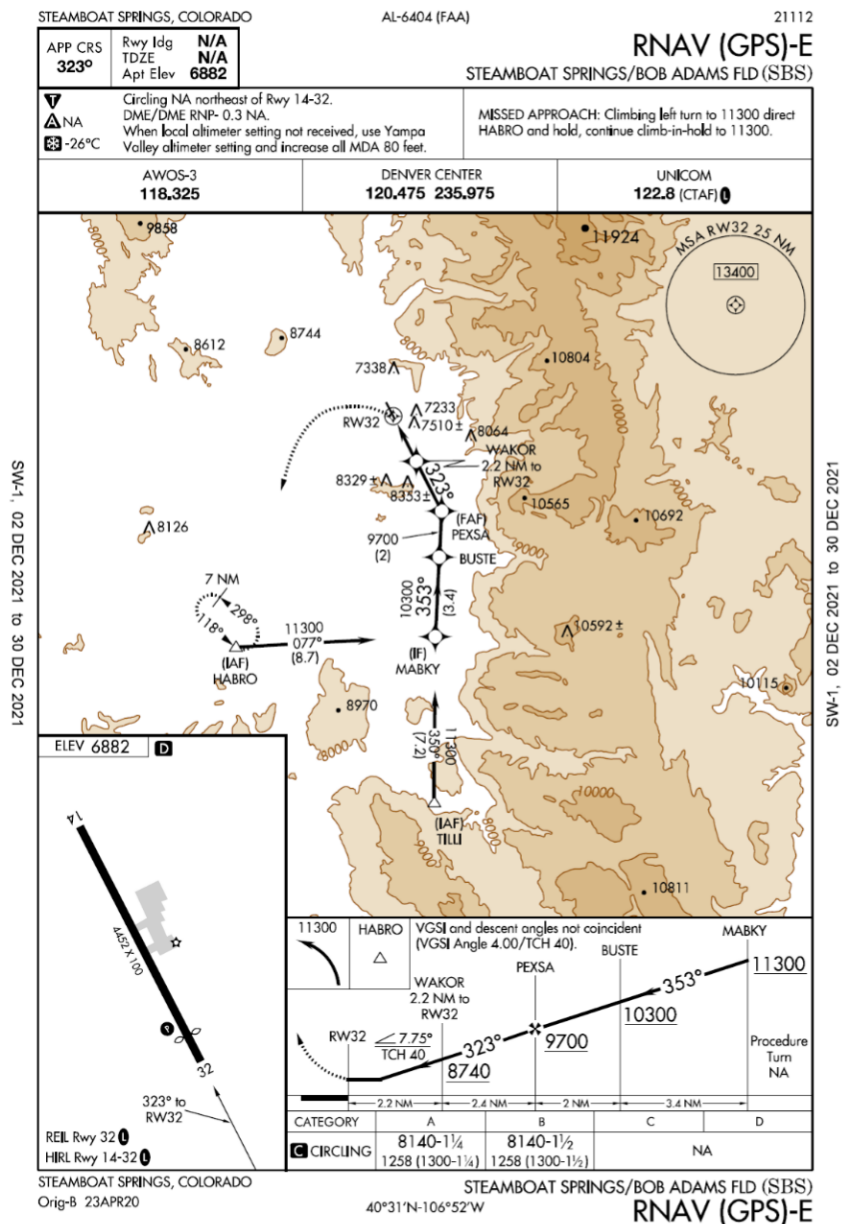
Figure 1: Published Instrument Approach Procedure

For terrain clearance, the procedure required the airplane to cross the final approach fix PEXSA at or above 9,700 ft mean sea level (msl) and WAKOR, the next waypoint located 2.2 nm from runway 32 threshold, at or above 8,740 ft msl. The ADS-B data showed that the accident airplane crossed PEXSA about 9,100 ft msl and WAKOR about 8,200 ft msl respectively.

The procedure allowed for a descent to the minimum descent altitude of 8,140 ft msl or 1,258 ft above ground level after passing WAKOR. The missed approach point for the procedure was

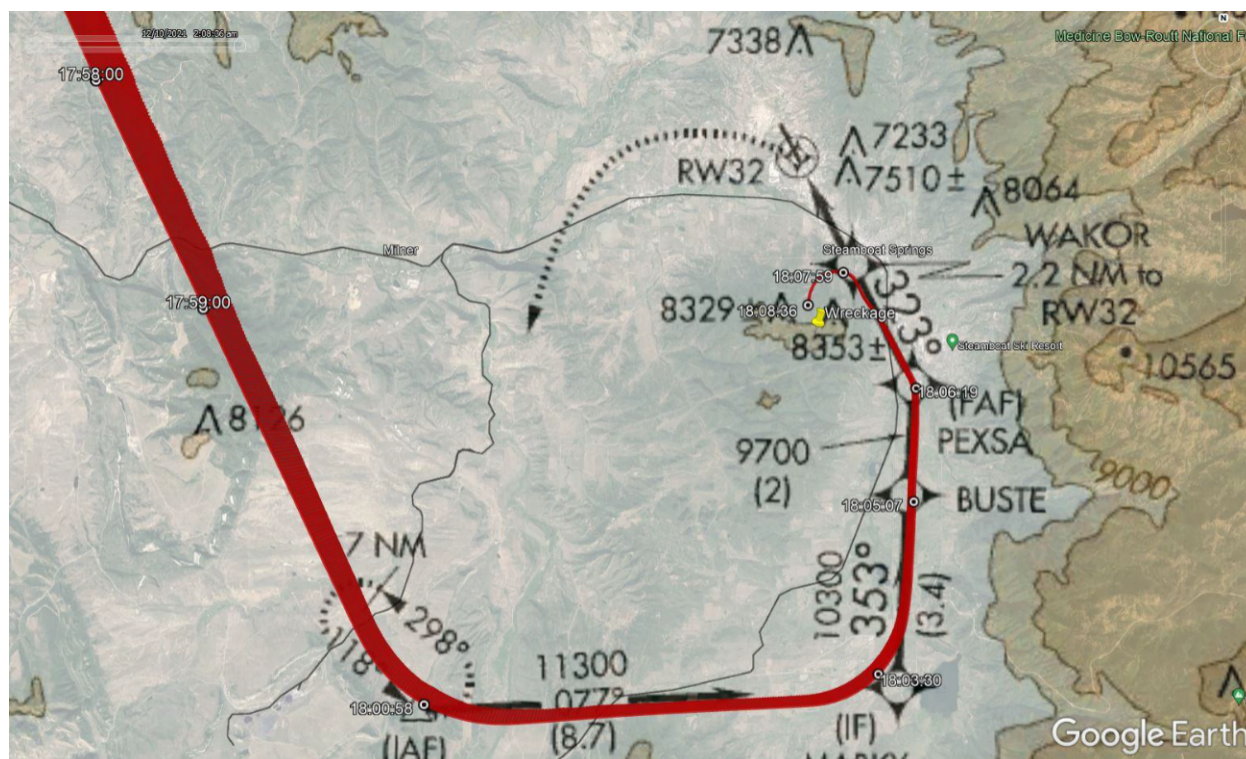
the runway 32 approach end, and then required a climbing left turn to 11,300 ft msl and indicated the pilot should proceed direct to the HABRO waypoint to enter a holding pattern. Immediately after passing WAKOR, the airplane made a left turn as shown in figure 2 and descended to an altitude of about 7,850 ft msl. The airplane subsequently began to climb, and the last ADS-B data point recorded at 1808:49 indicated an altitude of about 8,125 ft msl and was located about 3.5 miles north of the accident site.

Figure 2: A Google Earth plot showing the accident aiplane's ground track in the vicinity of the KSBS terminal area. An FAA published approach plate for the RNAV (GPS)-E approach has been overlaid with a 50% opacity. A yellow pin has been added indicating the position of the wreckage.
