# Aviation Investigation Final Report

<b>Location:</b>	Bermuda Dunes, California	<b>Accident Number:</b>	WPR22LA061
<b>Date &amp; Time:</b>	December 11, 2021, 12:30 Local	<b>Registration:</b>	N9YY
<b>Aircraft:</b>	MOUL WILLIS RV-3	<b>Aircraft Damage:</b>	Substantial
<b>Defining Event:</b>	Aerodynamic stall/spin	<b>Injuries:</b>	1 Fatal
<b>Flight Conducted Under:</b>	Part 91: General aviation - Personal

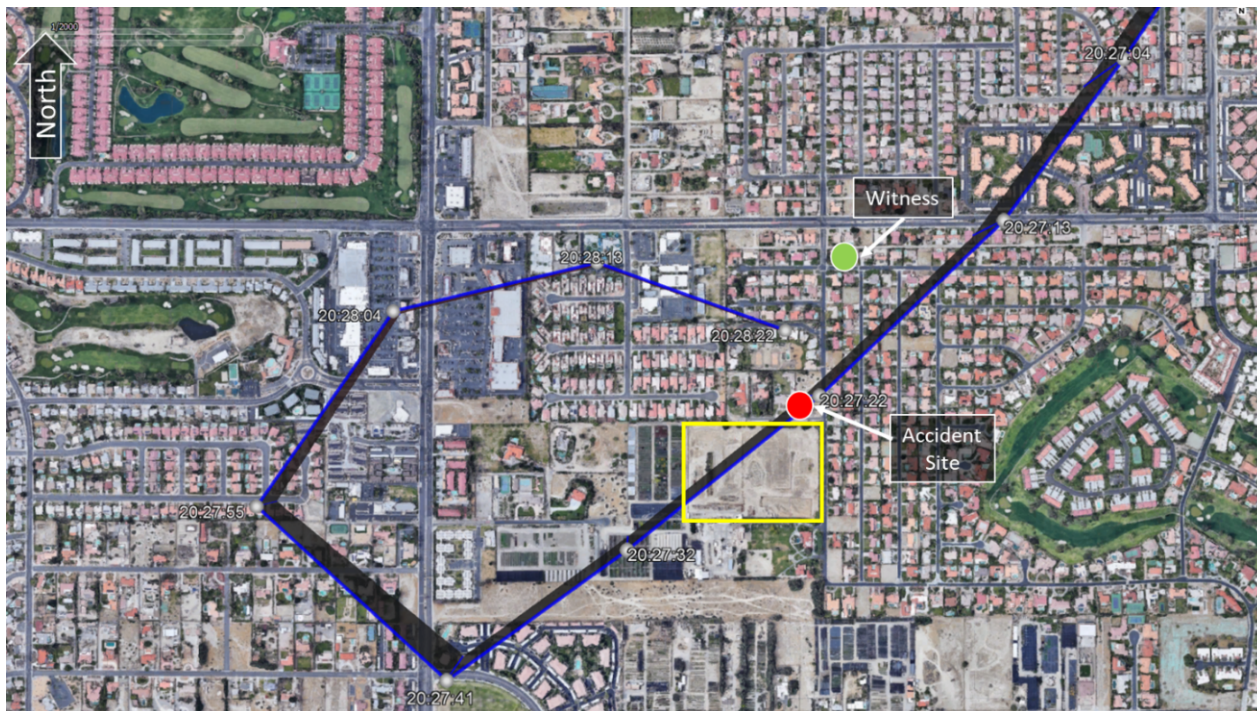
A security camera located at UDD, captured the airplane as it lifted off at 1226:17 and flew out of view. Automatic dependent surveillance-broadcast (ADS-B) data provided by the Federal Aviation Administration (FAA) revealed that, at 1226:55 the airplane was about .6 miles southwest of UDD at an altitude of 517 ft above ground level (agl), and on a heading consistent with a track toward the pilot’s residence. The airplane overflowed a portion of the city of Bermuda Dunes, California. The airplane maintained the southeast heading for about 1.3 miles. At 1227:22, the airplane overflowed a 300-ft-by-900 ft vacant lot. About 10 seconds later, the airplane had reached a maximum altitude of 712 ft agl. Nine seconds later, it had descended to 672 ft agl and began a right turn. The airplane continued the descending right turn until the end of the track data, at 1228:22. At that time, the airplane was on a heading of 124° at a low altitude, about 525 ft north of the accident site, as shown in figure 1. The accident site was immediately north of the vacant lot the airplane had previously overflowed.

Figure 1. Overhead view of the ADS-B flight track. A vacant lot is identified by a yellow border.

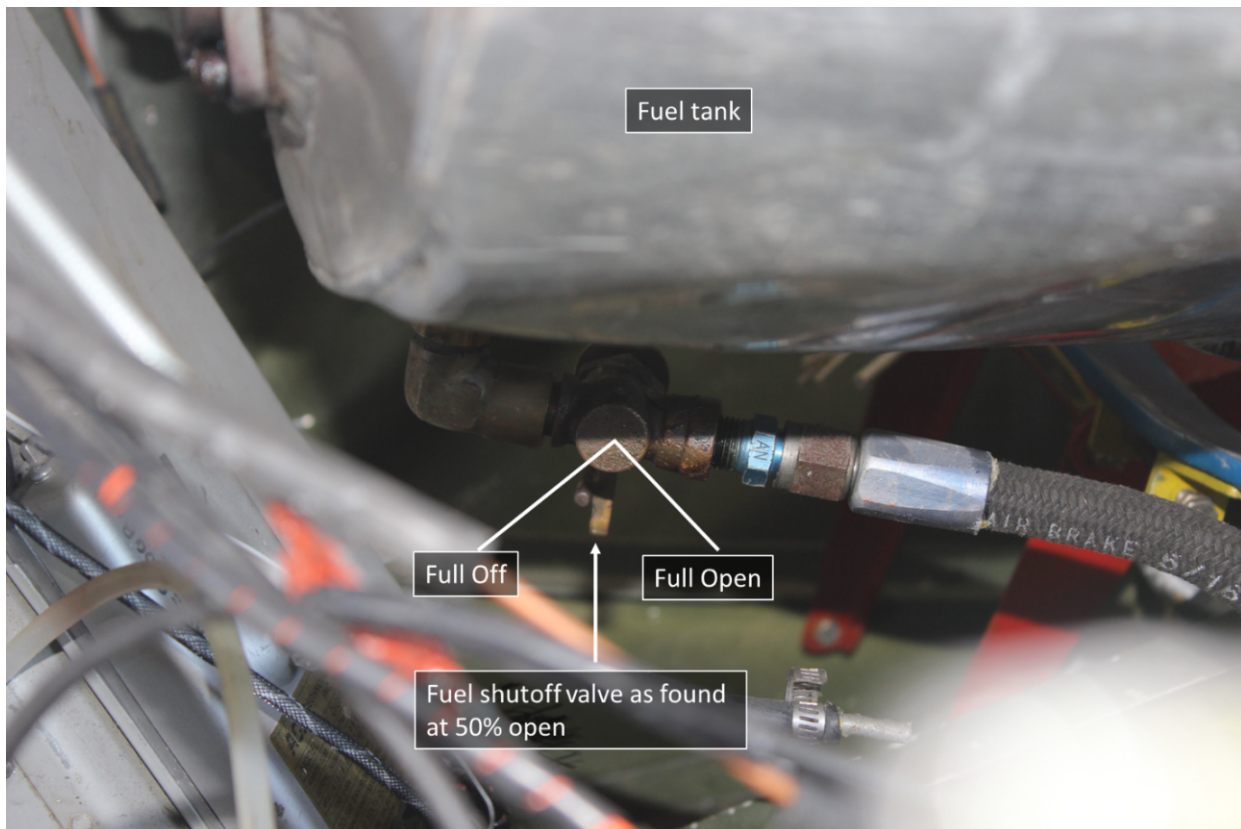
The pilot's improper positioning of the fuel shutoff valve, which resulted in a loss of engine power, and the pilot's subsequent exceedance of the airplane's critical angle of attack, resulting in an aerodynamic stall and loss of control.

Postaccident examination revealed a fuel shutoff valve mounted to the underside of the breached fuel tank. The fuel shutoff valve handle had no markings to identify an open or closed position, and it was positioned 90° to the fuel line. (see figure 2). The valve was disassembled and examined. When viewed through the fuel passage, and the valve handle was set at 90° to the fuel line; the fuel passage was open about 50%. When the handle was moved aft to the 135° position; the fuel flow was shut off. When the handle was pushed forward to the 45° position, the fuel passage was open 100%. According to a first responder, he did not see anyone manipulate the fuel shutoff valve following the accident. He reported that, by the time

Figure 2. Image of the fuel shutoff valve as found at the accident site.
