Aviation Investigation Final Report

Location:	El Cajon, California	Accident Number:	WPR22FA068
Date & Time:	December 27, 2021, 19:14 Local	Registration:	N880Z
Aircraft:	GATES LEARJET CORPORATION 35A	Aircraft Damage:	Destroyed
Defining Event:	Loss of control in flight	Injuries:	4 Fatal
Flight Conducted Under:	Part 91: General aviation - Positioning

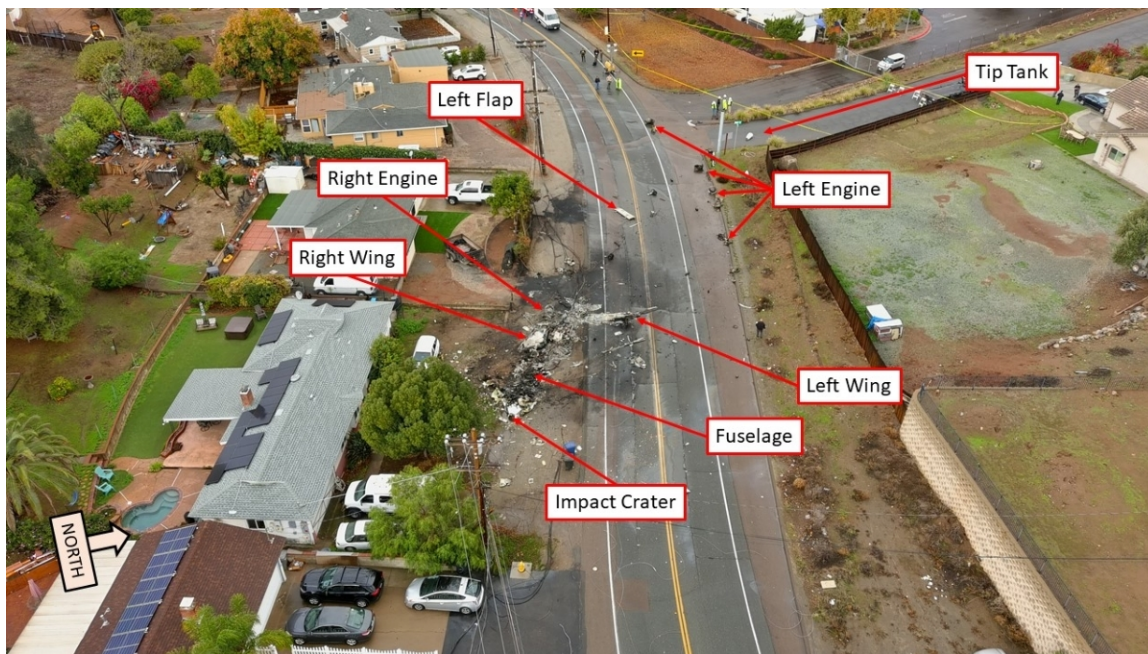
Figure 3: Accident site aerial photo (Courtesy of the San Diego Sheriff Office) with NTSB annotations.

Examination of the accident site revealed that the airplane struck a set of power lines and subsequently impacted the yard of a residential home about 1.43 nautical miles east of the approach end of runway 27R. The airplane came to rest upright on a heading of about 118° at an elevation of about 595 ft msl. The wreckage debris path was oriented on a heading of about 310° and was about 186 ft long and 90 ft wide.

The first identified point of impact was a large crater, which contained the forward portion of the fuselage, including the nose cone area, portions of the instrument panel, and the upper windscreen structure. The remains of the fuselage extended about 42 ft from the crater to where the elevator control horn was found. The right wing was immediately next to and in a parallel orientation to the fuselage. Portions of the left and right horizontal stabilizer and elevators, rudder, and right engine were located adjacent to the elevator control horn. The left wing was located just beyond the area where most of the fuselage was found.

Extending from the fuselage, various debris was found, including both main landing gear, the left flap, portions of the left engine, and tip tank. All major structural components were located within the wreckage debris path.
