Aviation Investigation Final Report

Location:	El Cajon, California	Accident Number:	WPR22FA068
Date & Time:	December 27, 2021, 19:14 Local	Registration:	N880Z
Aircraft:	GATES LEARJET CORPORATION 35A	Aircraft Damage:	Destroyed
Defining Event:	Loss of control in flight	Injuries:	4 Fatal
Flight Conducted Under:	Part 91: General aviation - Positioning

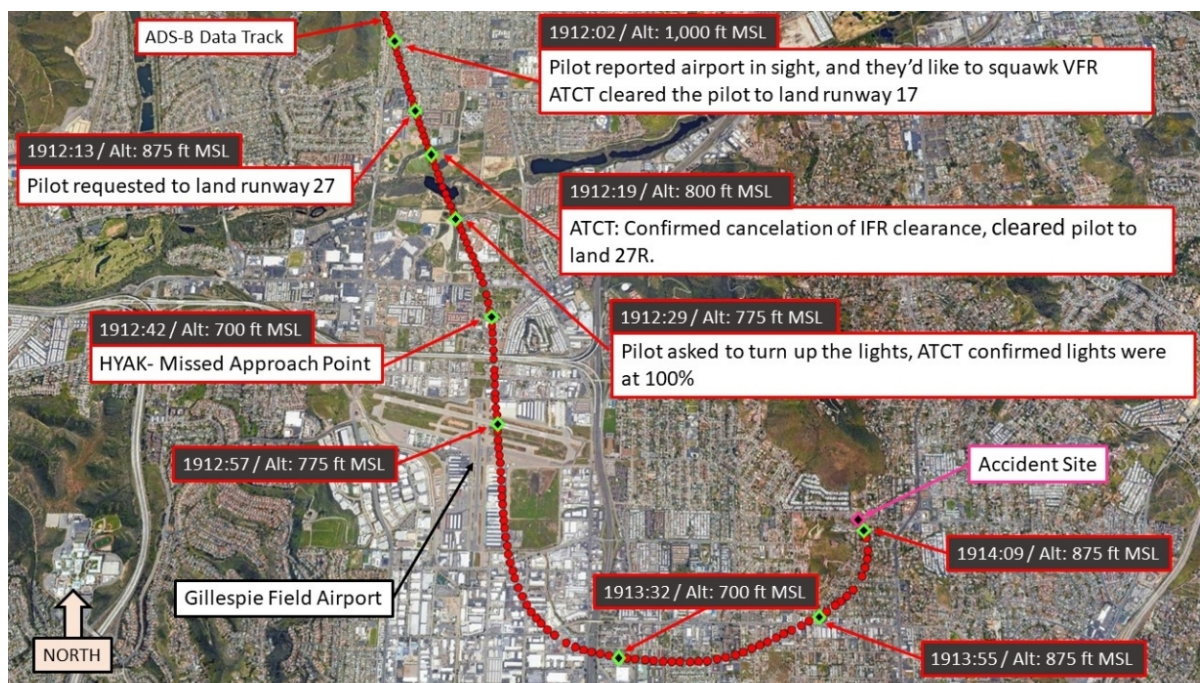
Figure 1: Recorded ADS-B data with ATC communication annotations.

Automatic dependent surveillance – broadcast (ADS-B) data showed that at the time the flight crew reported the runway in sight, they were about 360 ft below the instrument approach minimum descent altitude (MDA), and upon crossing the published missed approach point they were 660 ft below the MDA. The data showed that the flight overflew the destination airport at an altitude of about 775 ft mean sea level (msl), or 407 ft above ground level (agl), and entered a left downwind for runway 27R. While on the downwind leg, the airplane descended to an altitude of 700 ft msl, then ascended to an altitude of 950 ft msl while on the base leg. The last recorded ADS-B target was at an altitude of 875 ft msl, or about 295 ft agl.

ADS-B data showed that after departure from SNA, the flight made a left turn out over the waters of the Pacific Ocean and flew generally south-southeast along the coast and ascended to a cruise altitude of about 11,000 ft msl. After the flight passed Carlsbad, California, the airplane turned left and began to descend toward SEE. As shown in Figure 1, ADS-B data showed that the airplane was at 1,000 ft msl at the time flight crew reported the runway in sight. Additionally, as the airplane was abeam the HIRAK missed approach point, it was at an altitude of 700 ft msl. The data showed that the airplane overflew SEE at an altitude of about 775 ft msl (407 ft agl) and entered a left downwind for runway 27R. While on the downwind leg, the airplane descended to an altitude of 700 ft msl, then ascended to an altitude of 950 ft msl while on the base leg. The last recorded ADS-B target was at 1914:09, at an altitude of 875 ft msl, about 100 ft southeast of the accident site.

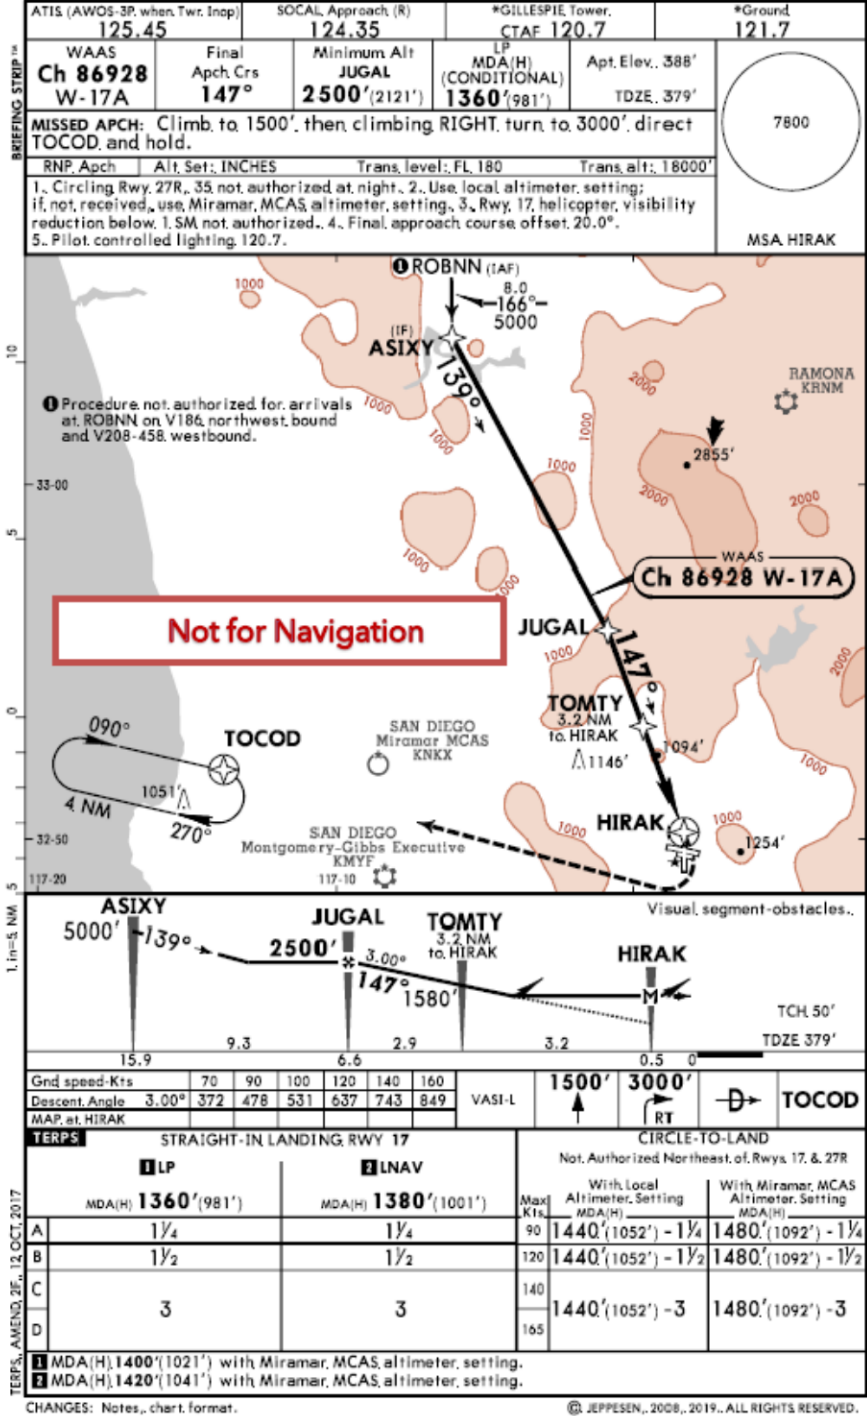
Figure 2: Runway 17 RNAV Instrument Approach Plate.

Review of air traffic control (ATC) communication, as well as cockpit voice recorder (CVR) recordings, showed that the flight crew initially was cleared on the RNAV (GPS) runway 17 instrument approach. The approach plate for the instrument approach stated that circling to runway 27R and 35 was not authorized at night.

Gillespie Field Airport (SEE) is a tower-controlled airport that operates under Class D airspace. The reported field elevation is 388 ft msl. The airport features 3 asphalt runways; runway 09L/27R, which is 5,342 ft long and 100 ft wide; runway 09R/27L, which is 2,738 ft long and 60 ft wide; and runway 17/35, which is 4,145 ft long and 100 ft wide. Runway 17 is equipped with an RNAV (GPS) instrument approach. The MDA for the localizer performance without vertical guidance (LP) for all categories was 1,360 ft msl. The approach plate notes that circling runway 27R and 35 was not authorized at night. The airport is also equipped AWOS.

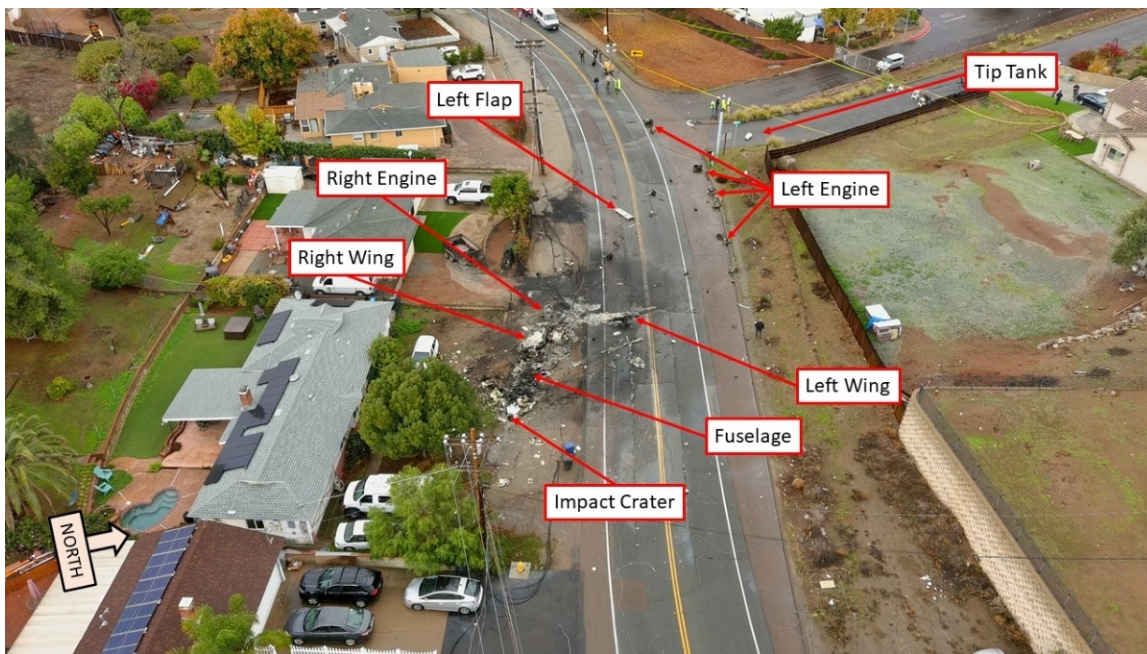
Figure 3: Accident site aerial photo (Courtesy of the San Diego Sheriff Office) with NTSB annotations.

Examination of the accident site revealed that the airplane struck a set of power lines and subsequently impacted the yard of a residential home about 1.43 nautical miles east of the approach end of runway 27R. The airplane came to rest upright on a heading of about 118° at an elevation of about 595 ft msl. The wreckage debris path was oriented on a heading of about 310° and was about 186 ft long and 90 ft wide.

The first identified point of impact was a large crater, which contained the forward portion of the fuselage, including the nose cone area, portions of the instrument panel, and the upper windscreen structure. The remains of the fuselage extended about 42 ft from the crater to where the elevator control horn was found. The right wing was immediately next to and in a parallel orientation to the fuselage. Portions of the left and right horizontal stabilizer and elevators, rudder, and right engine were located adjacent to the elevator control horn. The left wing was located just beyond the area where most of the fuselage was found.

Extending from the fuselage, various debris was found, including both main landing gear, the left flap, portions of the left engine, and tip tank. All major structural components were located within the wreckage debris path.
