Aviation Investigation Final Report

Location:	Livingston, Texas	Accident Number:	CEN22FA086
Date & Time:	December 30, 2021, 11:41 Local	Registration:	N8AU
Aircraft:	Bell 206B	Aircraft Damage:	Substantial
Defining Event:	Loss of tail rotor effectiveness	Injuries:	2 Fatal, 2 Minor
Flight Conducted Under:	Part 91: General aviation - Personal

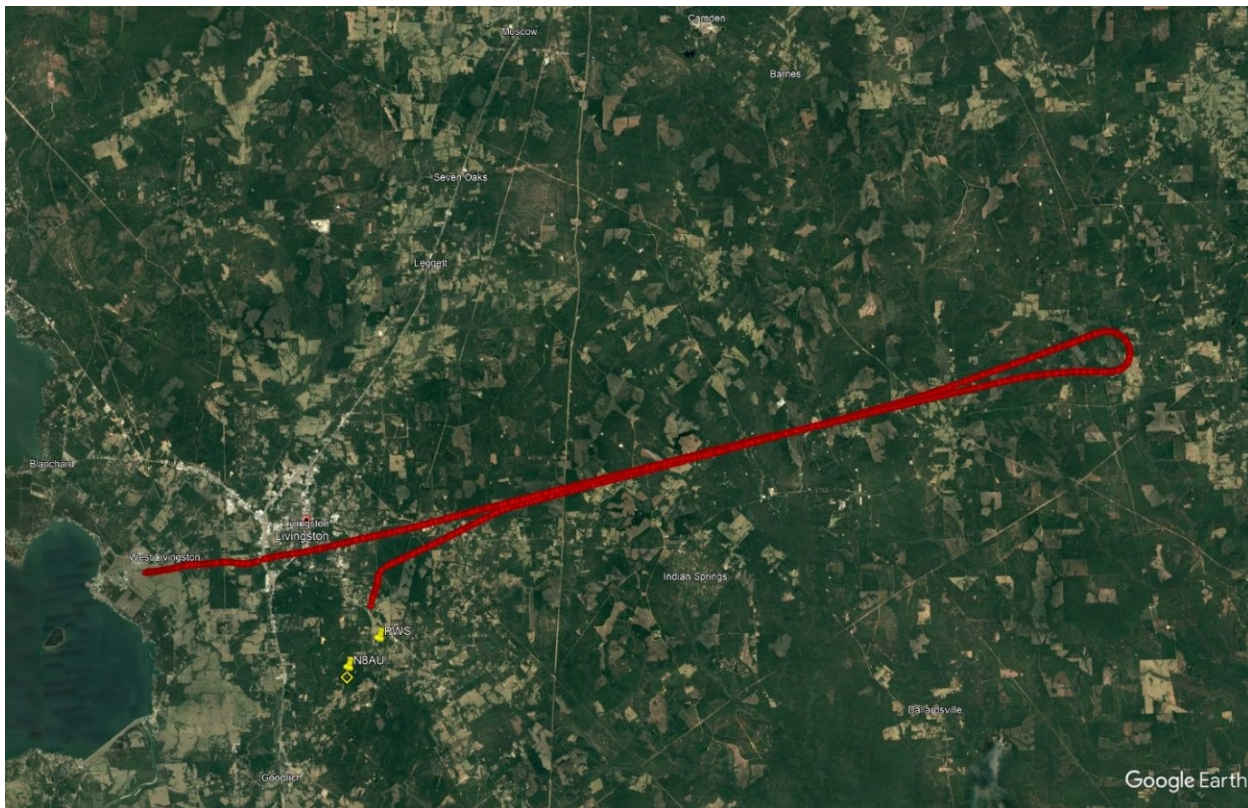
Automatic dependent surveillance - broadcast data for the flight showed that the helicopter departed the Livingston Municipal Airport (00R) about 1107 and headed east-northeast for about 25 nautical miles (nm) before reversing course to a west-southwest direction. The helicopter then turned further south before the end of the data at 1138. The final recorded location was 1.8 nm northeast of the accident site.

Figure 1. ADS-B Flight Path Depiction

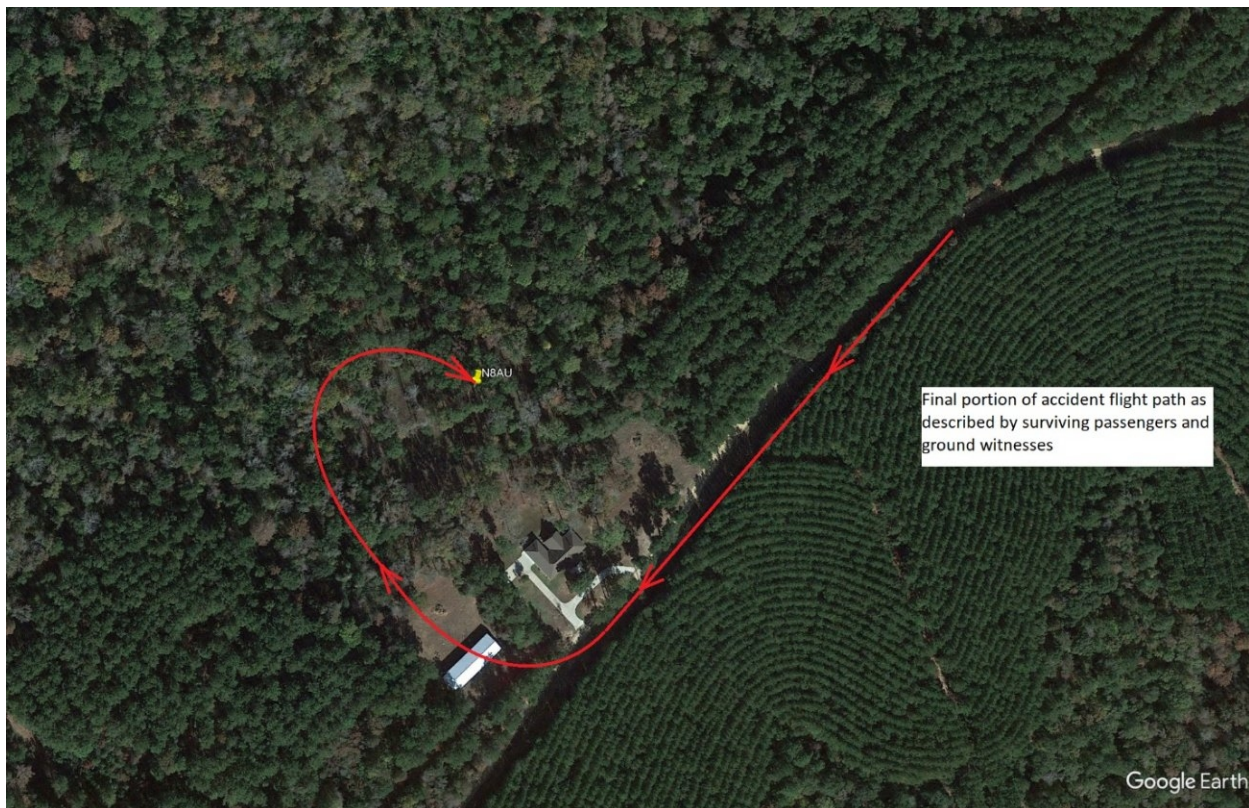
According to the surviving passengers, the flight was a sightseeing flight that the deceased front-seat passenger had won at a local charity auction. On the day of the accident, the passengers met the pilot at 00R. The original intent was to fly over the deceased passenger's childhood home near Woodville, TX. While on course toward Woodville, it became evident that the flight could not be continued due to low clouds and the helicopter was then maneuvered to the passenger's current residence near Livingston, TX. The rear-seat passengers stated that the helicopter flew down the road where the residence was located and then around the house making a level right turn at low speed. The helicopter then flew over a pond on the property and toward the house. As the helicopter approached the house it was facing a south direction and came to a hover above the trees where the accident occurred. The passengers stated that the helicopter was either motionless in the hover or slightly drifting.

Figure 2. Depiction of the Flight Final Path to the Accident Site

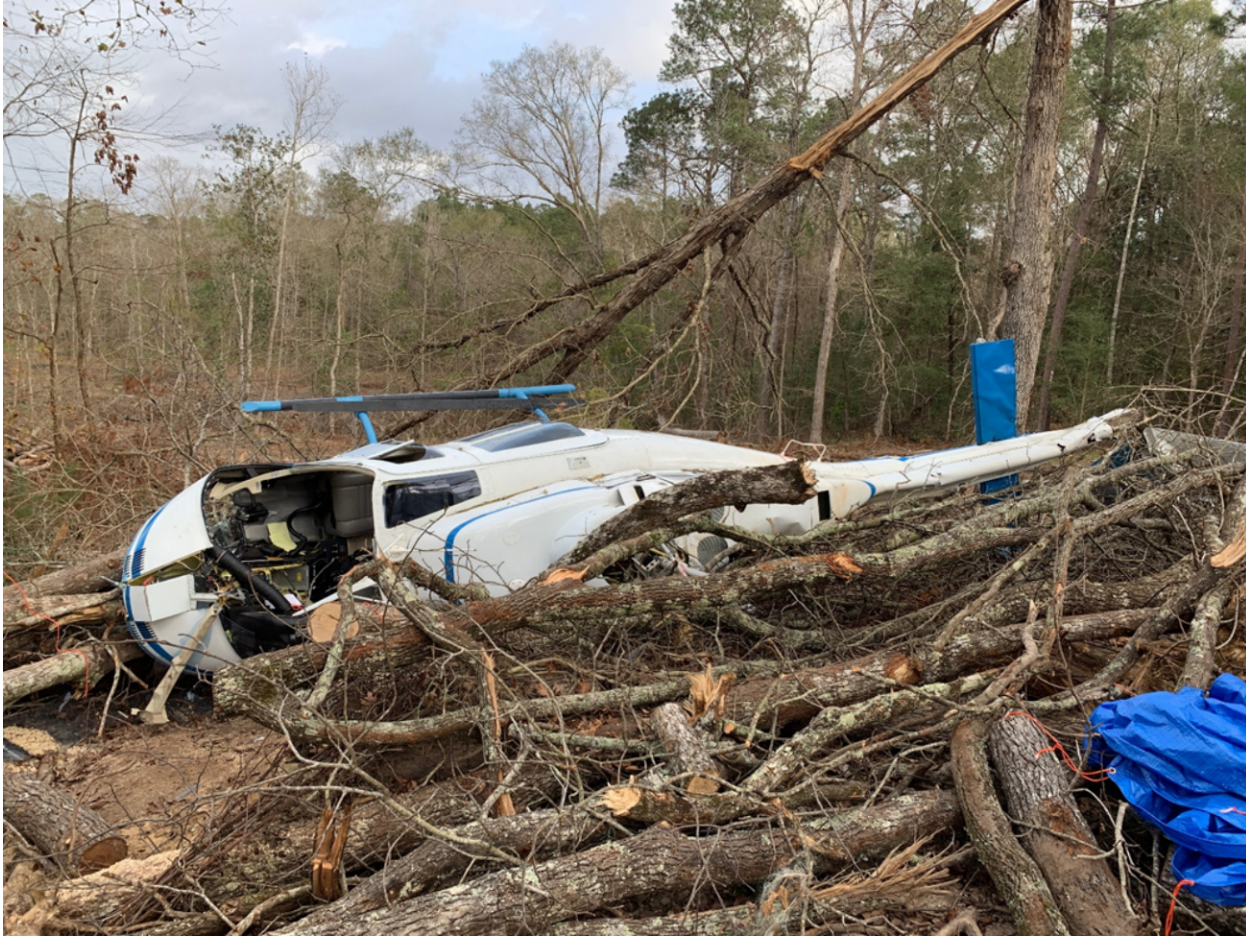
Figure 3. Helicopter as viewed during on-scene examination (NTSB Photo)

The helicopter impacted terrain and rolled over onto its left side coming to rest on a pile of logs. The forward fuselage and left side fuselage and tail boom sustained substantial damage. The main and tail rotors were separated. The elevation at the accident site was about 250 ft above mean sea level.

Postaccident examination of the helicopter did not reveal any preimpact failures or malfunctions with the airframe, rotor systems, engine, or flight controls that would have precluded normal operations.
