# Aviation Investigation Final Report

<b>Location:</b>	Upland, California	<b>Accident Number:</b>	WPR22LA072
<b>Date &amp; Time:</b>	January 3, 2022, 12:05 Local	<b>Registration:</b>	N76646
<b>Aircraft:</b>	Cessna 120	<b>Aircraft Damage:</b>	Substantial
<b>Defining Event:</b>	Loss of control in flight	<b>Injuries:</b>	1 Minor
<b>Flight Conducted Under:</b>	Part 91: General aviation - Personal

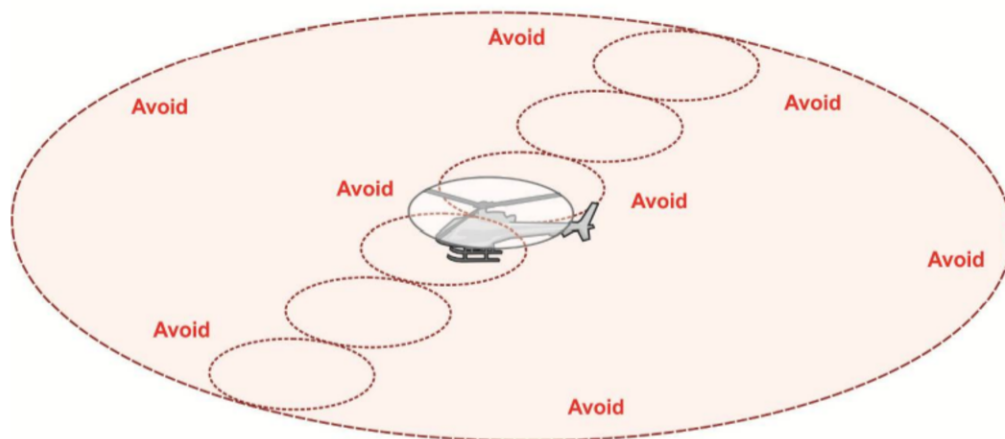
Figure 1. Excerpt of Helicopter Vortices Figure from AC 90-23G

According to Federal Aviation Administration Advisory Circular No. 90-23G, Aircraft Wake Turbulence, “pilots should avoid taxiing or flying within a distance of three rotor diameters of a helicopter hovering or in a slow hover taxi, as the downwash can contain high wind speeds.

## Slow Hover Taxi or Stationary Hover: Avoid Operations Within Distances of 3 Times Rotor Diameter
