Aviation Investigation Final Report

Location:	Marana, Arizona	Accident Number:	WPR22FA073
Date & Time:	December 31, 2021, 13:30 Local	Registration:	N6796N
Aircraft:	Mooney M20C	Aircraft Damage:	Substantial
Defining Event:	Loss of visual reference	Injuries:	1 Fatal
Flight Conducted Under:	Part 91: General aviation - Personal

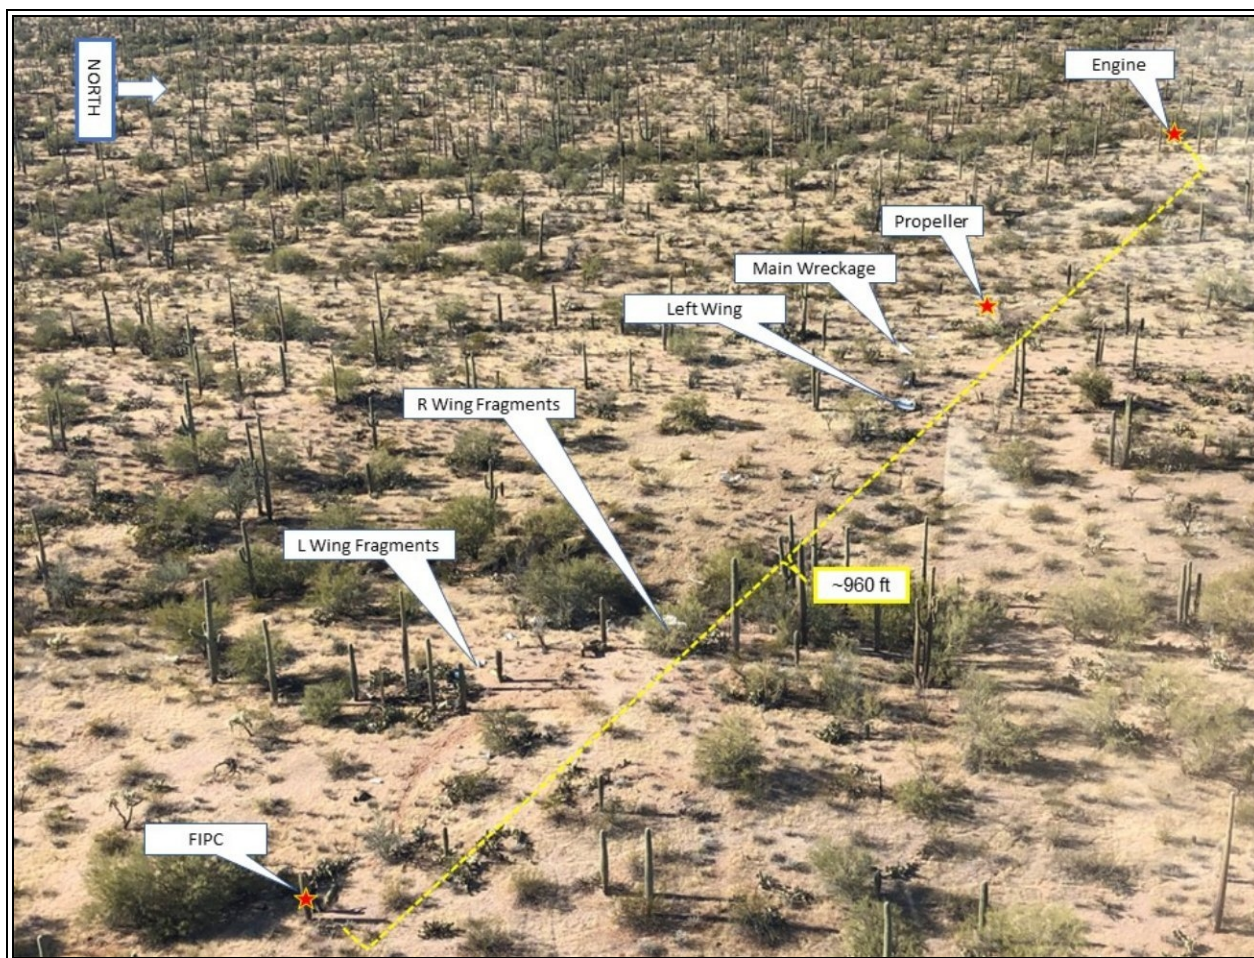
Examination of the accident site revealed that the airplane impacted open desert terrain about 56 miles northwest of the Marana Regional Airport at an elevation of 2,162 ft msl. The wreckage debris path was about 960 ft in length, and oriented on a heading of about 308°. All major structural components were observed throughout the debris path.

Figure 1: Aerial view of accident site.
