# Aviation Investigation Final Report

<b>Location:</b>	Defiance, Missouri	<b>Accident Number:</b>	CEN22FA096
<b>Date &amp; Time:</b>	January 8, 2022, 19:19 Local	<b>Registration:</b>	N585CK
<b>Aircraft:</b>	Beech 58	<b>Aircraft Damage:</b>	Destroyed
<b>Defining Event:</b>	Loss of control in flight	<b>Injuries:</b>	2 Fatal
<b>Flight Conducted Under:</b>	Part 91: General aviation - Positioning

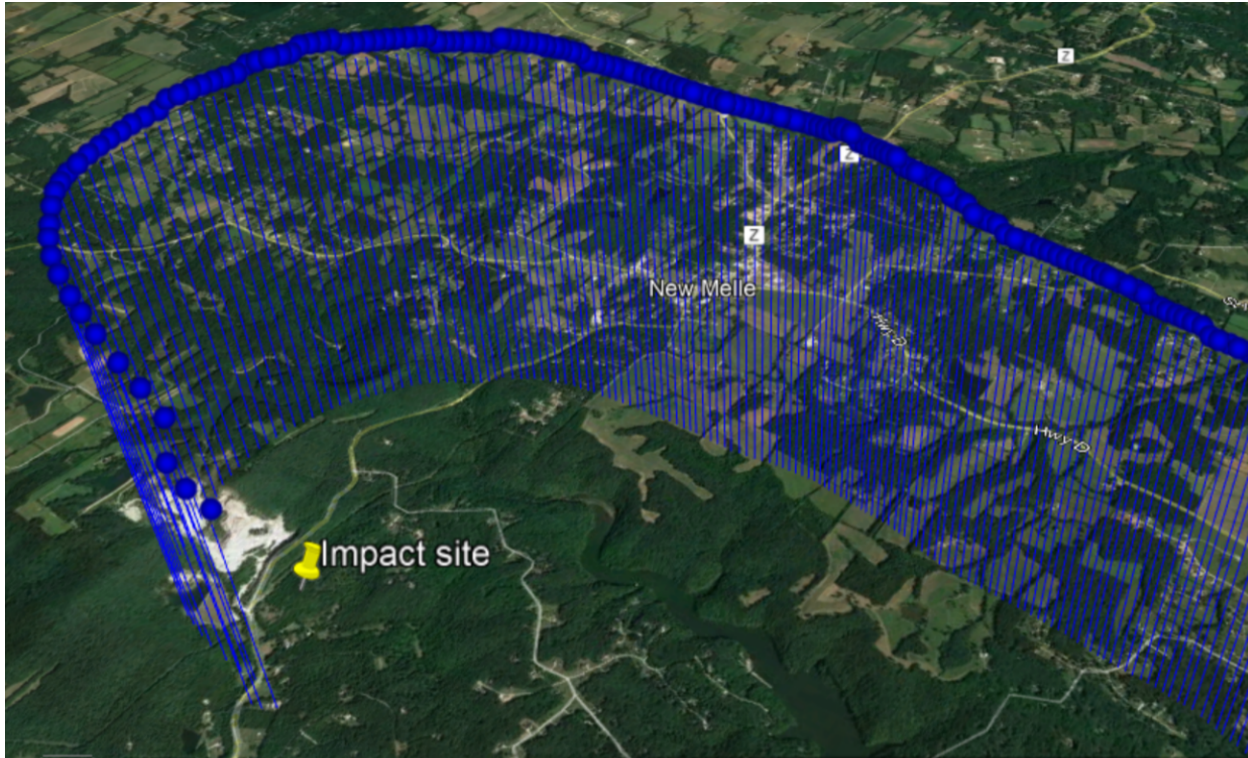
Figure 1. ADS-B Data and Impact Site

According to automatic dependent surveillance-broadcast (ADS-B) data, the airplane departed SUS at 1910. After leveling off at 8,000 ft mean sea level (msl) while on a westerly heading, the airplane made a gradual left turn toward the southeast. The airplane continued turning left and descended rapidly.

The controller queried about the airplane's incorrect altitude and direction of flight. A jumbled radio transmission was made by the copilot and no distress call was received. During the final 10 seconds of captured ADS-B data, the airplane descended from 7,500 to 4,700 ft msl.

The airplane impacted forested terrain about 0.40-mile northwest of the last recorded ADS-B data (see figure 1). Two surveillance systems located less than 1 mile from the accident site recorded audio of an airplane with engine noise increasing and the ground impact.

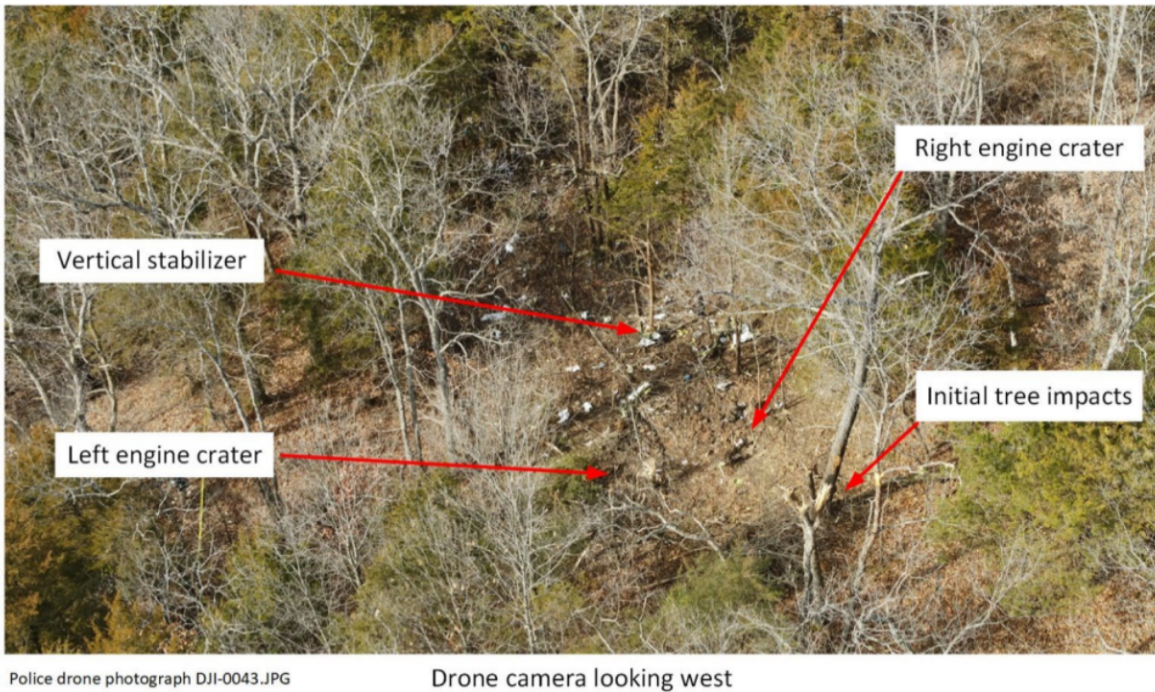
Figure 3. Overhead view of accident site

The airplane impacted into forested terrain (see figure 3). The debris path was on a westerly heading and highly fragmentary. Broken tree limbs indicated the airplane was in a steep descent with a left-wing-low attitude at impact.
