Aviation Investigation Final Report

Location:	Defiance, Missouri	Accident Number:	CEN22FA096
Date & Time:	January 8, 2022, 19:19 Local	Registration:	N585CK
Aircraft:	Beech 58	Aircraft Damage:	Destroyed
Defining Event:	Loss of control in flight	Injuries:	2 Fatal
Flight Conducted Under:	Part 91: General aviation - Positioning

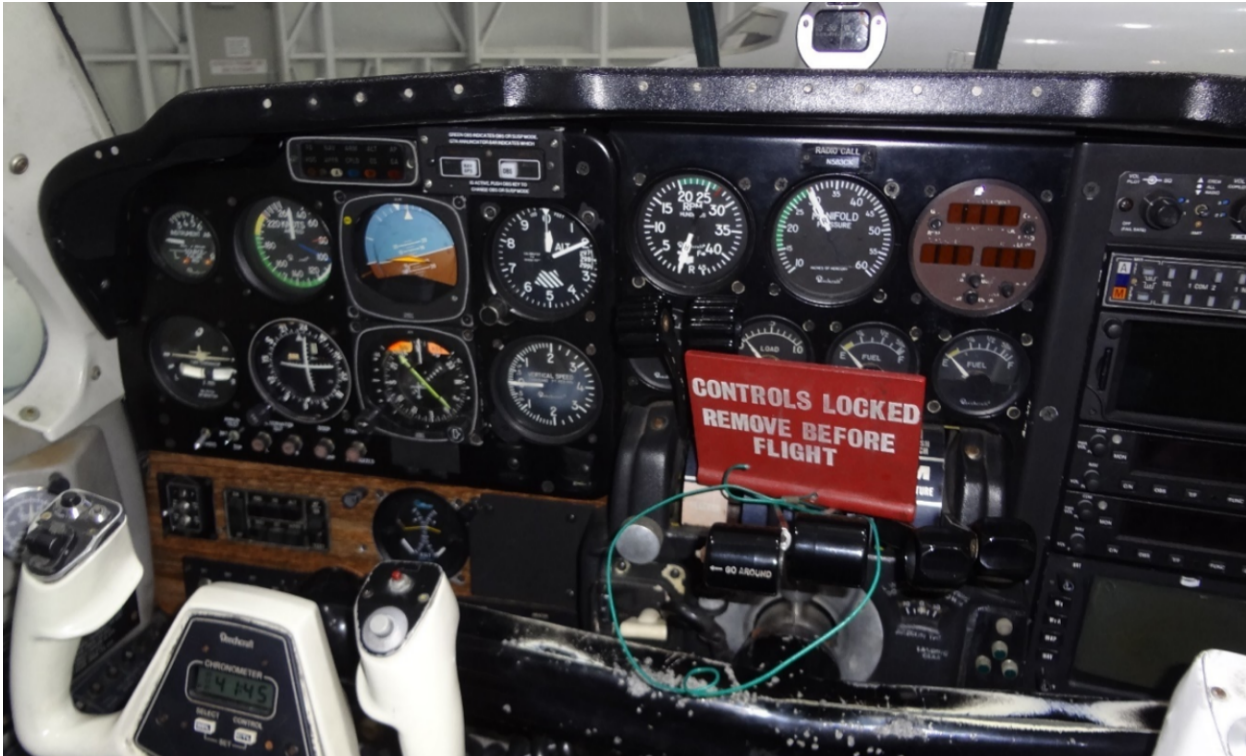
Figure 2. Instrument panel similar to accident airplane (Note: dual yoke was not installed on the accident airplane)

The airplane was equipped with a “throw-over” type control column, which controlled the elevator and ailerons. To change the yoke from one side of the cockpit to the other, the pilots could pull a T-handle latch on the back of the control arm, then the yoke could be positioned as desired. An optional dual control column that was required for flight instruction existed but was not installed on the accident airplane.

The flight instruments were located on the left side of the panel directly in front of the pilot's seat (see figure 2). Flight instrumentation included attitude and directional gyros, airspeed, altimeter, vertical speed, and turn coordinator. A magnetic compass was mounted above center of the instrument panel.
