Aviation Investigation Final Report

Location:	Hutchinson, Minnesota	Accident Number:	CEN22FA111
Date & Time:	January 31, 2022, 12:56 Local	Registration:	N227BD
Aircraft:	CIRRUS DESIGN CORP SR22	Aircraft Damage:	Substantial
Defining Event:	Unknown or undetermined	Injuries:	1 Fatal, 1 Serious
Flight Conducted Under:	Part 91: General aviation - Instructional

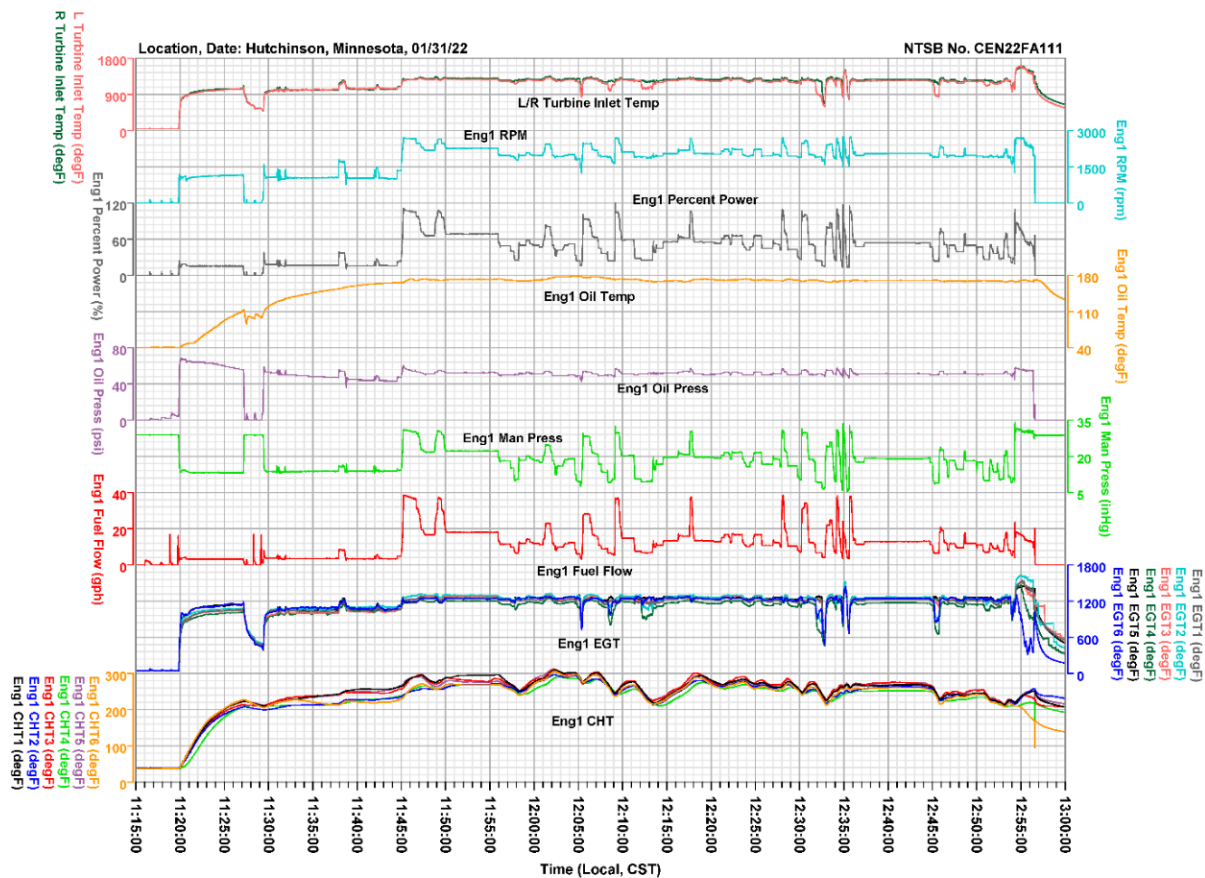
Figure 1. Plot of Engine Parameters from the RDM for the entire flight.

About 1253:50, the engine parameters decreased consistent with the airplane's final approach to the airport. At 1254:17, the GPS data indicated that the airplane crossed the runway threshold. Two seconds later, the engine parameters increased consistent with the go-around described by the flight instructor. The fuel flow increased initially to 23.7 gallons per hour but then decreased to less than 13 gallons per hour; during the initial takeoff about 1145 the fuel flow increased to 38 gallons per hour (See Figure 1).

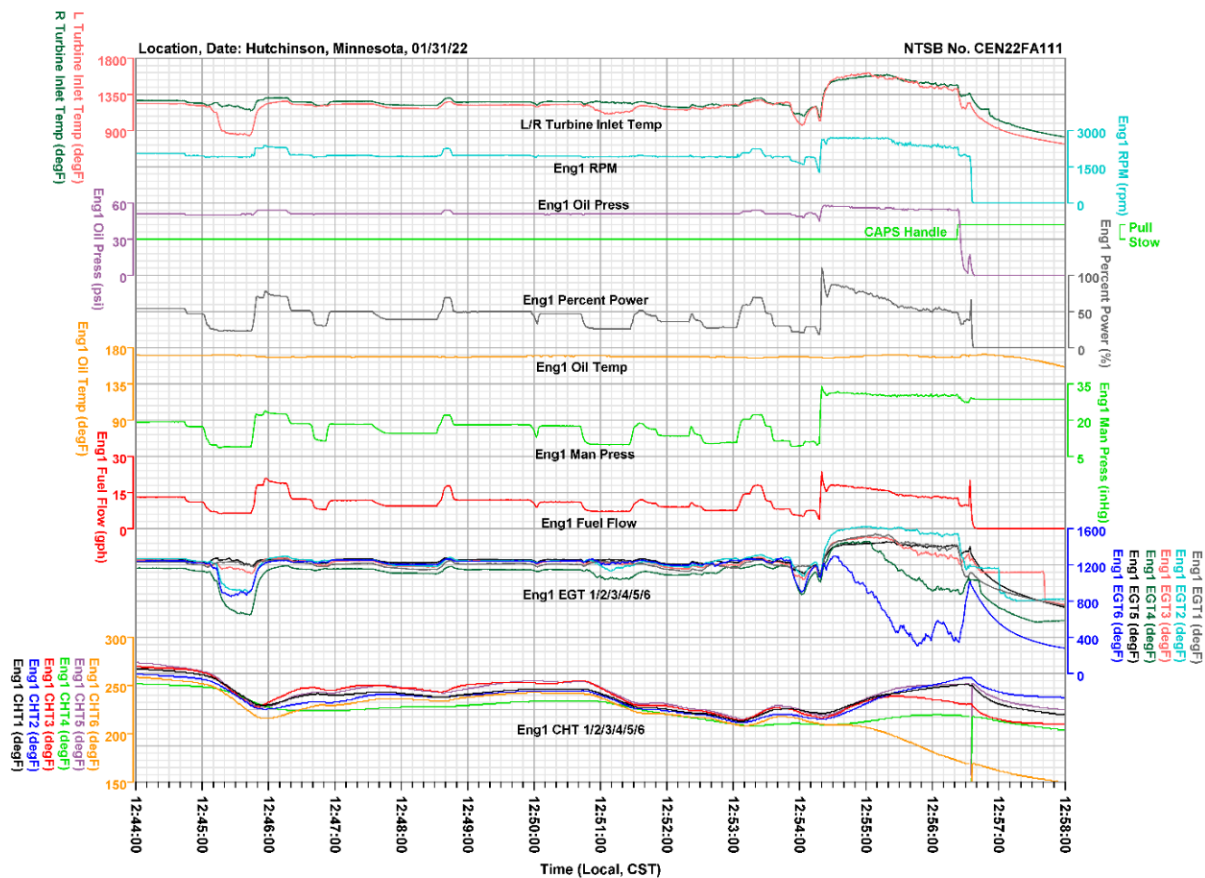
Figure 2. Plot of Engine Parameters from the RDM at the end of the flight from 1244 to 1258.

Following the increase in engine power, the exhaust gas temperature (EGT) and cylinder head temperature (CHT) for cylinder Nos. 2, 4, and 6 diverged. Over the next few minutes cylinder No. 2 increased to 1600° F (EGT) and 220° F (CHT), cylinder No. 4 initially increased and then dropped to 930° F (EGT) and stabilized around 220° F (CHT) and cylinder No. 6 decreased to below 500° F (EGT) and 175° F (CHT)(See Figure 2).

The recorded data also showed that the stall warning initially sounded about 1256:04 and again about 1256:15, continuing for about 8 seconds until the CAPS handle was pulled. At this same time the recorded engine parameters decreased consistent with the flight instructor's description of adjusting the mixture control to lean and the engine throttle to idle.
