Aviation Investigation Final Report

Location:	Hutchinson, Minnesota	Accident Number:	CEN22FA111
Date & Time:	January 31, 2022, 12:56 Local	Registration:	N227BD
Aircraft:	CIRRUS DESIGN CORP SR22	Aircraft Damage:	Substantial
Defining Event:	Unknown or undetermined	Injuries:	1 Fatal, 1 Serious
Flight Conducted Under:	Part 91: General aviation - Instructional

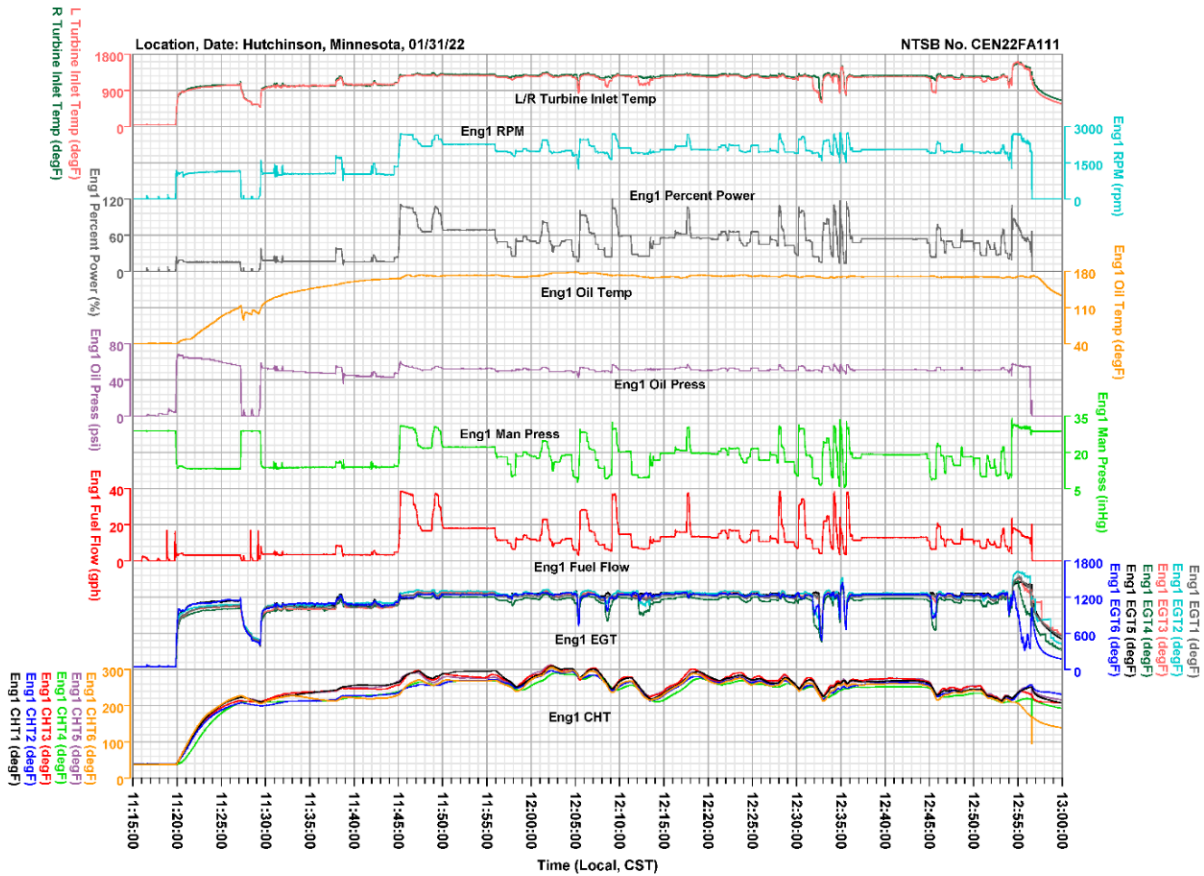
Figure 1. Plot of Engine Parameters from the RDM for the entire flight.

About 1253:50, the engine parameters decreased consistent with the airplane's final approach to the airport. At 1254:17, the GPS data indicated that the airplane crossed the runway threshold. Two seconds later, the engine parameters increased consistent with the go-around described by the flight instructor. The fuel flow increased initially to 23.7 gallons per hour but then decreased to less than 13 gallons per hour; during the initial takeoff about 1145 the fuel flow increased to 38 gallons per hour (See Figure 1).

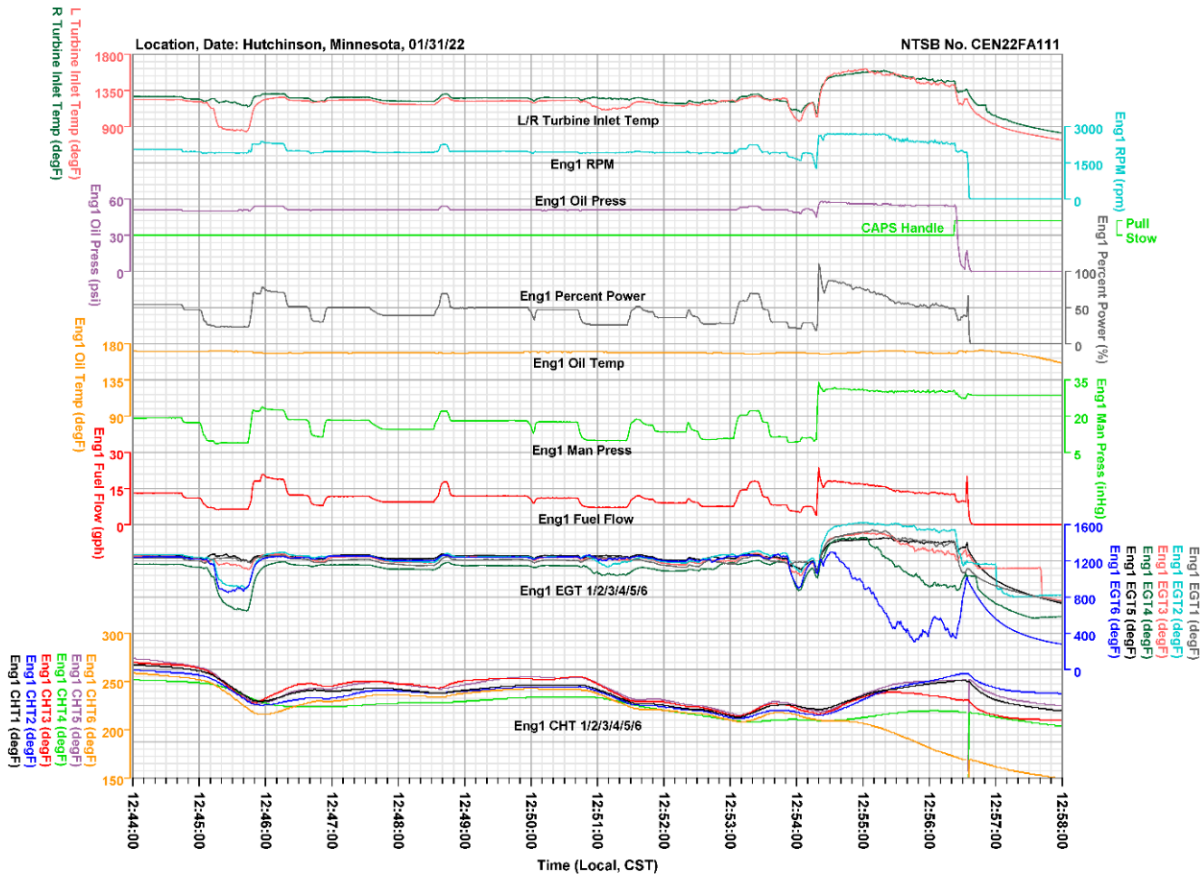
Figure 2. Plot of Engine Parameters from the RDM at the end of the flight from 1244 to 1258.

Following the increase in engine power, the exhaust gas temperature (EGT) and cylinder head temperature (CHT) for cylinder Nos. 2, 4, and 6 diverged. Over the next few minutes cylinder No. 2 increased to 1600° F (EGT) and 220° F (CHT), cylinder No. 4 initially increased and then dropped to 930° F (EGT) and stabilized around 220° F (CHT) and cylinder No. 6 decreased to below 500° F (EGT) and 175° F (CHT)(See Figure 2).

The recorded data also showed that the stall warning initially sounded about 1256:04 and again about 1256:15, continuing for about 8 seconds until the CAPS handle was pulled. At this same time the recorded engine parameters decreased consistent with the flight instructor’s description of adjusting the mixture control to lean and the engine throttle to idle.
