# Aviation Investigation Final Report

<b>Location:</b>	Beaufort, North Carolina	<b>Accident Number:</b>	ERA22LA120
<b>Date &amp; Time:</b>	February 13, 2022, 14:02 Local	<b>Registration:</b>	N79NX
<b>Aircraft:</b>	PILATUS AIRCRAFT LTD PC-12/47E	<b>Aircraft Damage:</b>	Destroyed
<b>Defining Event:</b>	Loss of control in flight	<b>Injuries:</b>	8 Fatal
<b>Flight Conducted Under:</b>	Part 91: General aviation - Personal

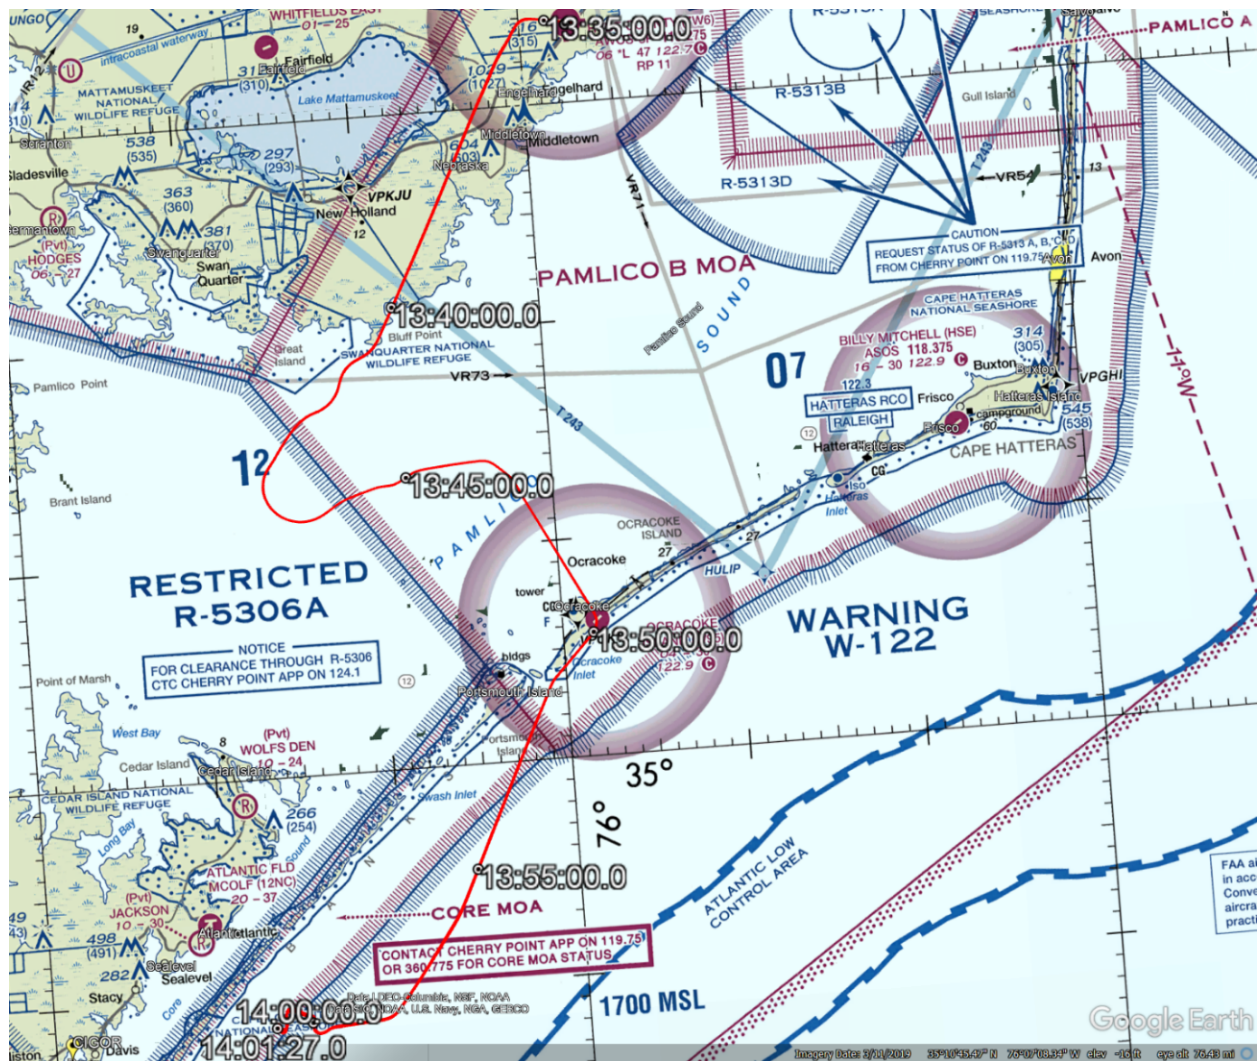
Figure 1. View of the airplane’s flight track (red) overlaid onto a visual flight rules sectional chart. The airplane’s position at various 5 minute time increments is also labeled.

After departure, the pilot and passenger spent several minutes amending and activating a flight plan into the airplane’s integrated flight management system before the pilot contacted air traffic control and reported they were going to level off at 3,500 ft mean sea level (msl). He requested VFR flight following as well as an IFR clearance to MRH. At 1338, the controller advised the pilot that a nearby restricted airspace was active, and the pilot confirmed that they would remain clear of the airspace and fly to the east. After that, while still attempting to program the autopilot flight plan, he stated, “I don’t know what I need to do. Just I almost [want] to take it all out and start from scratch.”

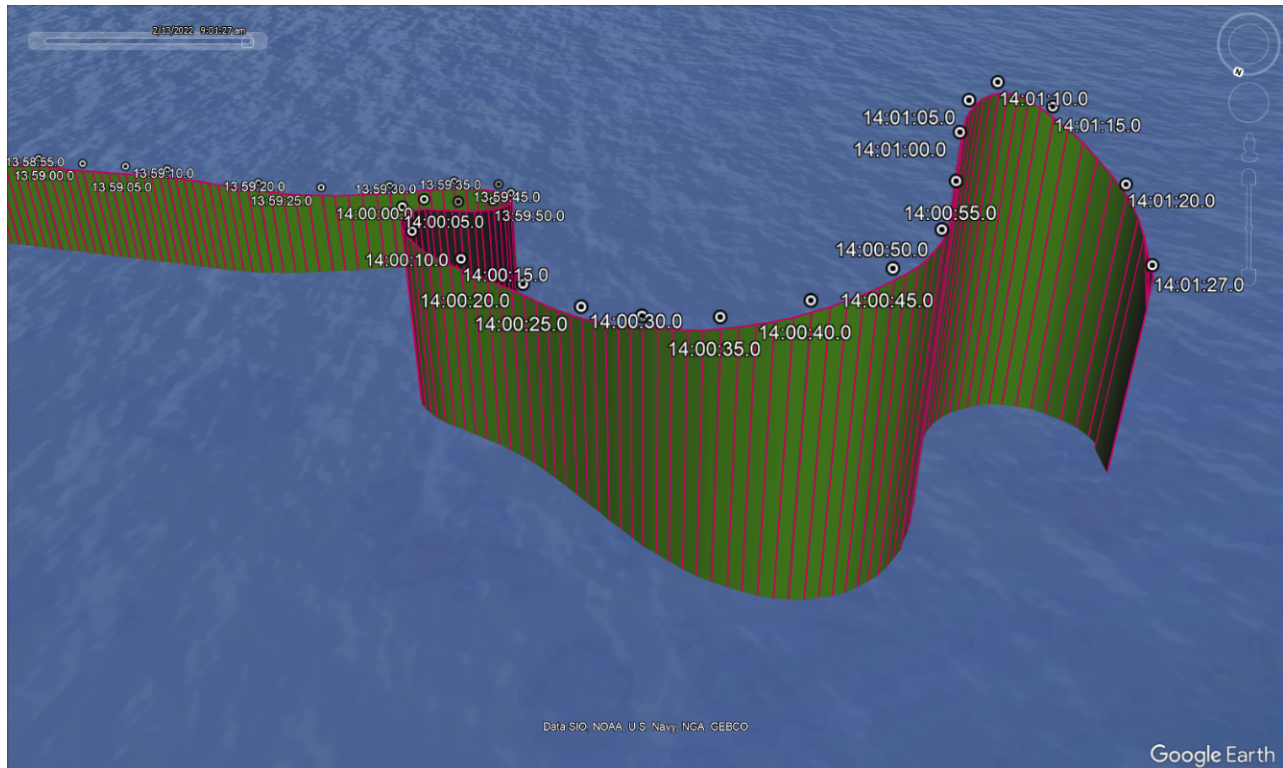
At 1358, the controller contacted the pilot and issued a heading to CIGOR, but then indicated that he had observed that the airplane was "correcting now." At 1358:46, the controller called the pilot and issued the local altimeter setting (the airplane was flying at 1,700 ft msl, but the pilot had been instructed to maintain 1,900 ft msl). The pilot read back the altimeter setting correctly, which was the last transmission from the pilot. At 1358:56, the airplane's barometric altimeter setting changed from 29.98 inHg to 29.96 inHg. At that time, the pitch increased to 10° nose up, while the airspeed had decayed to 109 knots. At 1359:12, the "stall" alert sounded from the CAS, the stick shaker activated, and the autopilot automatically disengaged. The airspeed reached a low of 93 knots and the autopilot remained disconnected for the rest of the recording. At 1359:13, the engine torque increased, which was also correlated with a sound consistent with the engine power increasing. The autopilot disconnect warning sounded continuously at 1359:15 and over the next 2 minutes until the end of the recording. During this time the pilot also continued to make comments about the airplane's navigation system including, "what are we doin'," "it'll navigate," and "activate vectors." At 1359:40, the passenger stated, "we're sideways." Following the stick shaker activation, at 1359:50, the engine power was increased to nearly full power, the stall alert sounded 8 times, the airspeed decayed to 83 knots and the pitch increased to 31.7° when the stick shaker and pusher activated again. At 1401:21, the sink rate alert sounded, and the terrain avoidance warning system announced "pull up" and "speed" before the recording ended at 1401:29. In the final moments of flight, the airplane rolled to a bank of more than 90° to the right and pitched more than 50° nose down. Figure 2 depicts the airplane's horizontal and vertical flight track during the final 2 ½ minutes of the flight.

Figure 2. View of altitude variation during the final 2 ½ minutes of the flight.

At 1401, the controller attempted to contact the pilot to inquire about the airplane’s altitude (the airplane was at 4,700 ft msl and climbing quickly). There was no response.
