Aviation Investigation Final Report

Location:	Coalinga, California	Accident Number:	WPR22FA098
Date & Time:	February 16, 2022, 21:30 Local	Registration:	N72297
Aircraft:	Bell UH-1H	Aircraft Damage:	Substantial
Defining Event:	Controlled flight into terr/obj (CFIT)	Injuries:	1 Fatal
Flight Conducted Under:	Part 137: Agricultural

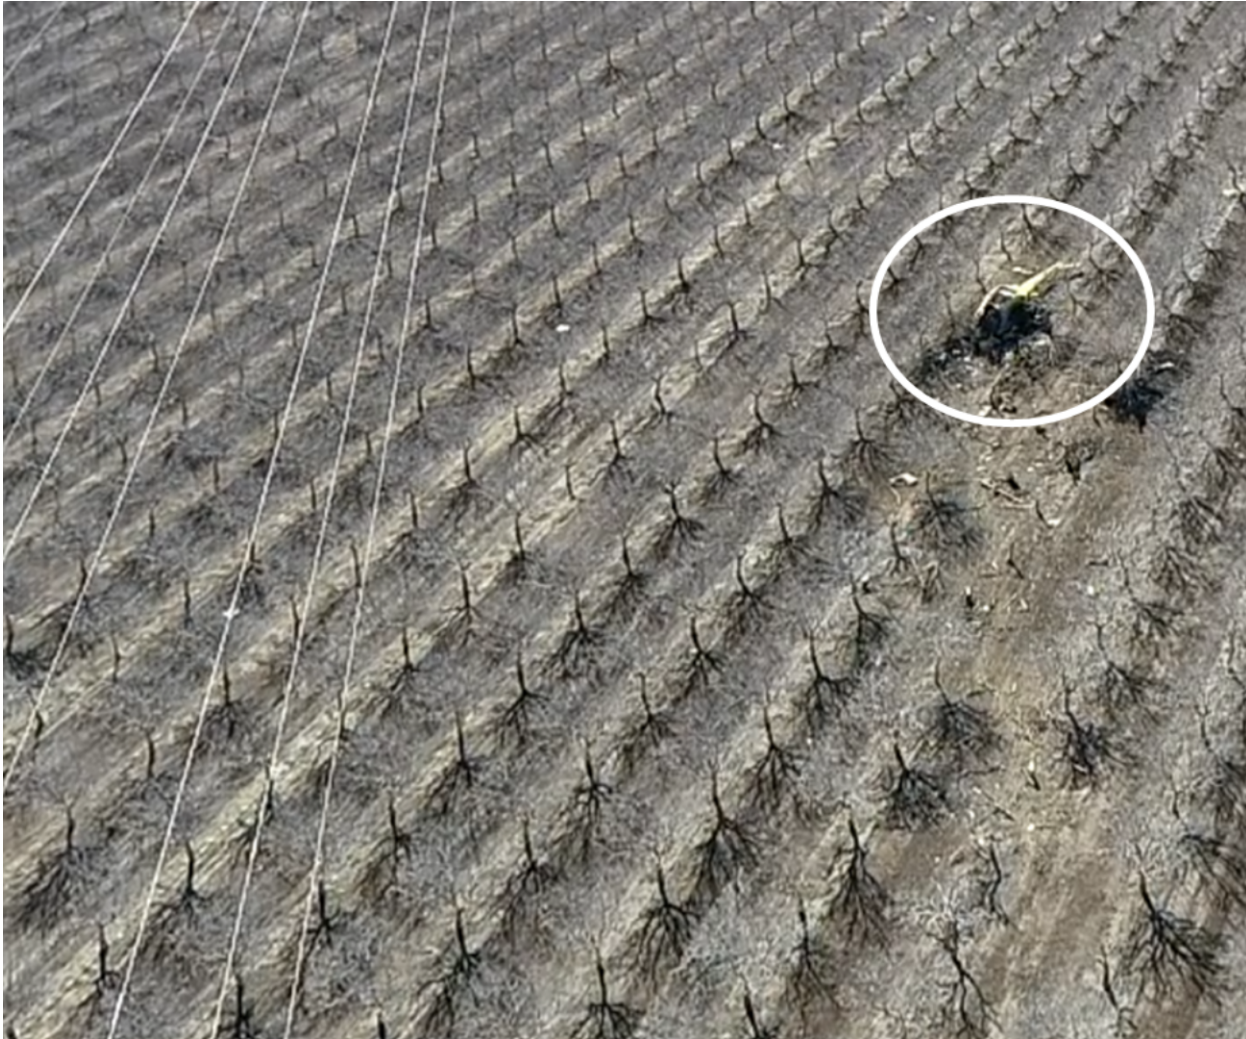
A set of power distribution lines was located about 120 ft east of the accident site. The power distribution line towers were about 100 ft tall and ran generally north and south parallel to an interstate highway and alongside the fourth job site and 308. The power distribution lines and the towers near the accident site showed no evidence of damage.

The helicopter came to rest on its left side in an orchard, as shown in figure 2. The orchard was at an elevation of about 385 ft mean sea level and consisted of 12-ft trees spaced about

15 ft apart. An area of disturbed ground and felled trees extended back from the helicopter about 120 ft on a magnetic bearing of 170°. The fuselage had rotated about 180°.

Figure 2. Aerial view of the accident site and the power distribution lines (left side).

All major components of the helicopter were observed near the accident location. The forward area of the fuselage exhibited damage consistent with a nose-low, left-bank impact. Flight control continuity was established for all flight controls to the hydraulic servos for the respective systems and from the hydraulic servos to the respective flight control surfaces.
