# Aviation Investigation Final Report

<b>Location:</b>	Coalinga, California	<b>Accident Number:</b>	WPR22FA098
<b>Date &amp; Time:</b>	February 16, 2022, 21:30 Local	<b>Registration:</b>	N72297
<b>Aircraft:</b>	Bell UH-1H	<b>Aircraft Damage:</b>	Substantial
<b>Defining Event:</b>	Controlled flight into terr/obj (CFIT)	<b>Injuries:</b>	1 Fatal
<b>Flight Conducted Under:</b>	Part 137: Agricultural

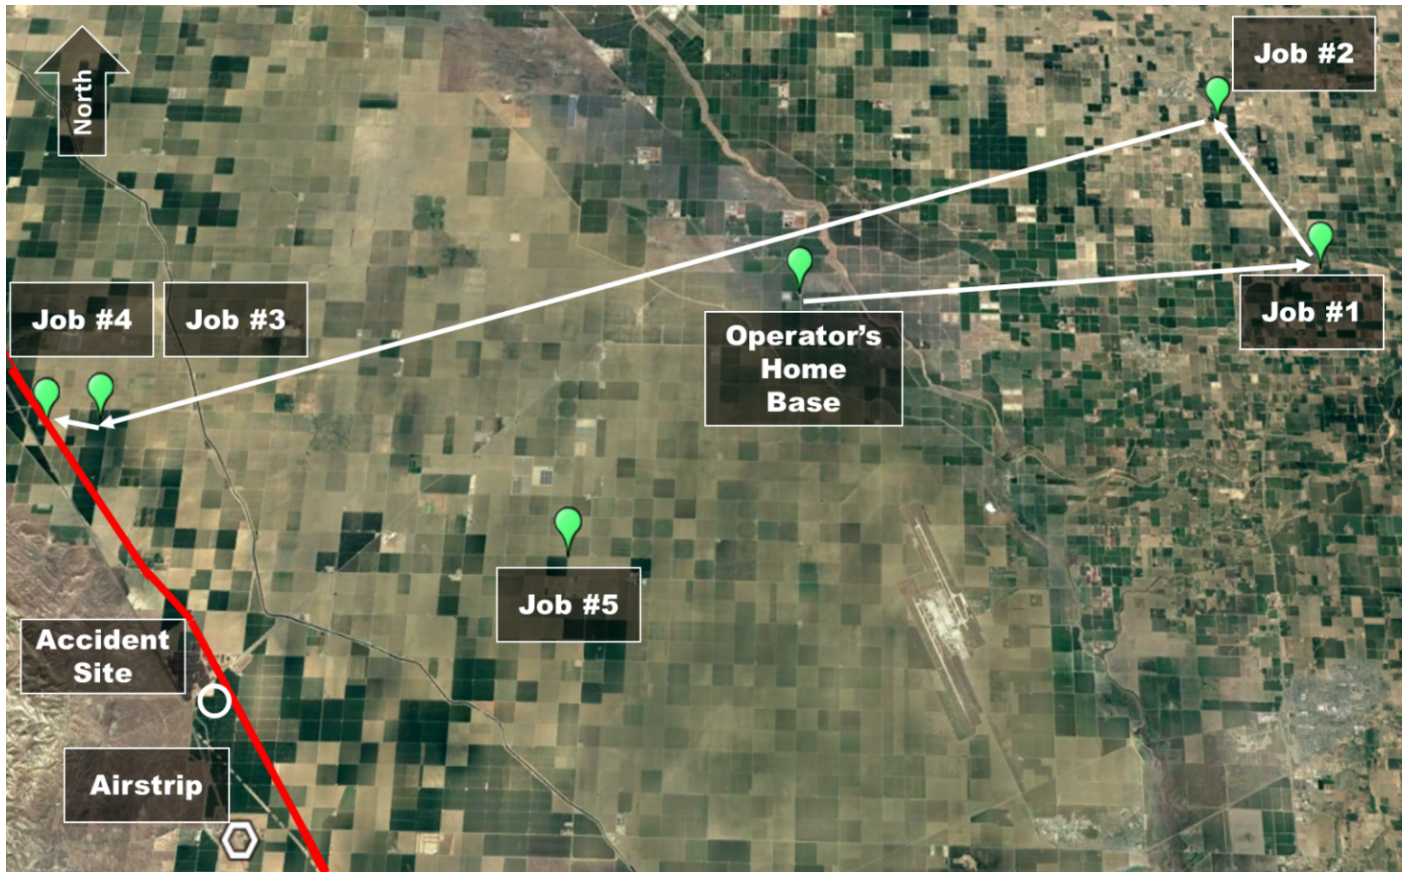
Figure 1. Google Earth image of the five job sites, the accident site, and the airstrip.

Note: The white arrows denote the direction of travel. The red line indicates the location of large power distribution lines. The two insets show the proximity of the power distribution lines to the fourth job site and the accident site.
