# Aviation Investigation Final Report

<b>Location:</b>	Jolon, California	<b>Accident Number:</b>	DCA22FA082
<b>Date &amp; Time:</b>	February 16, 2022, 09:58 Local	<b>Registration:</b>	N542AJ
<b>Aircraft:</b>	JOBY AERO INC JAS4-2	<b>Aircraft Damage:</b>	Substantial
<b>Defining Event:</b>	Part(s) separation from AC	<b>Injuries:</b>	1 None
<b>Flight Conducted Under:</b>	Part 91: General aviation - Flight test

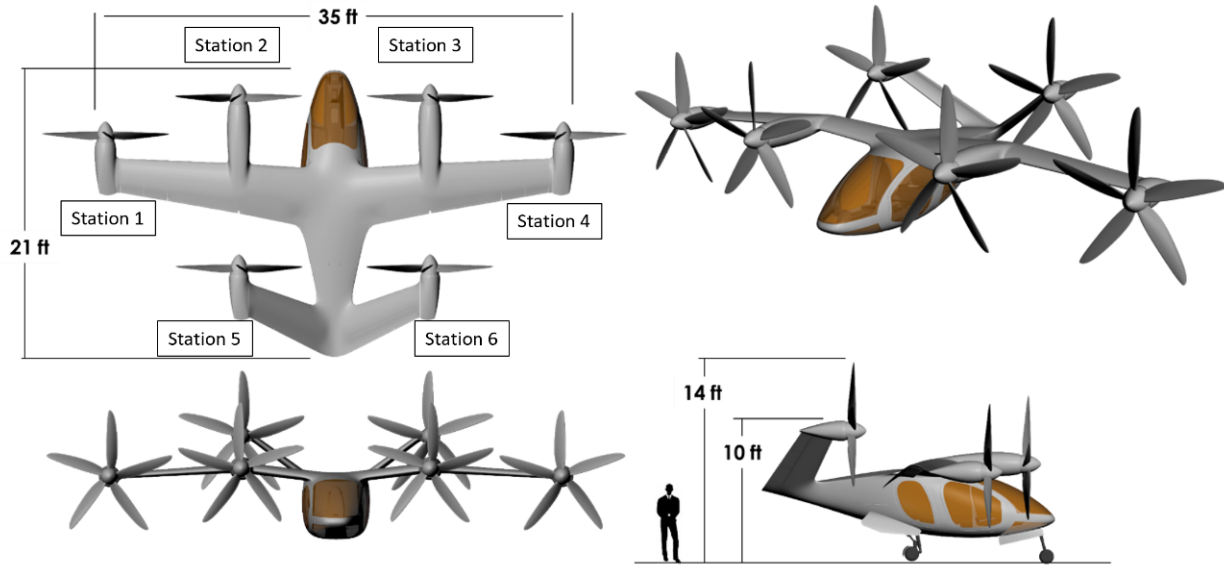
Figure 1. Depiction of a JAS4-2 aircraft (Source: Joby Aviation)

The aircraft was configured with six tilting propellers directly driven by six dual-powered electric motors supplied by power from four battery packs. The six electric propulsion unit (EPU) stations are identified numerically based on location as station 1-outboard left wing, station 2-inboard left wing, station 3-inboard right wing, station 4- outboard right wing, station 5-left tail, and station 6-right tail. Each of the six variable pitch propeller assemblies were equipped with five blades and actuated by a single variable pitch actuator driving a mechanical pitch change mechanism.
