Aviation Investigation Final Report

Location:	White Hills, Arizona	Accident Number:	WPR22FA100
Date & Time:	February 19, 2022, 13:28 Local	Registration:	N787NV
Aircraft:	MOYNIHAN RICHARD D VANS RV-7A	Aircraft Damage:	Destroyed
Defining Event:	Aircraft structural failure	Injuries:	1 Fatal
Flight Conducted Under:	Part 91: General aviation - Personal

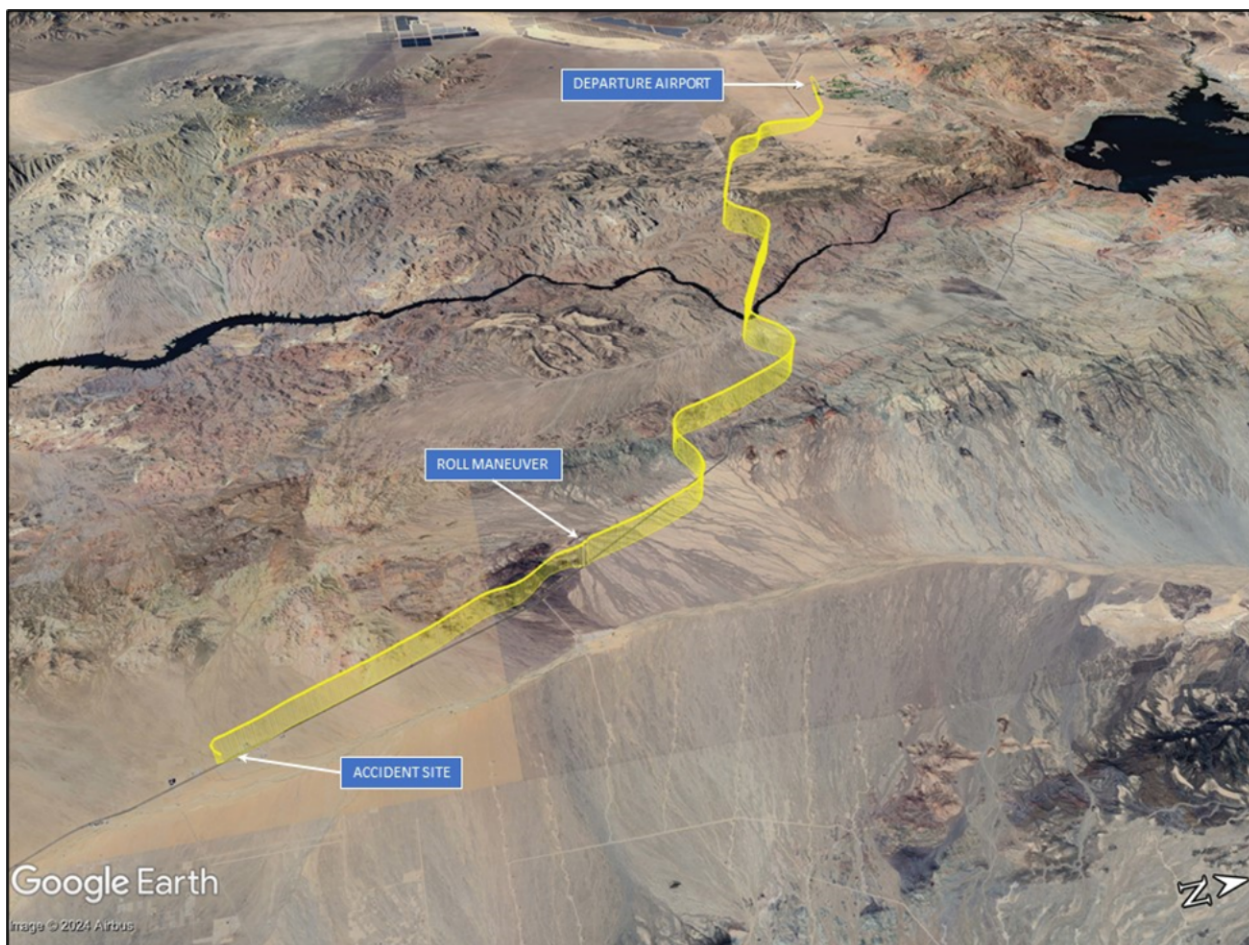
Figure 1. Dynon accident flight track data.

Recorded automatic dependent surveillance-broadcast (ADS-B) data and recorded data from the airplane showed that the airplane departed from Boulder City Municipal Airport (BVU), Boulder City, Nevada, about 1315, climbed to about 5,500 ft mean sea level (msl), and traveled east for about 7 minutes, making several wide 90-degree turns. After crossing US Highway 93 the airplane track turned right and tracked above the highway. A few seconds later the airplane data showed a maneuver consistent with an aileron roll followed by a rapid descent about 1,000 ft before regaining its prior altitude and track above the highway. About 2 minutes later, near Triangle Airpark (AZ50), White Hills, Arizona, the airplane data showed a slight turn to the right and a maneuver consistent with a split-S before it descended rapidly to the left over the accident site.

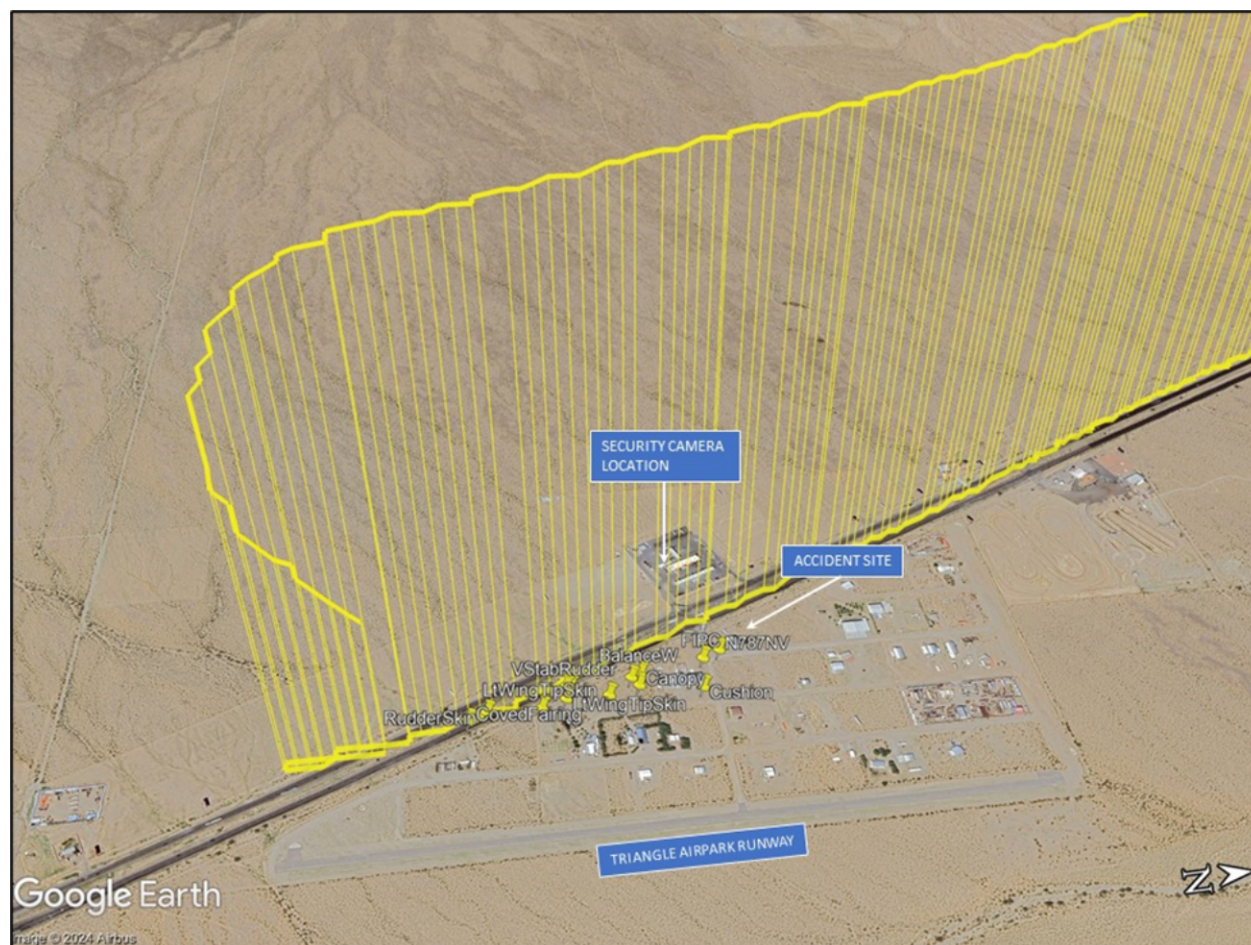
Figure 2. Dynon flight track data.

A Dynon SkyView D1000 panel-mounted display was recovered from the wreckage and sent to the National Transportation Safety Board (NTSB) Vehicle Recorders Division. The data showed the airplane was in cruise flight to the southwest at a GPS altitude about 5,600 ft msl in the minutes before the accident. About 3 minutes before the last recorded data point, the data showed the airplane was wings-level about 5,575 ft msl, at an airspeed about 137 KIAS (150 KTAS) when a left roll maneuver began. The airplane rolled more than 360° in about 10 seconds and lost about 1,000 ft of altitude. The throttle was not reduced during the maneuver. During the next 2.5 minutes the airplane was mostly wings-level while climbing to its initial course. About 11.5 seconds before the last recorded data point, the airplane was in a wings-level attitude about 5,609 ft msl, at an airspeed about 138 KIAS (150 KTAS) with a slight nose up-pitch about 1.8° and a vertical climb rate about 215 ft/min, when a right roll maneuver began. During the maneuver the airplane rolled right to a maximum recorded angle about 166° and the pitch angle decreased continuously to about 62° nose down. The descent rate increased to 9,587 fpm in 7 seconds before being recorded at 9,999 fpm for the final 4.5 seconds. The throttle was not reduced during the maneuver. The last recorded data point showed the airplane about 3,199 ft msl, an airspeed about 248 KIAS (262 KTAS), a magnetic

heading about 307°, a nose-down pitch about 61.7°, a right roll about 133.1°, and a vertical acceleration about 4.1 g. (See Figure 2.)

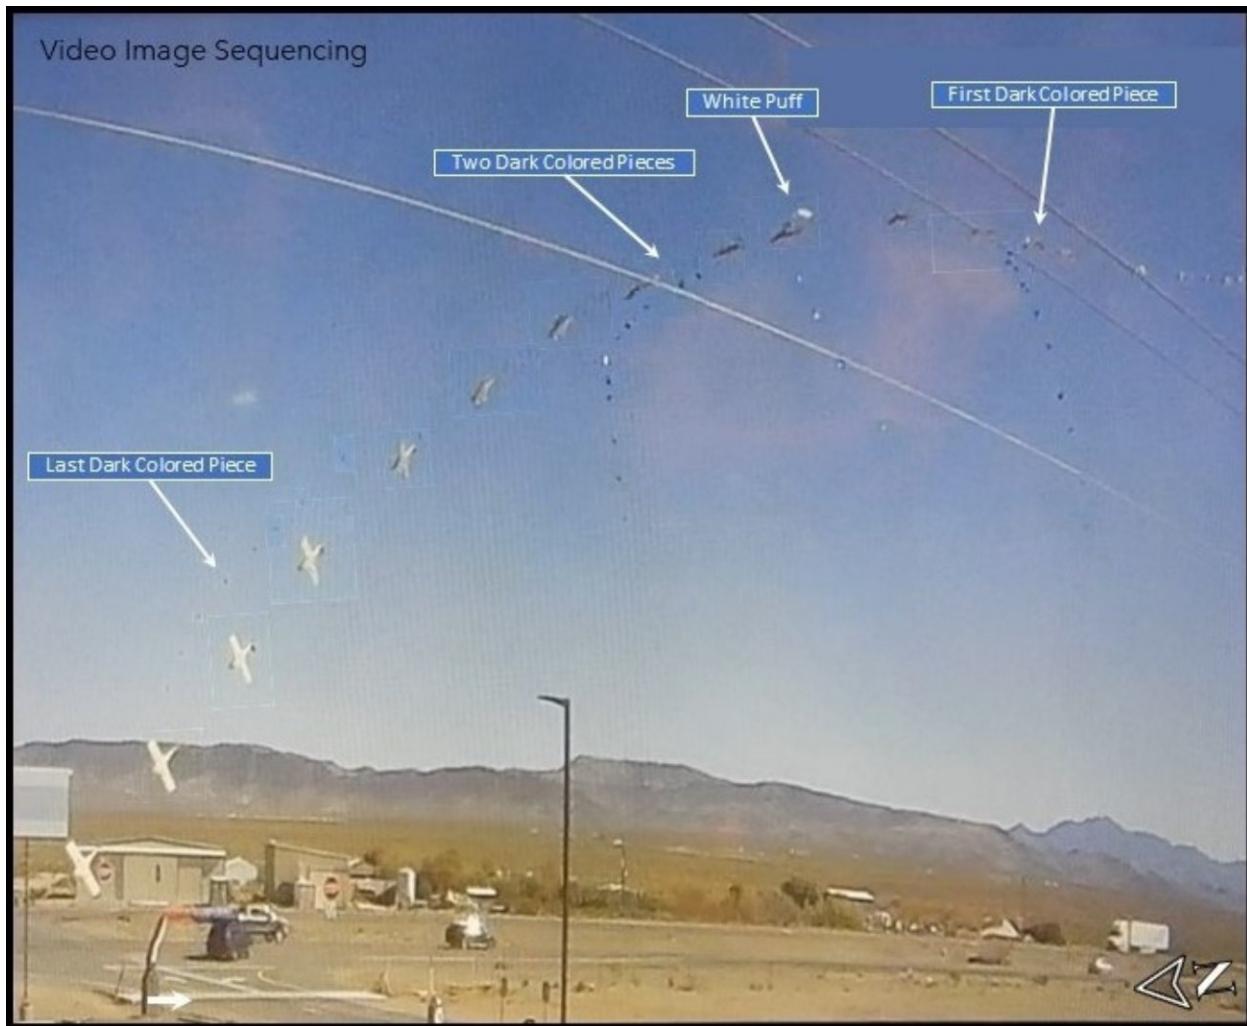
Figure 3. Video image sequencing.

Security video near the accident site captured the airplane in a steep nose-down descent before impacting the ground near hangars at AZ50. Several other objects were seen falling to the ground south of the accident site. Video image sequencing helped illustrate the accident sequence flight path. (See Figure 3.) Another video near the impact crater captured the airplane moments before impact with the ground. An image of the airplane shows that the left horizontal stabilizer and elevator, and the vertical stabilizer and rudder, were not attached to the airplane. A portion of the right horizontal stabilizer and elevator remained attached. The left wing tip and canopy were also not attached to the airplane. (See Figure 4.)
