# Aviation Investigation Final Report

<b>Location:</b>	Newport Beach, California	<b>Accident Number:</b>	WPR22FA101
<b>Date &amp; Time:</b>	February 19, 2022, 18:34 Local	<b>Registration:</b>	N521HB
<b>Aircraft:</b>	McDonnell Douglas 500N	<b>Aircraft Damage:</b>	Substantial
<b>Defining Event:</b>	Loss of tail rotor effectiveness	<b>Injuries:</b>	1 Fatal, 1 Minor
<b>Flight Conducted Under:</b>	Public aircraft

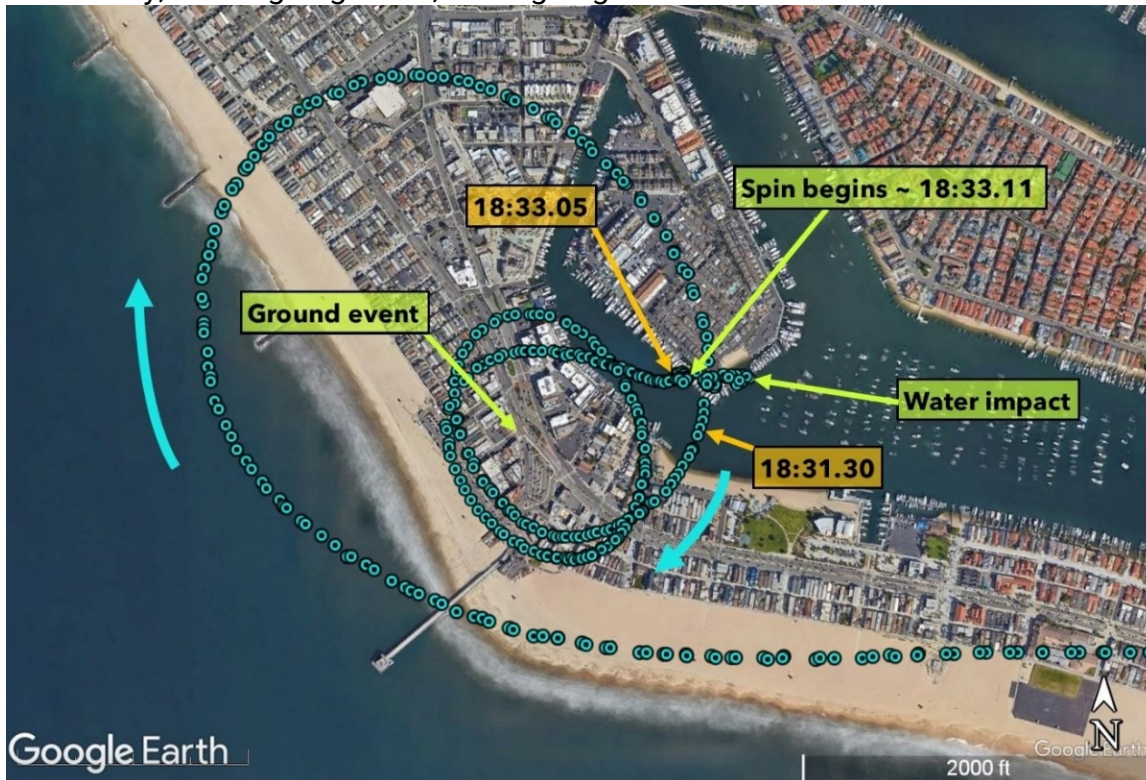
**Figure 1** – Final flight path segment

The pilot stated that, suddenly, the helicopter yawed aggressively to the right, and he immediately applied full left foot pedal and forward cyclic to arrest the rotation, but there was no response. He then applied right pedal to see if the pedals had malfunctioned, and observing no change, he reverted to full left pedal. He continued to apply corrective control inputs, but the helicopter did not respond and began to progress into a spinning descent. (see Figure 1.) The

TFO transmitted over the police radio channel, “We’re having some mechanical issues right now”, followed by, “we’re going down, we’re going down”.

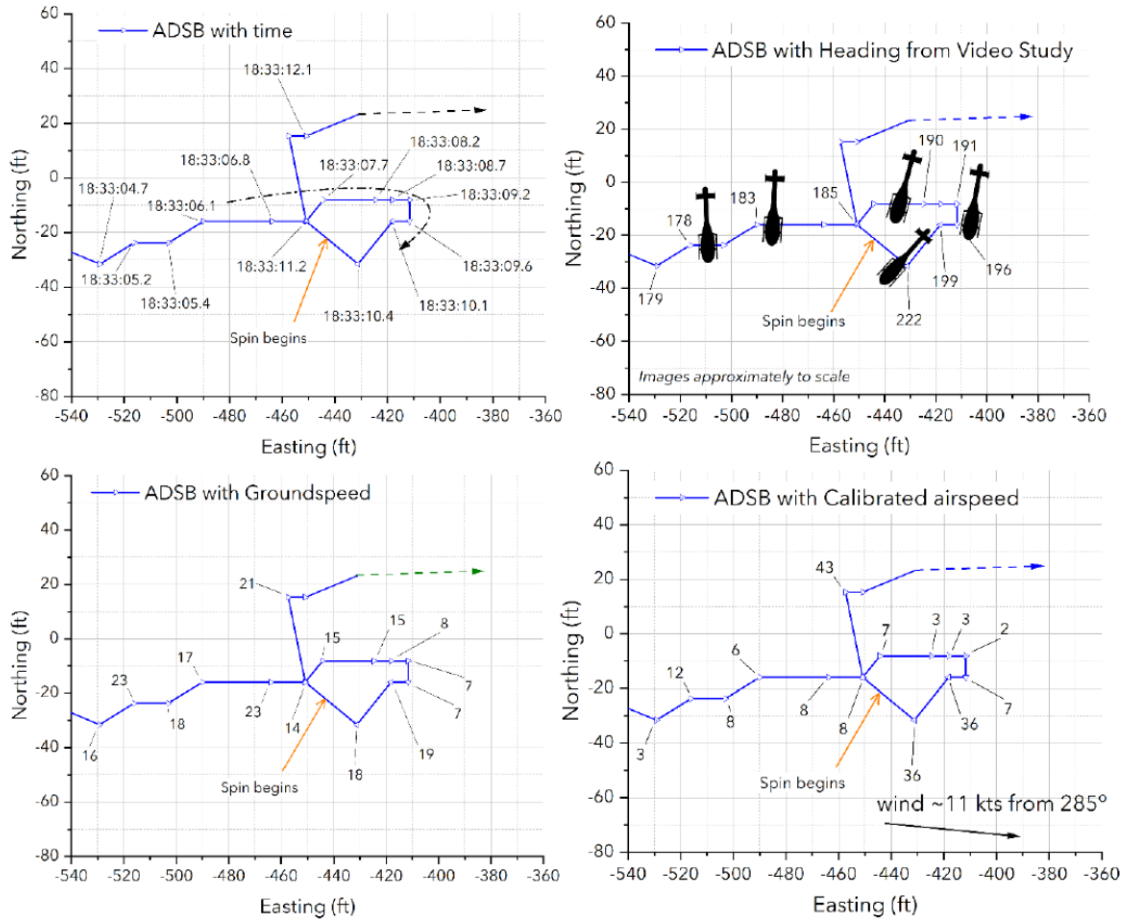
The results indicated that, after performing two orbits, the helicopter slowed to a ground speed of between 15-23 kts as it moved east, which correlated to a calibrated speed of between 3-12 kts. During the next 5 seconds, the helicopter was pointing perpendicular to the direction of

travel, on a heading of about 180°. The helicopter then held its position over the ground and started to move west while still pointing south, and two seconds later, it began to spin to the right as the imaging system’s camera pitched up. The spin progressed at a rate of about 130° per second, and ground-based security video footage indicated that the rate remained about the same until the helicopter impacted the water. (See Figure 2.)

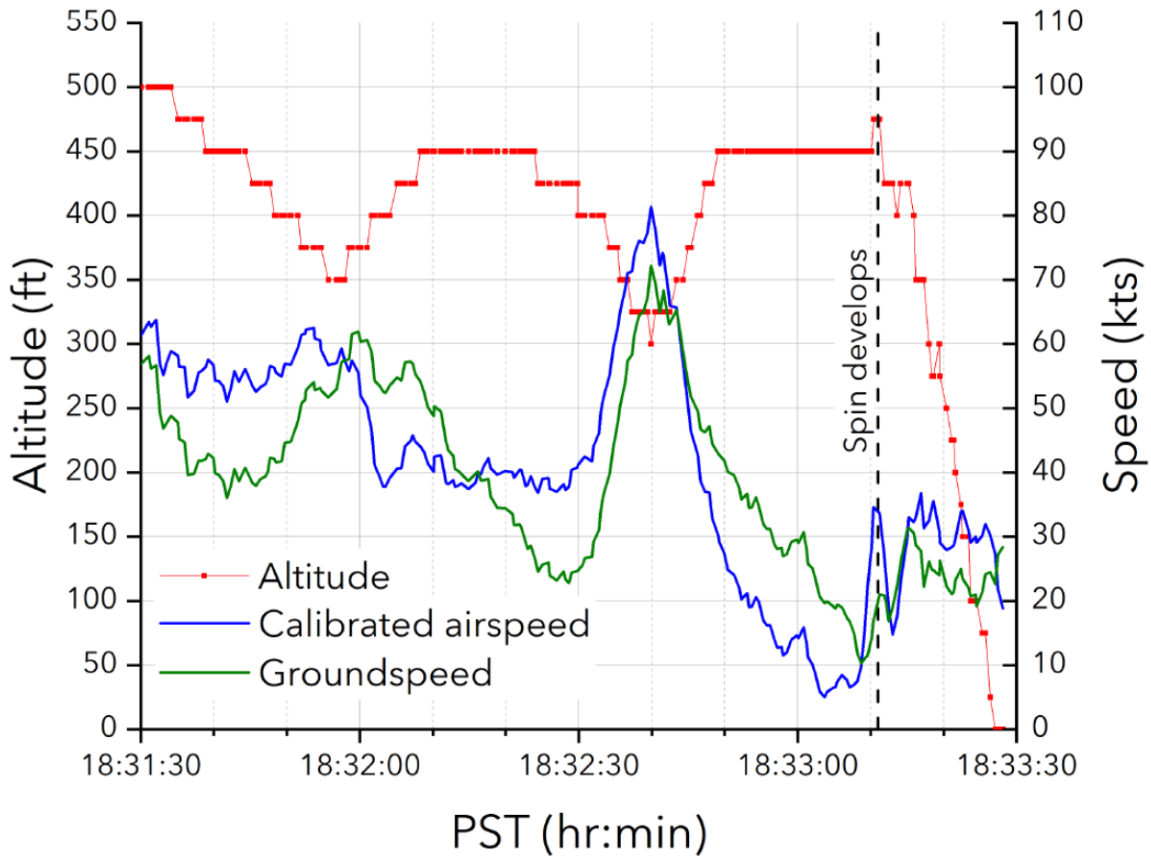
**Figure 3** - Altitude (msl), calibrated airspeed, and groundspeed of the end of flight.

The data indicated that the helicopter approached the area for the first orbit at an altitude about 850 ft agl. It descended to 350 ft agl after completing the first orbit; its altitude varied between 450 ft and 300 ft for the final two orbits until the diversion. (see Figure 3.) The radius of the final two orbits was about 650 ft.
