# Aviation Investigation Final Report

<b>Location:</b>	Aspen, Colorado	<b>Accident Number:</b>	CEN22LA130
<b>Date &amp; Time:</b>	February 21, 2022, 11:33 Local	<b>Registration:</b>	N99AP
<b>Aircraft:</b>	RAYTHEON AIRCRAFT COMPANY HAWKER 800XP	<b>Aircraft Damage:</b>	Substantial
<b>Defining Event:</b>	Runway excursion	<b>Injuries:</b>	6 None
<b>Flight Conducted Under:</b>	Part 91: General aviation - Business

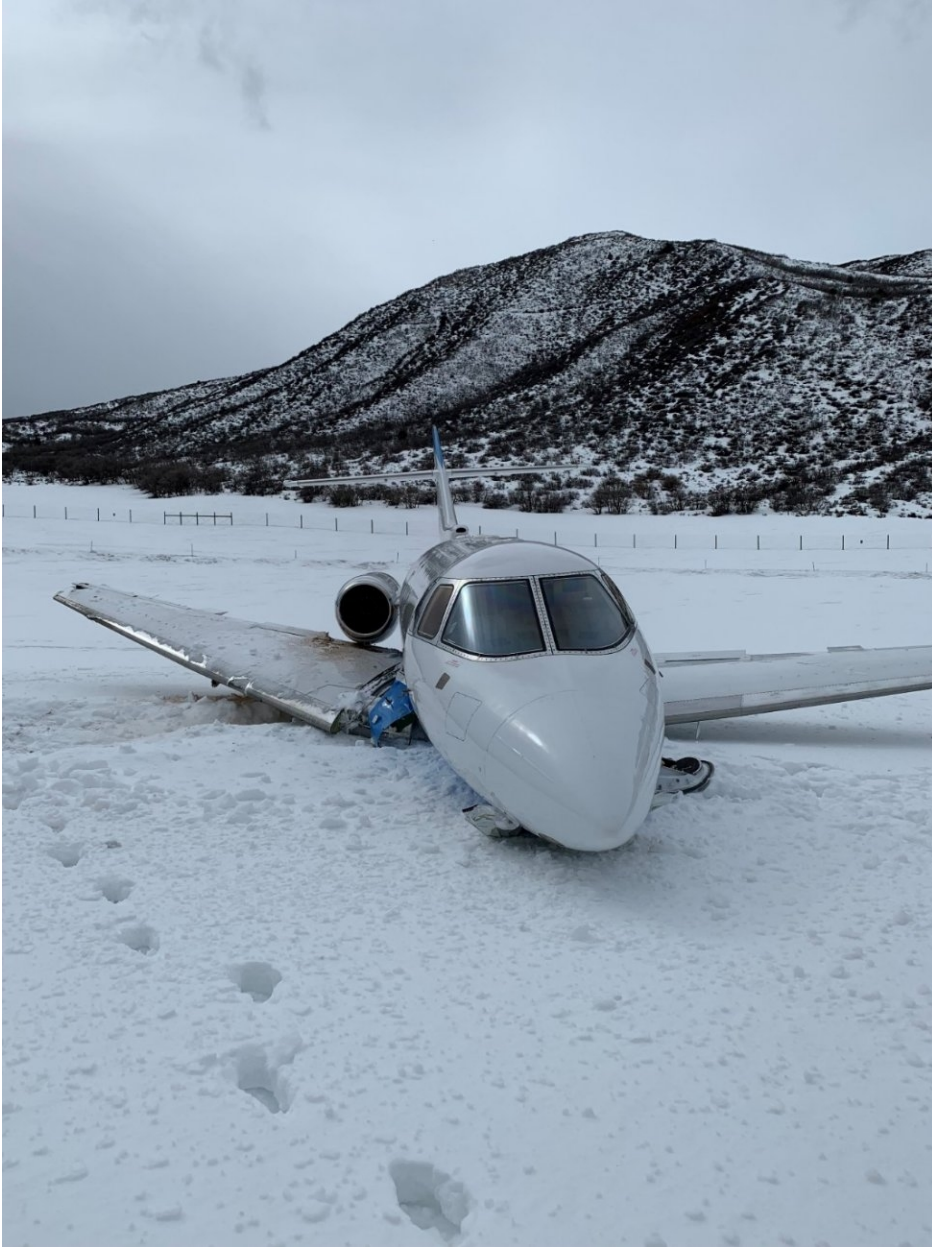
About 30 seconds after receiving the takeoff clearance and the current wind report from ATC, the captain performed a static takeoff, which began at the end of the runway, and the first officer made all the callouts. According to the captain, at rotation speed ( $V_R$ ), he applied back pressure on the yoke; however, the airplane would not become airborne. After a few seconds without any indication the airplane would take off, the captain called for and performed an aborted the takeoff. The captain reduced the engines to idle, deployed the thrust reversers, and applied the brakes. The airplane subsequently departed the end of the runway into the snow and sustained substantial damage to the right wing and fuselage.

After a few seconds without any indication the airplane would take off, the captain called for and performed an aborted takeoff by reducing the engines to idle, deploying the thrust reversers, and applying the brakes. The airplane subsequently departed the end of the runway into the snow (see figure 1). The captain secured the airplane and assisted in the evacuation of the passengers.

Figure 1. Accident airplane following runway excursion (Source: ASE airport operations)

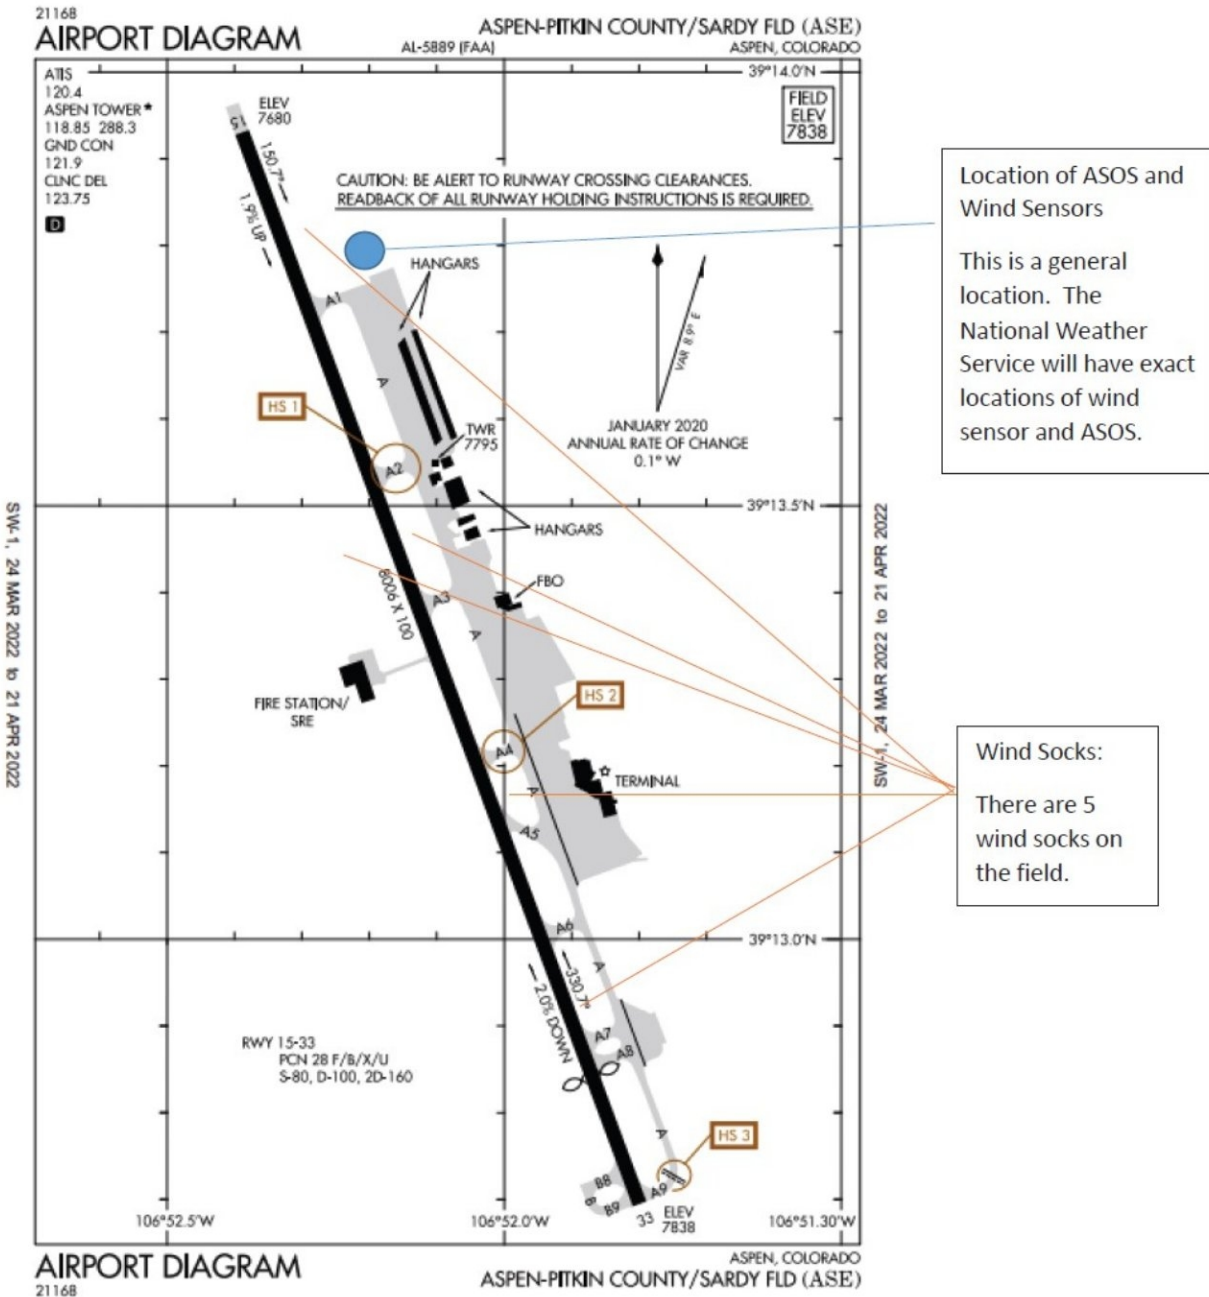
ASE is equipped with multiple windsocks, an automated surface observing system (ASOS) (maintained by the National Weather Service) and a standalone weather sensor (SAWS) (maintained by the Federal Aviation Administration (FAA) Technical Operations), which are located about 20 ft from each other on the north side of taxiway A1 (see figure 2).

Figure 2. Annotated ASE airport diagram

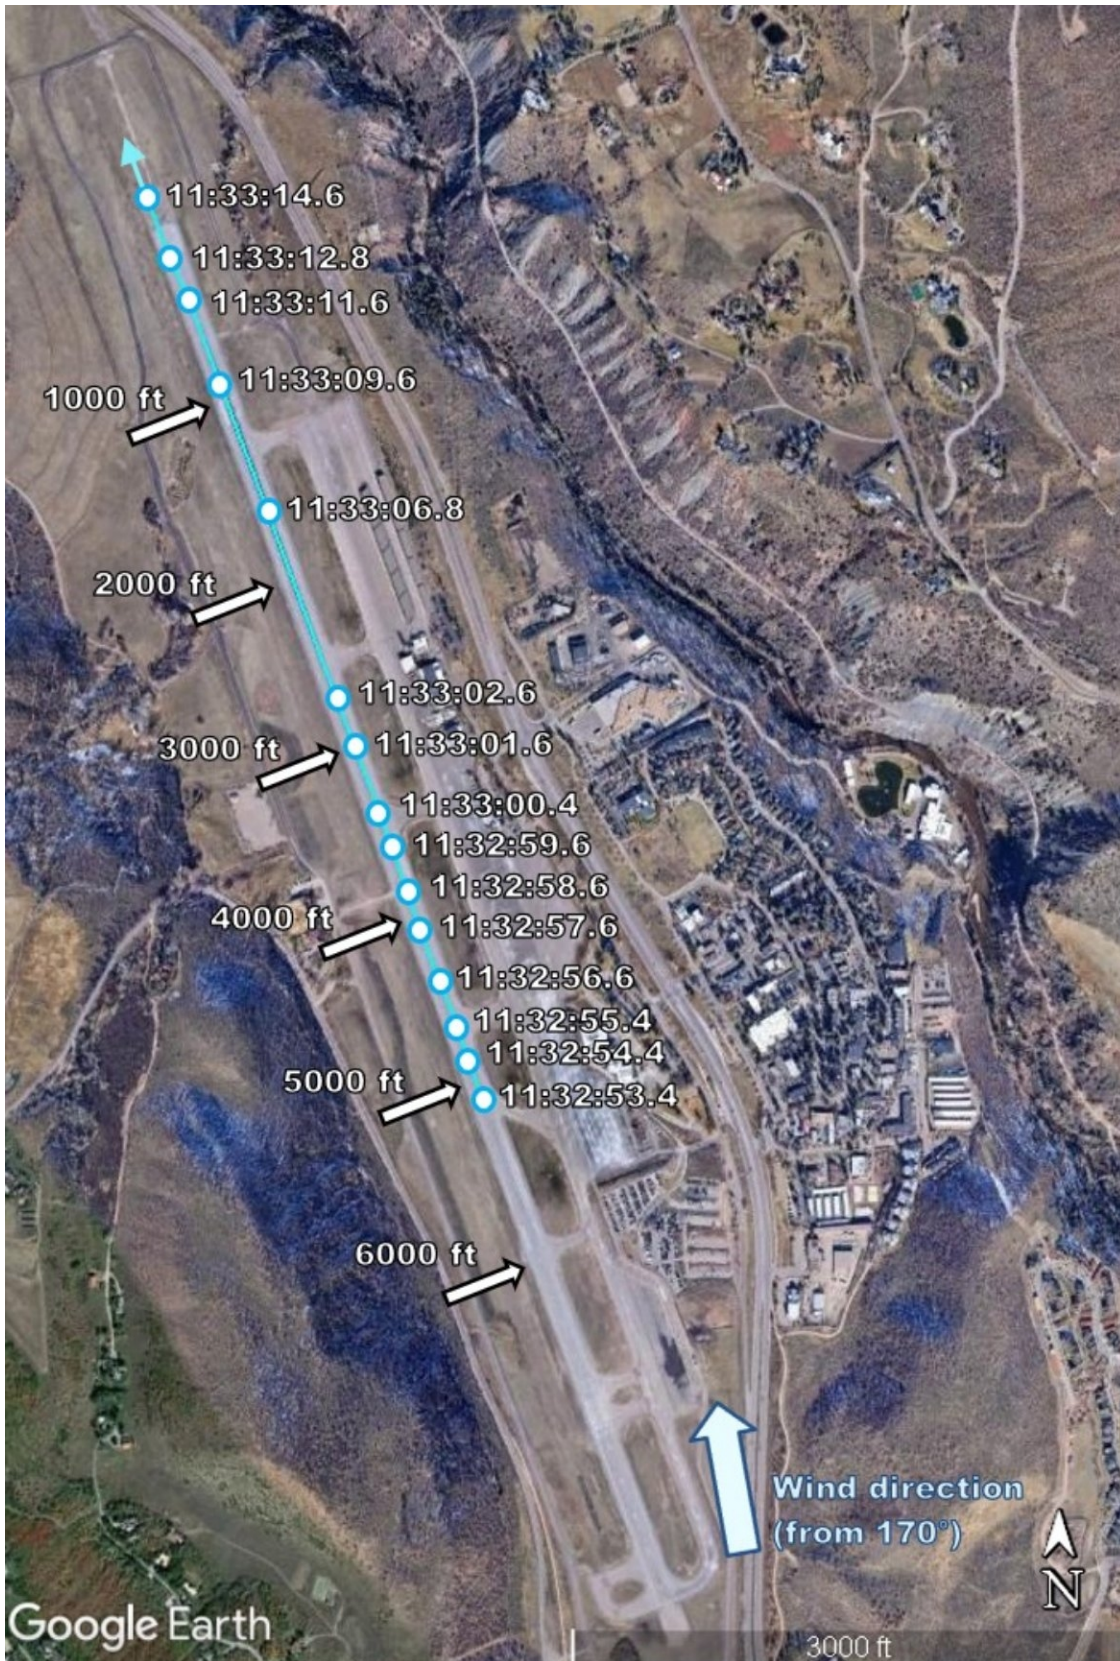
ADS-B coverage of the takeoff roll (see figure 3) did not start until 1132:53, when the airplane was already at a groundspeed of 135 kts. The airplane accelerated to 165 kts by 1133:01.6 when it was about 3,300 ft from the end of the runway, it then decelerated and left the paved surface at a groundspeed of 120 kts (see figure 4).

Figure 3. Aircraft takeoff roll with times and distance to end of runway

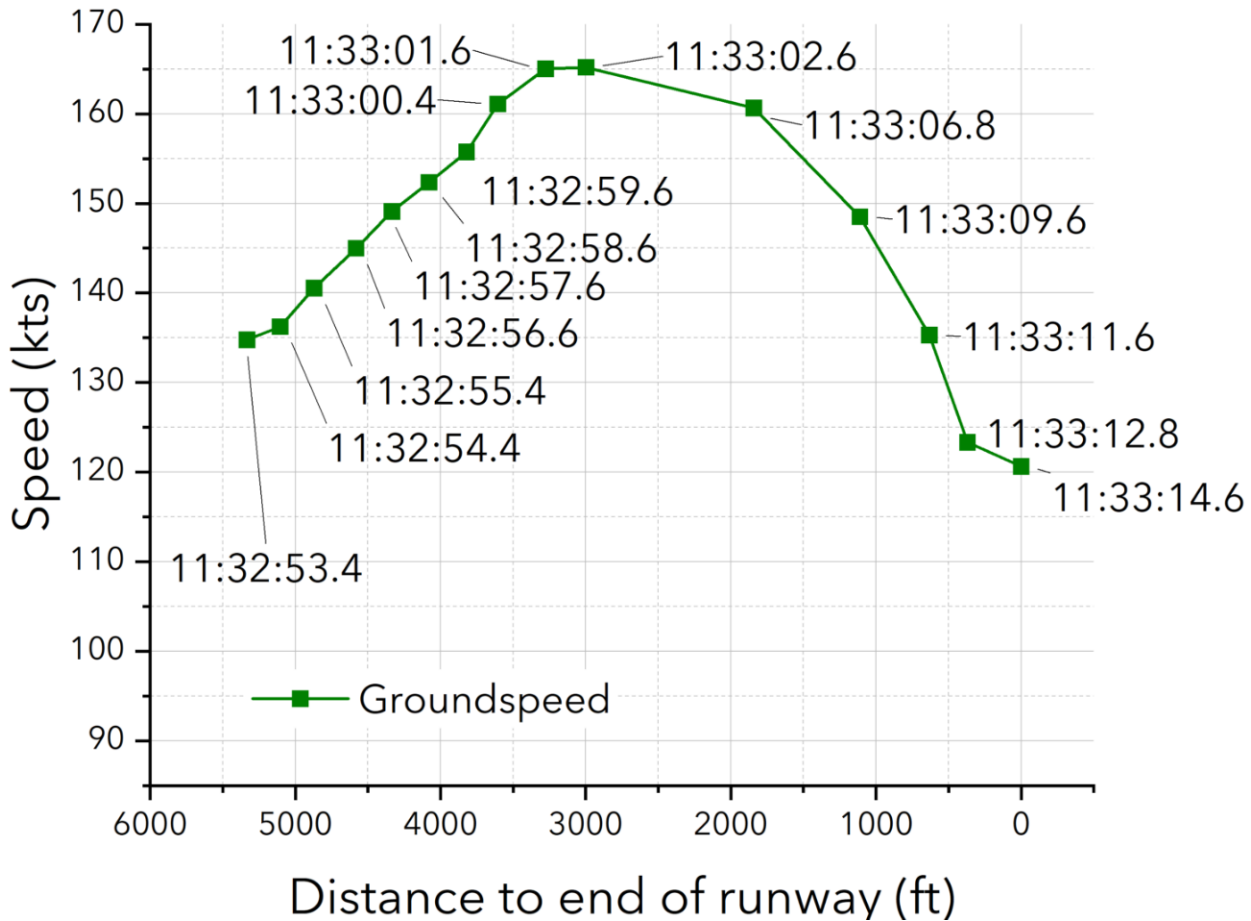
Figure 4. Calculated groundspeed versus distance to end of runway.

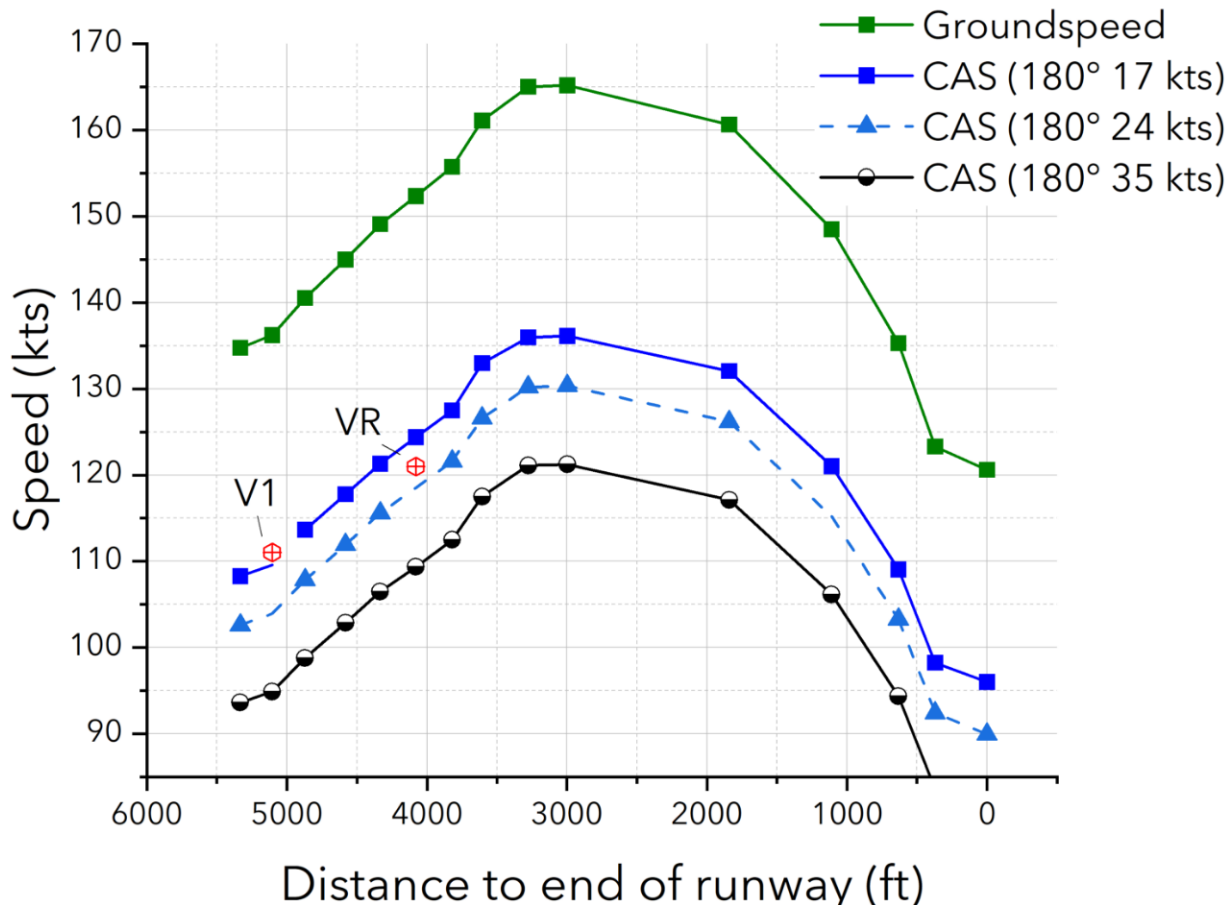
Figure 5. Calculated CAS for three different wind conditions

The black line in Figure 5 shows the calculated CAS for 35 kt wind from 180°. At the maximum achieved ground speed of 165 kts, a wind of this magnitude would lower the airplane's indicated airspeed to just below  $V_R$ . Title 14 *Code of Federal Regulations* Part 25.107, Takeoff Speeds, requires that the  $V_R$  be at least 10% greater than the minimum calibrated airspeed at which the airplane can safely rotate and lift off.

Therefore, for a reported  $V_R$  of 121 kts, the airplane should have lifted off after reaching an airspeed of 110 kts. A 35-kt wind would not reduce the maximum achieved ground speed of 165 kts sufficiently to prevent the airplane from flying, and thus after achieving  $V_1$  (111 kts), the flight crew should have had sufficient air load to rotate the airplane. This was not consistent with the flight crew account that the yoke did not have any air resistance when the yoke was pulled back, considering that the wreckage examination revealed no discrepancies with flight control continuity to the elevator system. Even if a tailwind increased to more than the
