Aviation Investigation Final Report

Location:	Kekaha, Hawaii	Accident Number:	ANC22FA018
Date & Time:	February 22, 2022, 10:20 Local	Registration:	N615CK
Aircraft:	Sikorsky S-61N	Aircraft Damage:	Destroyed
Defining Event:	Loss of control in flight	Injuries:	4 Fatal
Flight Conducted Under:	Part 133: Rotorcraft ext. load

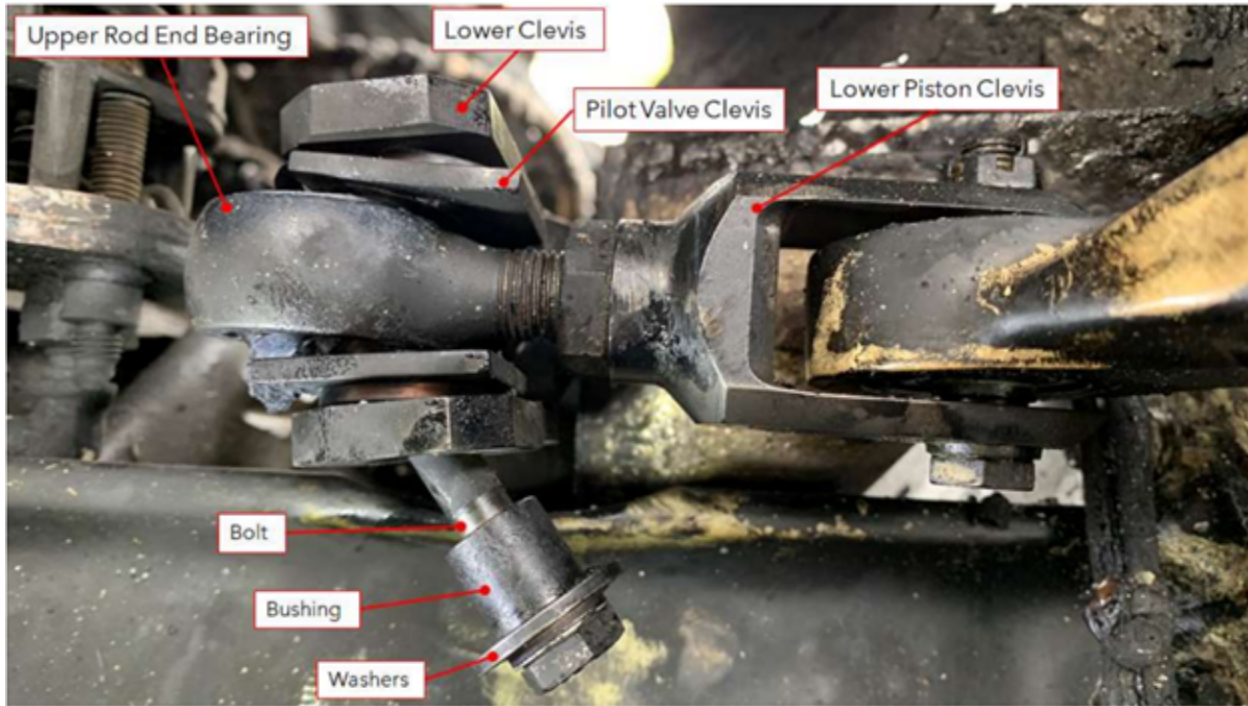
Figure 2. Fore/Aft Primary servo N615CK at accident site

An examination of the wreckage revealed the flight control fore/aft servo input link remained connected at its clevis end to the flight control fore/aft bellcrank, located adjacent to the main gearbox. However, the rod end was partially connected to the fore/aft servo input clevises and its bolt had mostly backed out of its normally installed position. The bolt exhibited no evidence of fractures or visible deformation and its threads exhibited no unusual wear. Therefore, the bolt likely backed out of its normally installed position during the accident flight due to the absence of its nut and cotter pin. This would have caused an uncommanded input to the

fore/aft servo, resulting in the helicopter's nose-down attitude, and the inability of the crew to control the pitch attitude of the helicopter.

The improper installation of the fore/aft primary servo by maintenance personnel, which resulted in the attaching hardware backing out and which subsequently rendered the helicopter uncontrollable. Contributing to the accident was the company's quality control personnel to identify the improper installation before certifying the helicopter for flight.

An examination of the wreckage revealed that the flight control fore/aft servo input link remained connected at its clevis end to the flight control fore/aft bellcrank, located adjacent to the main gearbox. The rod end was partially connected to the fore/aft servo input clevises, but

the attaching hardware had mostly backed out of its normally installed position and the bolt was cocked (Figure 2).

This bolt remained partially within the rod end bearing inner race, which was also cocked, exposing a portion of the bearing's rolling elements. The bolt head-side bushing and three washers were present between the bolt head and rod end. The nut, nut-side bushing, nut-side washers, and cotter pin were not present. A search of the main transmission deck found a loose bushing within the right-side longitudinal beam. The bolt between the fore/aft servo input link and the fore/aft servo input clevises was removed and it exhibited no evidence of fractures or visible deformation of the bolt shank.
