Aviation Investigation Final Report

Location:	Kekaha, Hawaii	Accident Number:	ANC22FA018
Date & Time:	February 22, 2022, 10:20 Local	Registration:	N615CK
Aircraft:	Sikorsky S-61N	Aircraft Damage:	Destroyed
Defining Event:	Loss of control in flight	Injuries:	4 Fatal
Flight Conducted Under:	Part 133: Rotorcraft ext. load

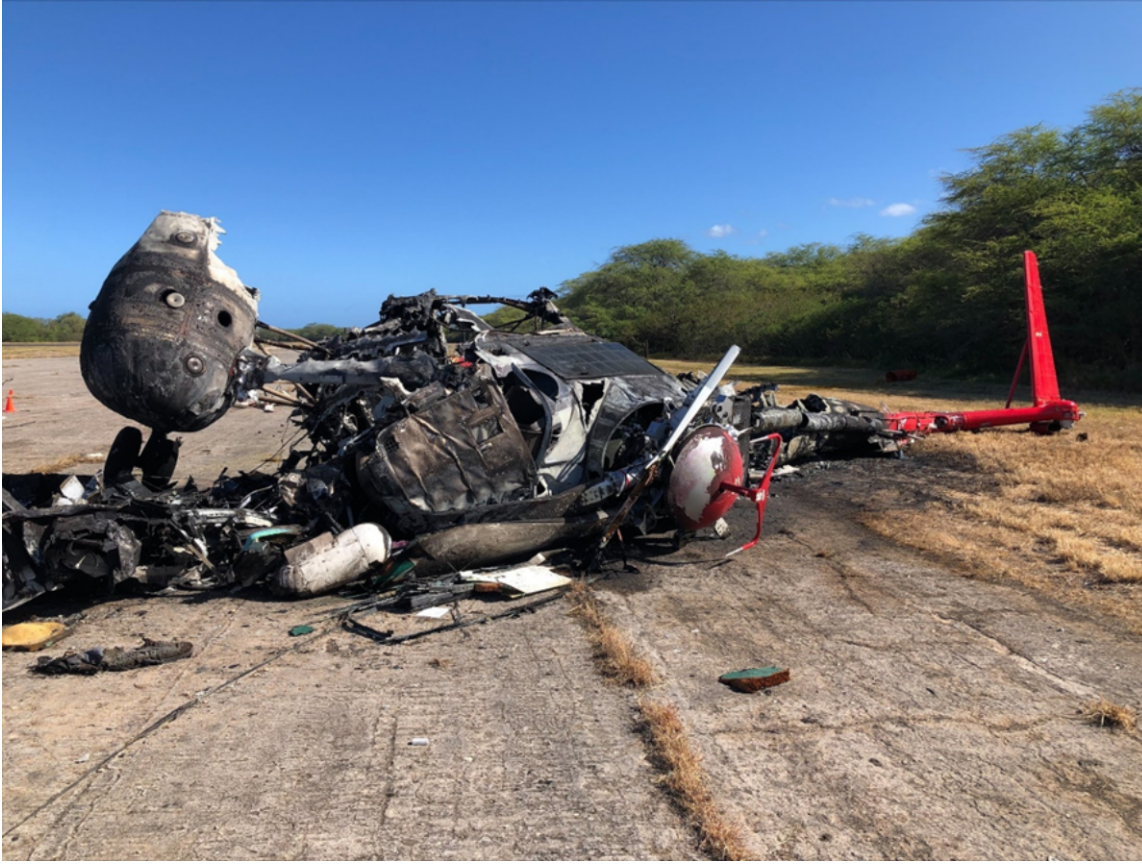
Figure 1. N615CK at accident site

The helicopter came to rest on its left side on a heading of about 230° magnetic. Three ground scars consistent with main rotor blade impact marks were present near the initial airframe ground impact location. The nose bay door for avionics was found near the start of the debris trail, followed by pieces of debris from the cockpit structure and cockpit instruments, and then the remainder of the helicopter. The initial ground impact mark and debris trail leading up to the main wreckage was oriented about 65° magnetic. A postcrash fire consumed most of the cockpit and the cabin, though remnant frame sections were present near the main (forward) landing gear as well as the transmission deck. The cockpit voice recorder was found near the forward end of the main wreckage.

The main transmission gearbox remained whole and installed on the airframe. The main gearbox exterior was coated in soot from the postcrash fire but was not consumed by the postcrash fire.

The main rotor blades exhibited considerable fragmentation, with numerous fragments of main rotor blades found throughout the vicinity of the accident site.

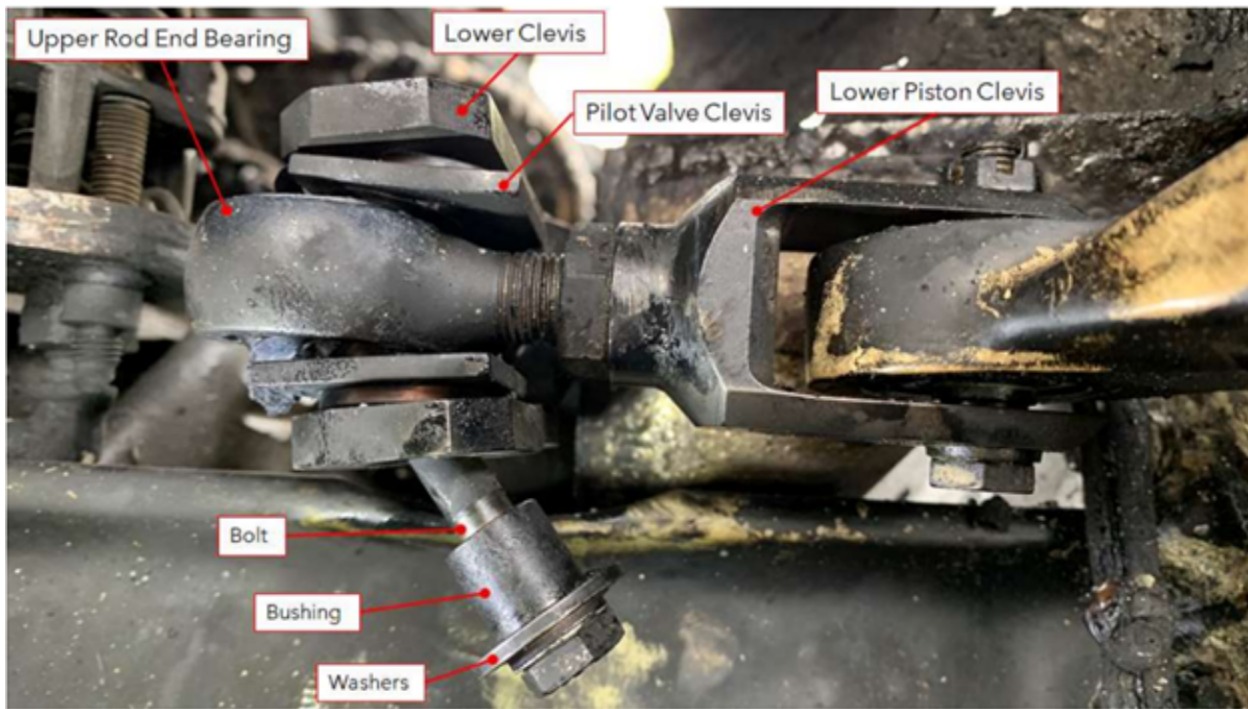
Figure 2. Fore/Aft Primary servo N615CK at accident site

An examination of the wreckage revealed the flight control fore/aft servo input link remained connected at its clevis end to the flight control fore/aft bellcrank, located adjacent to the main gearbox. However, the rod end was partially connected to the fore/aft servo input clevises and its bolt had mostly backed out of its normally installed position. The bolt exhibited no evidence of fractures or visible deformation and its threads exhibited no unusual wear. Therefore, the bolt likely backed out of its normally installed position during the accident flight due to the absence of its nut and cotter pin. This would have caused an uncommanded input to the

fore/aft servo, resulting in the helicopter’s nose-down attitude, and the inability of the crew to control the pitch attitude of the helicopter.

The fore/aft primary servo was installed on December 28, 2021. About 7.5 flight hours had elapsed from the time the fore/aft primary servo was installed until the day of the accident. The mechanic who installed the fore/aft servo input link to the fore/aft primary servo likely failed to correctly install the attaching hardware. The company’s certified inspector and who oversaw and inspected all of the work at completion, failed to ensure the hardware attaching the fore/aft servo input link to the fore/aft primary servo was installed correctly.

The improper installation of the fore/aft primary servo by maintenance personnel, which resulted in the attaching hardware backing out and which subsequently rendered the helicopter uncontrollable. Contributing to the accident was the company’s quality control personnel to identify the improper installation before certifying the helicopter for flight.

An examination of the wreckage revealed that the flight control fore/aft servo input link remained connected at its clevis end to the flight control fore/aft bellcrank, located adjacent to the main gearbox. The rod end was partially connected to the fore/aft servo input clevises, but

the attaching hardware had mostly backed out of its normally installed position and the bolt was cocked (Figure 2).

This bolt remained partially within the rod end bearing inner race, which was also cocked, exposing a portion of the bearing's rolling elements. The bolt head-side bushing and three washers were present between the bolt head and rod end. The nut, nut-side bushing, nut-side washers, and cotter pin were not present. A search of the main transmission deck found a loose bushing within the right-side longitudinal beam. The bolt between the fore/aft servo input link and the fore/aft servo input clevises was removed and it exhibited no evidence of fractures or visible deformation of the bolt shank.
