# Aviation Investigation Final Report

<b>Location:</b>	Fostoria, Ohio	<b>Accident Number:</b>	CEN22FA131
<b>Date &amp; Time:</b>	February 22, 2022, 22:41 Local	<b>Registration:</b>	N3952W
<b>Aircraft:</b>	Piper PA-32-260	<b>Aircraft Damage:</b>	Destroyed
<b>Defining Event:</b>	Loss of control in flight	<b>Injuries:</b>	2 Fatal
<b>Flight Conducted Under:</b>	Part 91: General aviation - Business

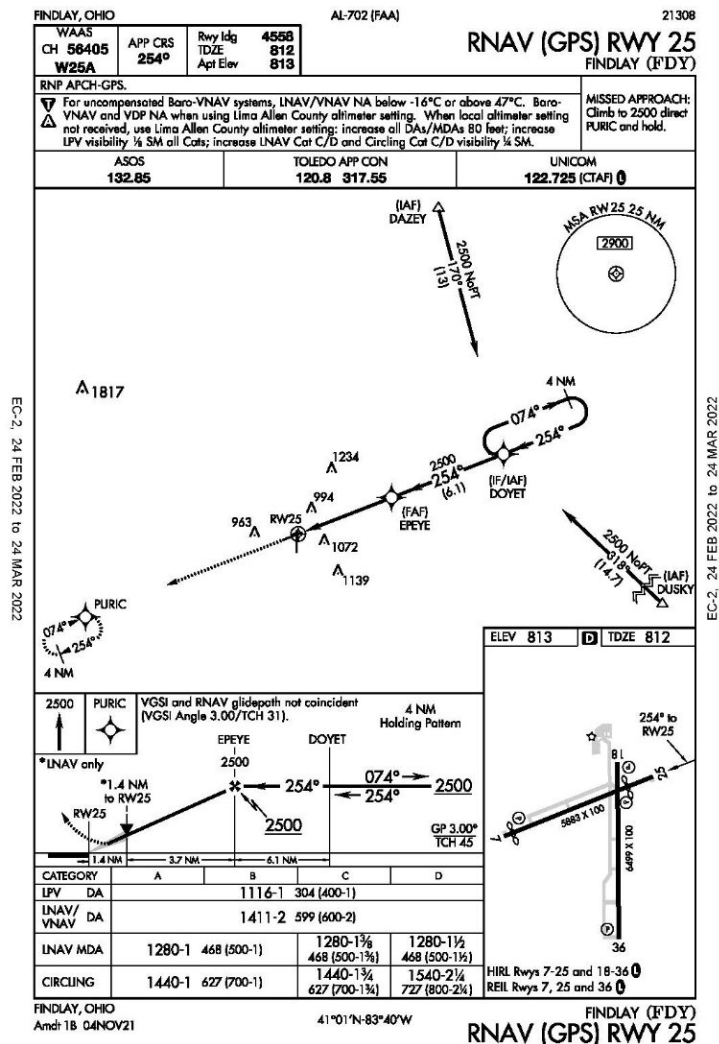
Figure 1: Published Instrument Approach Procedure

A review of archived Federal Aviation Administration (FAA) automatic dependent surveillance broadcast data revealed that the airplane departed 1H2 about 1956 central standard time, climbed to about 7,000 ft msl and proceeded on a relatively direct track toward DOYET, the initial approach fix for the RNAV/GPS runway 25 instrument approach, as shown in figure 1.

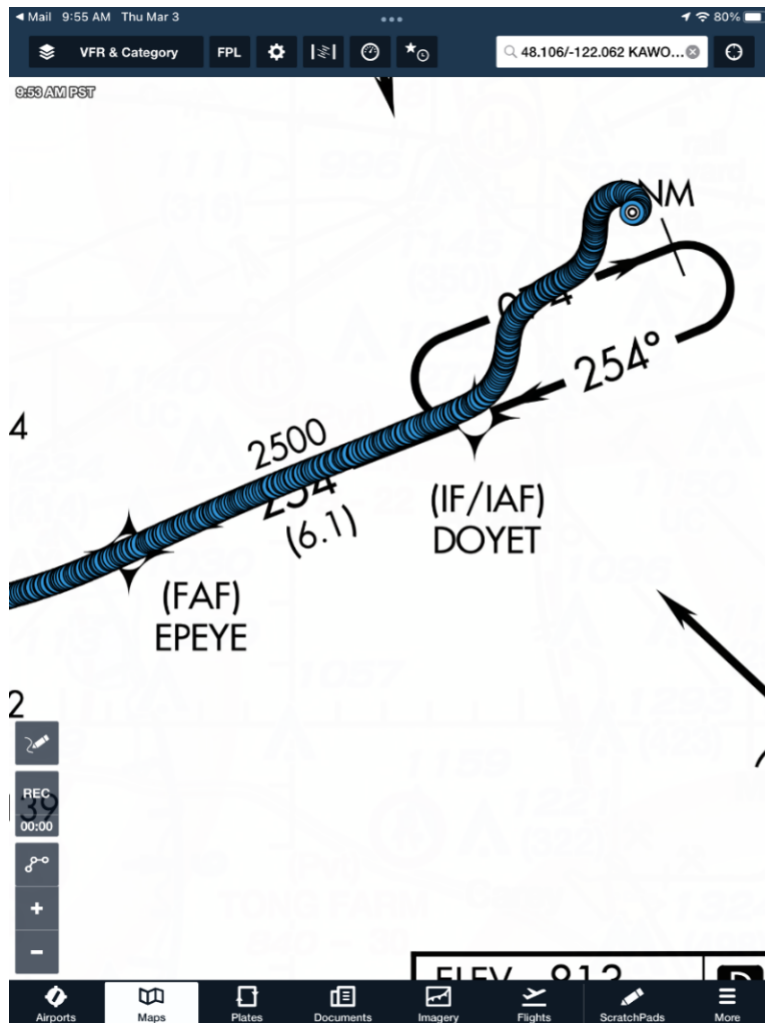
Figure 2: Instrument Approach with Flight Track Overlay

Based upon the wreckage fragmentation, which was consistent with a high-speed impact, the constant descending turn and IMC, it is likely that the accident pilot experienced spatial disorientation and lost airplane control.

After passing DOYET, the airplane made about a 30° left turn, consistent with a teardrop entry into the procedure turn. The airplane aligned with the outbound side of the holding pattern for about a mile before turning left again. As the airplane flew north of the published holding pattern in its final minute of flight its altitude decreased from about 3,000 ft to about 2,600 ft before climbing back to about 3,000 ft. About 4 nm from the IAF, the airplane turned right, and descended rapidly in a spiral and impacted terrain on a heading of 340° (see figure 2).
