Aviation Investigation Final Report

Location:	Oceanside, California	Accident Number:	WPR22LA114
Date & Time:	February 24, 2022, 12:45 Local	Registration:	N10JA
Aircraft:	Cessna 208B	Aircraft Damage:	Substantial
Defining Event:	Collision with terr/obj (non-CFIT)	Injuries:	2 Serious
Flight Conducted Under:	Part 91: General aviation - Skydiving

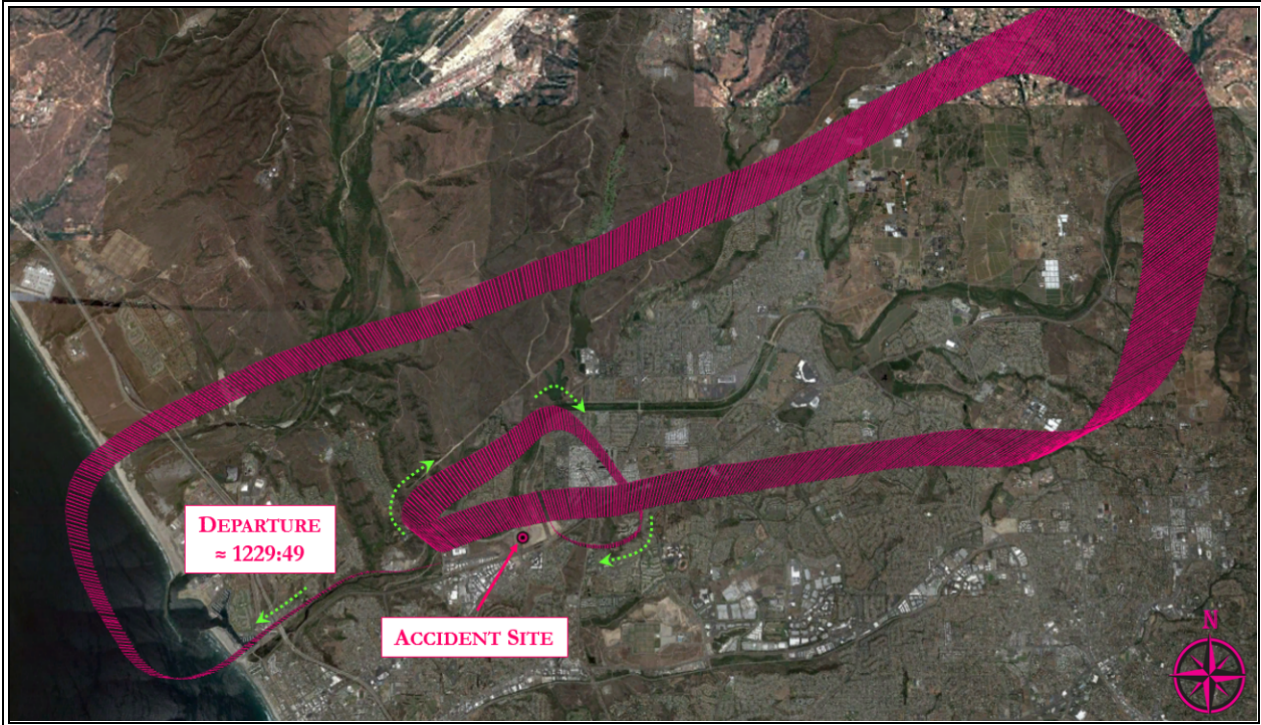
Figure 1: Flight Path on Accident Flight

The pilot further stated that despite his attempt to add power, the engine did not respond to movements of the power lever. He moved the propeller speed lever, which also had no effect. The pilot presumed that the engine had flamed out and attempted a restart. With the propeller still windmilling, he switched the ignition to “continuous” and turned the boost pump on. He observed the torque gauge increase from 0% to 20%, but the engine was still unresponsive to movements of the power lever. He applied full nose-up trim and pulled the control yoke full aft against the stop, but the airplane would not maintain a level attitude. With the airplane in a nose-low attitude, it collided with terrain about 1,400 ft short of the runway (see Figures 1 and 2 below). The pilot did not feather the propeller.

ADS-B information indicated that the airplane reached a maximum rate of descent of about 6,400 fpm shortly after entering the descent, and was descending around 5,300 fpm descent while turning from the base leg to final approach about 3,350 ft above ground level.
