Aviation Investigation Final Report

Location:	Abingdon, Virginia	Accident Number:	ERA22LA145
Date & Time:	March 6, 2022, 23:59 Local	Registration:	N29VA
Aircraft:	Airbus Helicopters MBB-BK 117 C-2	Aircraft Damage:	Substantial
Defining Event:	Landing area undershoot	Injuries:	1 Serious, 2 None
Flight Conducted Under:	Public aircraft

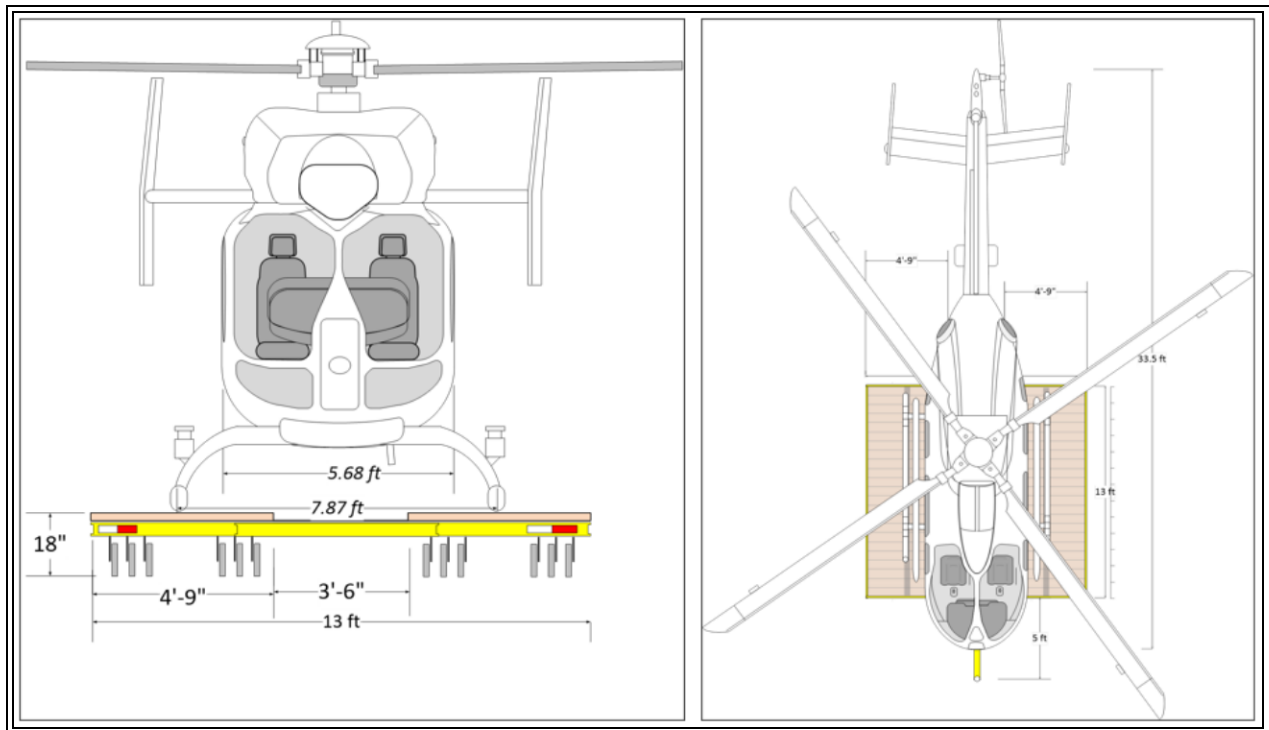
Available evidence suggests that the helicopter skids were misaligned during the attempted landing on the dolly, and the right skid likely fell into the dolly's 3.5-ft-wide center gap, which resulted in a rapid loss of helicopter control. This likelihood is consistent with the pilot's report that the helicopter abruptly entered a nose-low attitude and right bank. The helicopter likely dragged the dolly and tractor during the bank to the right before breaking free of the dolly and impacting terrain. The dolly and its design is no longer sold by the manufacturer without a center plate that covers the gap.

The landing dolly, portions of which were painted yellow, sat 18 inches from the ground on wheels and was manufactured with an open center gap that was 3.5 ft wide. Figure 2 provides an overview of the landing dolly (shown in yellow) and shows how the accident helicopter would look atop it when properly positioned.

Figure 2- Forward view of the helicopter and top-down view of the dolly with the helicopter atop (Source: Airbus Helicopters).
 Note: The three-dimensional model was developed using National Transportation Safety Board measurements.

The landing dolly sustained impact-related twisting and deformation. Several witness marks were observed on the left edge, right top, and underside of the dolly. Examination of the helicopter's skids revealed evidence of yellow paint transfer on the inboard forward area of the left skid. Additional yellow paint transfer was observed on the right skid forward area and rearward top portions. The forward portion of the right skid had sheared off; yellow paint transfer and an indentation were observed within that portion.

Following the accident, the operator reduced the standard scheduled shifts from 24.3 hours to a maximum of 16 hours and 12 hours where staffing permits. In addition, the operator no longer utilizes landing dollies that possess a center gap.
