Aviation Investigation Final Report

Location:	Abingdon, Virginia	Accident Number:	ERA22LA145
Date & Time:	March 6, 2022, 23:59 Local	Registration:	N29VA
Aircraft:	Airbus Helicopters MBB-BK 117 C-2	Aircraft Damage:	Substantial
Defining Event:	Landing area undershoot	Injuries:	1 Serious, 2 None
Flight Conducted Under:	Public aircraft

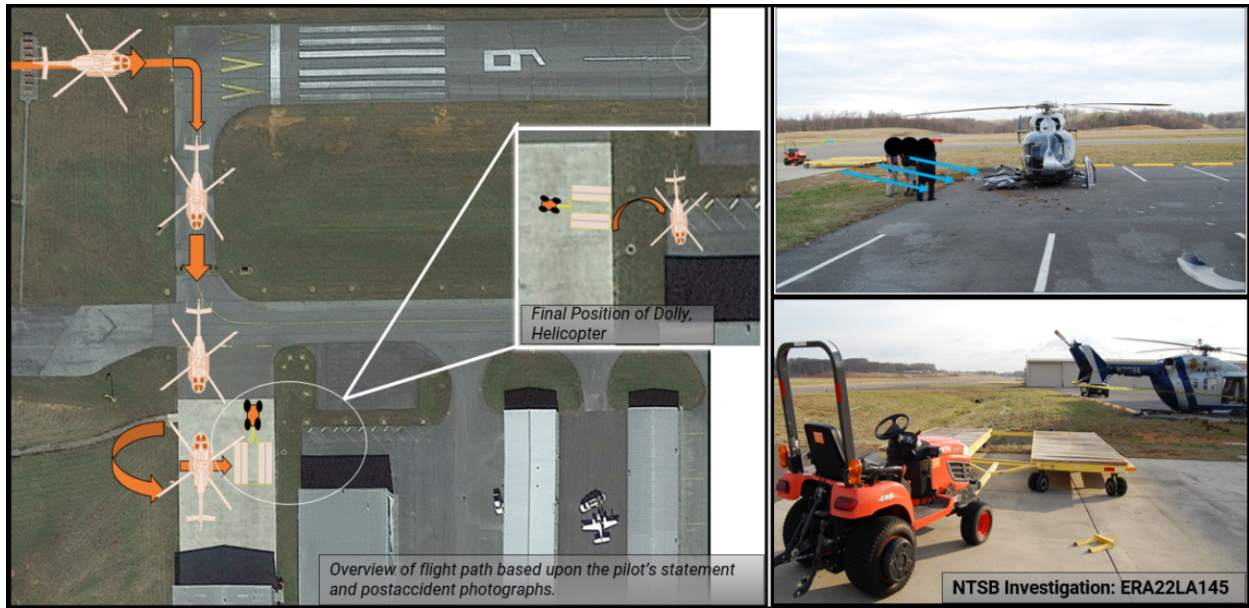
helicopter subsequently impacted terrain. Figure 1 provides an overview of the helicopter's flight track and sidestep maneuver to land on the dolly.

Figure 1 - Overview of the flight track to land on the dolly along with postaccident photographs (Source: Virginia State Police).

The helicopter came to rest upright, the skids had collapsed, and the dolly was found near the area where the helicopter impacted terrain. The helicopter came to rest about 50 ft to the east of the original dolly position. The engines continued to run afterward. The pilot shut down the helicopter, and he and flight paramedics had no difficulties evacuating. Neither flight paramedic reported hearing or feeling an anomaly with the engines at any point during the flight.

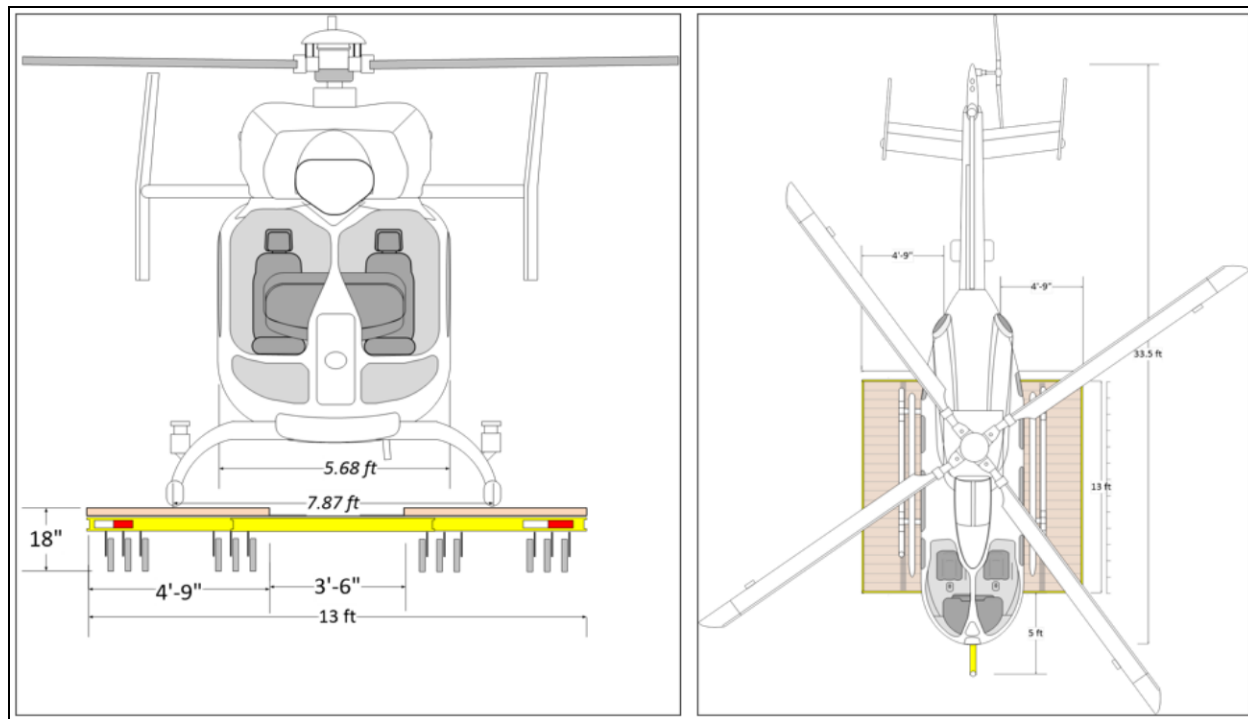
Available evidence suggests that the helicopter skids were misaligned during the attempted landing on the dolly, and the right skid likely fell into the dolly's 3.5-ft-wide center gap, which resulted in a rapid loss of helicopter control. This likelihood is consistent with the pilot's report that the helicopter abruptly entered a nose-low attitude and right bank. The helicopter likely dragged the dolly and tractor during the bank to the right before breaking free of the dolly and impacting terrain. The dolly and its design is no longer sold by the manufacturer without a center plate that covers the gap.

The landing dolly, portions of which were painted yellow, sat 18 inches from the ground on wheels and was manufactured with an open center gap that was 3.5 ft wide. Figure 2 provides an overview of the landing dolly (shown in yellow) and shows how the accident helicopter would look atop it when properly positioned.

Figure 2- Forward view of the helicopter and top-down view of the dolly with the helicopter atop (Source: Airbus Helicopters).
 Note: The three-dimensional model was developed using National Transportation Safety Board measurements.

The landing dolly sustained impact-related twisting and deformation. Several witness marks were observed on the left edge, right top, and underside of the dolly. Examination of the helicopter's skids revealed evidence of yellow paint transfer on the inboard forward area of the left skid. Additional yellow paint transfer was observed on the right skid forward area and rearward top portions. The forward portion of the right skid had sheared off; yellow paint transfer and an indentation were observed within that portion.

Following the accident, the operator reduced the standard scheduled shifts from 24.3 hours to a maximum of 16 hours and 12 hours where staffing permits. In addition, the operator no longer utilizes landing dollies that possess a center gap.
