Aviation Investigation Final Report

Location:	St. George, Utah	Accident Number:	WPR22LA127
Date & Time:	March 24, 2022, 13:49 Local	Registration:	N111NW
Aircraft:	Piper PA-32R-300	Aircraft Damage:	Substantial
Defining Event:	Unknown or undetermined	Injuries:	2 Serious
Flight Conducted Under:	Part 91: General aviation - Personal

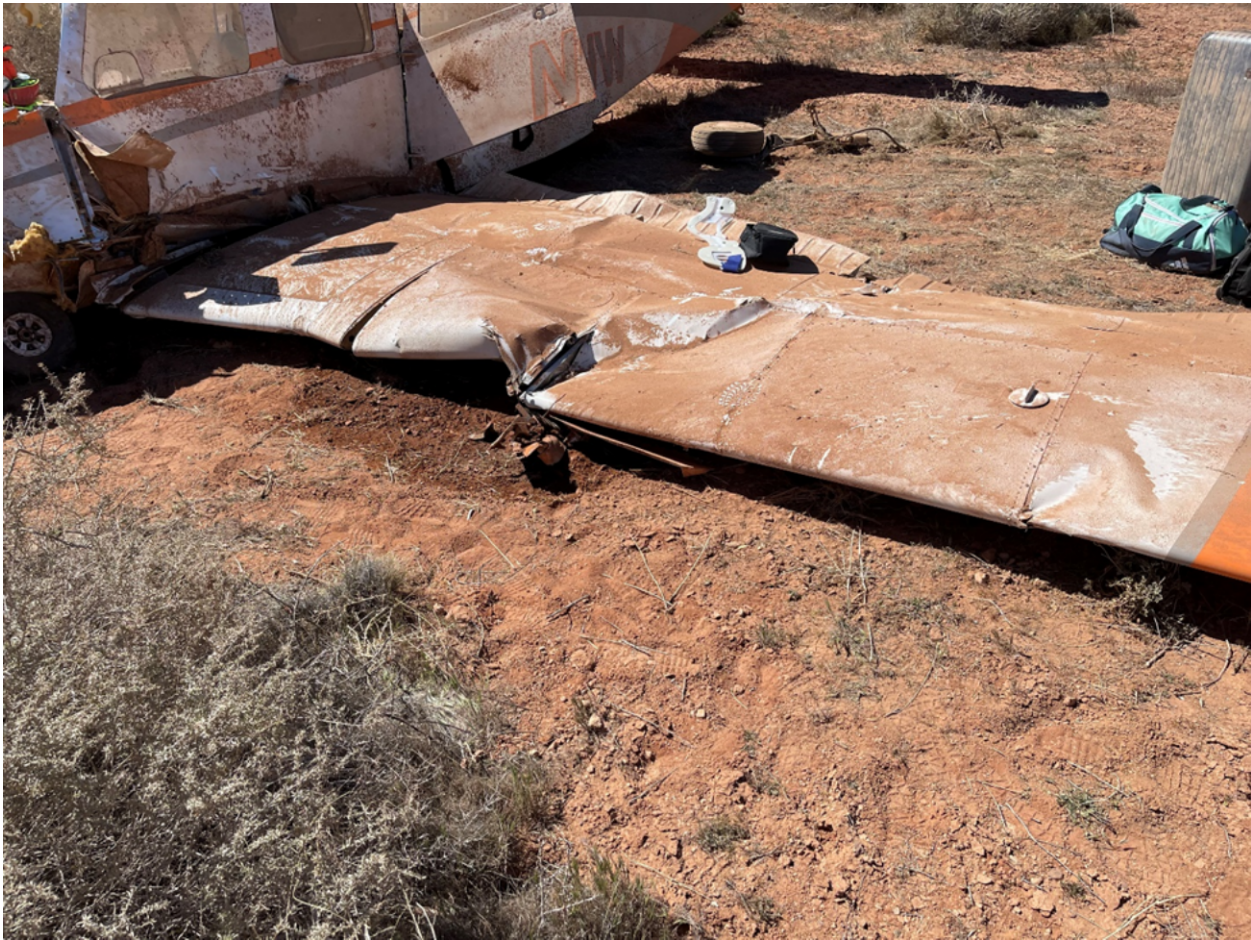
First responder photos from the accident site showed dark colored and fuel saturated ground underneath the left inboard tank. During the wreckage recovery efforts, the left-wing tanks were empty. Twenty gallons of fuel was recovered from the right-wing tanks.

Figure 1-Accident site, view of the left wing and fuel spill.
