Aviation Investigation Final Report

Location:	Rowlett, Texas	Accident Number:	CEN22FA151
Date & Time:	March 25, 2022, 11:27 Local	Registration:	N514CD
Aircraft:	ROBINSON HELICOPTER R44	Aircraft Damage:	Destroyed
Defining Event:	Loss of control in flight	Injuries:	2 Fatal
Flight Conducted Under:	Part 91: General aviation - Instructional

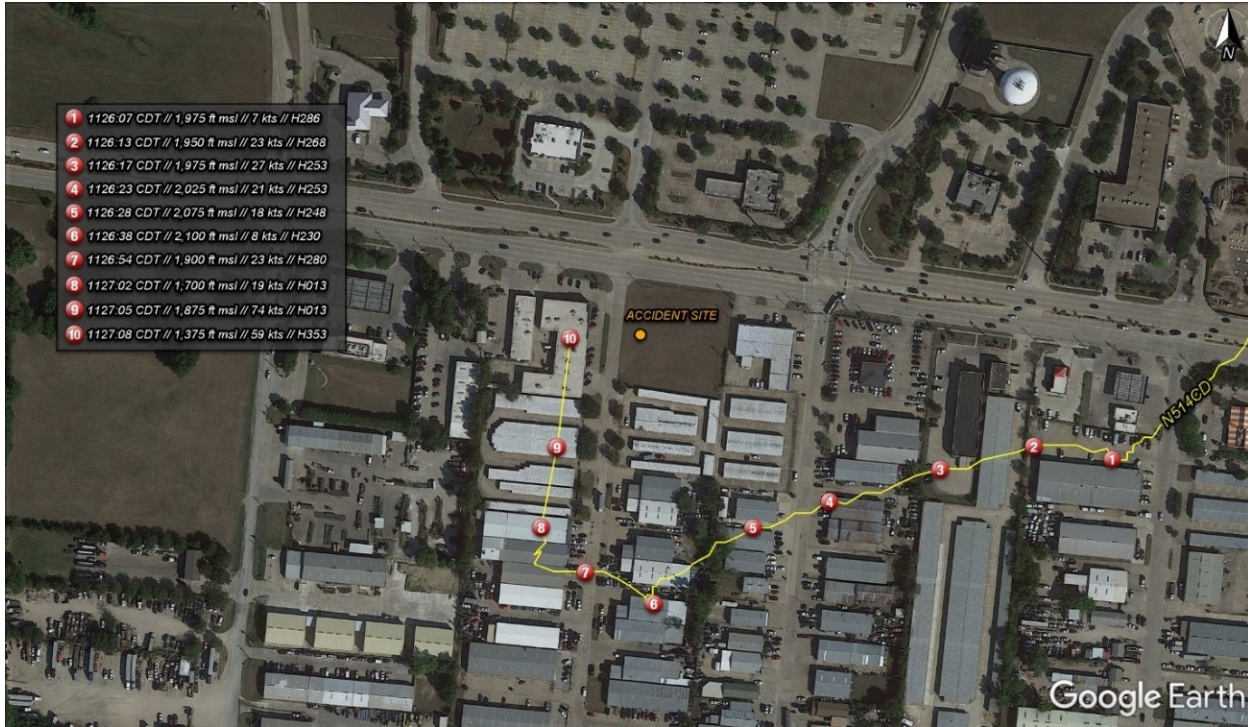
Figure 1. Final Minute of Flight Track from ADS-B Data

Video provided to the National Transportation Safety Board (NTSB) showed the helicopter and its separated tailboom and tail rotor section falling. The video did not show the actual in-flight separation of the tail section. About the last minute of the automatic dependent surveillance – broadcast (ADS-B) data for the flight showed that the helicopter was maneuvering at various slow airspeeds and altitudes. At 1126:07, the helicopter was about 1,975 ft mean sea level (msl) and flying at 7 knots ground speed. (See figure 1.)

The ADS-B data points were consistent with a witness report. The witness heard the helicopter and did not think much of it until after a minute, when he noticed that the helicopter was not moving. He then looked up and saw the helicopter hovering in one place and assumed that it was taking photos of the area. Continuing to observe the helicopter, the witness saw it move about 100 ft and hovered in one place again. After about 10 seconds, the helicopter moved about another 100 ft and hovered. The witness then observed something separate from the helicopter. He saw the helicopter start to go backwards and the tail section fell toward the west. He then saw the helicopter spiraling and falling for about 100 ft. The helicopter stopped falling and spinning for a couple of seconds. Then the helicopter started to spin again and nose-dived to the ground.
