Aviation Investigation Final Report

Location:	Rowlett, Texas	Accident Number:	CEN22FA151
Date & Time:	March 25, 2022, 11:27 Local	Registration:	N514CD
Aircraft:	ROBINSON HELICOPTER R44	Aircraft Damage:	Destroyed
Defining Event:	Loss of control in flight	Injuries:	2 Fatal
Flight Conducted Under:	Part 91: General aviation - Instructional

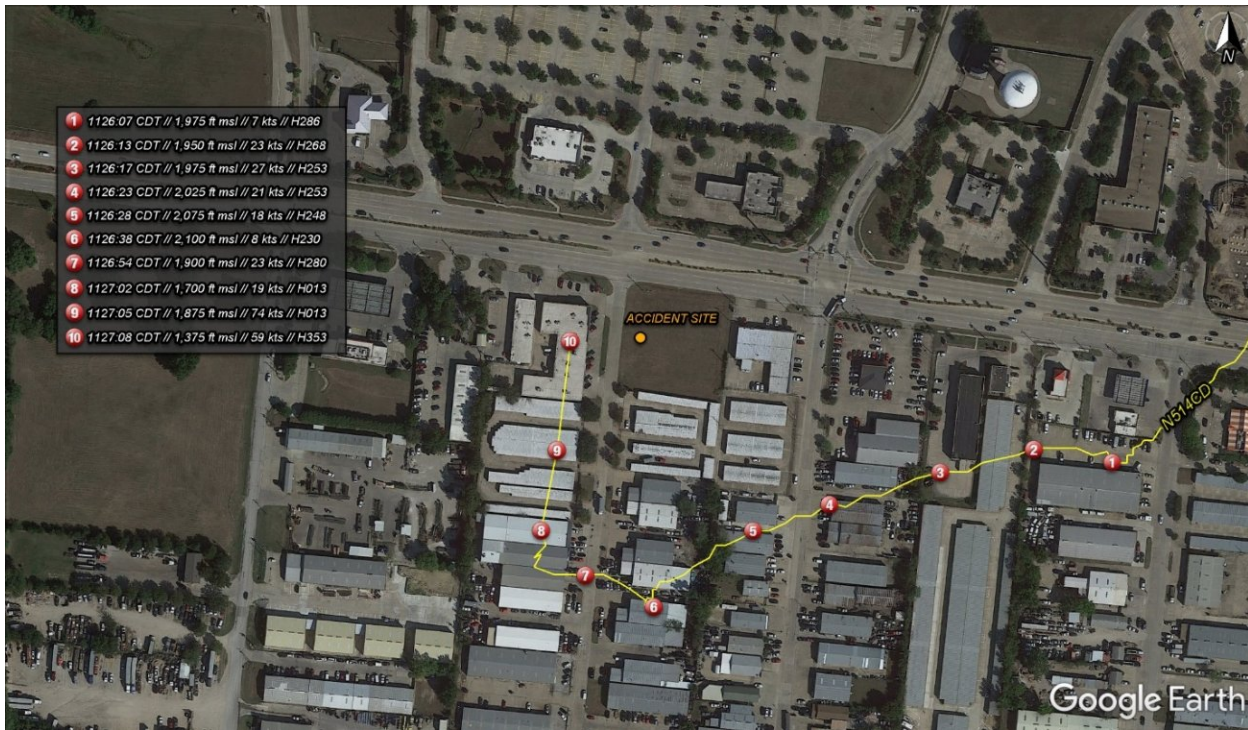
Figure 1. Final Minute of Flight Track from ADS-B Data

Video provided to the National Transportation Safety Board (NTSB) showed the helicopter and its separated tailboom and tail rotor section falling. The video did not show the actual in-flight separation of the tail section. About the last minute of the automatic dependent surveillance – broadcast (ADS-B) data for the flight showed that the helicopter was maneuvering at various slow airspeeds and altitudes. At 1126:07, the helicopter was about 1,975 ft mean sea level (msl) and flying at 7 knots ground speed. (See figure 1.)
