Aviation Investigation Final Report

Location:	Counselor, New Mexico	Accident Number:	WPR22FA148
Date & Time:	April 9, 2022, 12:00 Local	Registration:	N24345
Aircraft:	Taylorcraft BL-65	Aircraft Damage:	Substantial
Defining Event:	Loss of control in flight	Injuries:	1 Fatal, 1 Serious
Flight Conducted Under:	Part 91: General aviation - Personal

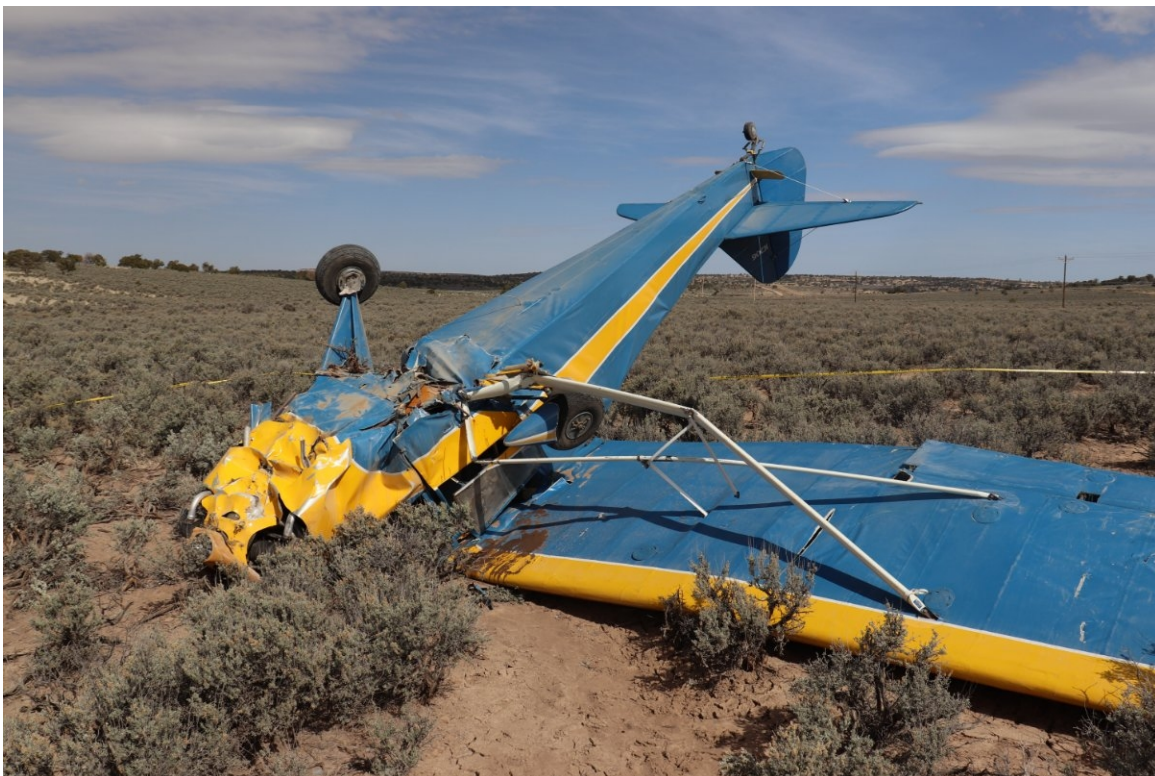
Figure 1. Accident Site with view of airplane

The airplane was located about 53 nautical miles (nm) southeast of FMN, about 5 nm south of Counselor, New Mexico, and about 68 nm northwest from their next intended destination of Double Eagle II Airport, Albuquerque, New Mexico. The airplane came to rest inverted on a dirt field surrounded by sage brush at an elevation of about 7,100 ft msl (Figure 1), on a heading of about 360° magnetic. The airplane sustained substantial damage to the wings, lift struts, and fuselage; all major components of the airplane were accounted for at the accident site.

Examination revealed no evidence of mechanical malfunctions or anomalies with the airplane or engine that would have precluded normal operation.
