Aviation Investigation Final Report

Location:	Leicester, Massachusetts	Accident Number:	ERA22LA187
Date & Time:	April 10, 2022, 11:08 Local	Registration:	N7KJ
Aircraft:	Lancair IV	Aircraft Damage:	Substantial
Defining Event:	Part(s) separation from AC	Injuries:	2 None
Flight Conducted Under:	Part 91: General aviation - Personal

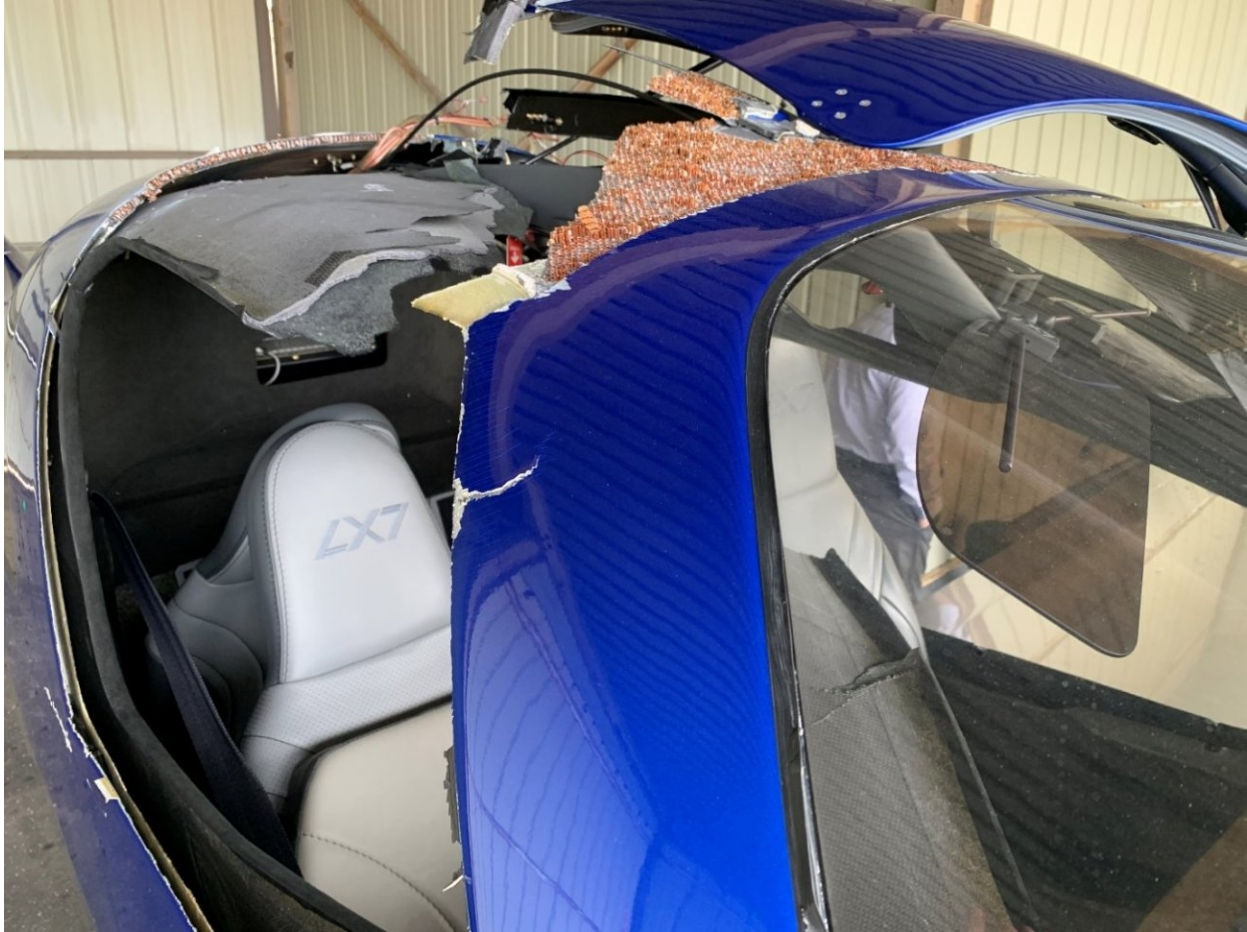
A separation of the window from the airframe for undetermined reasons.

Examination of the airplane by a Federal Aviation Administration (FAA) inspector revealed that the right front window and portions of the roof fractured and separated from the fuselage, resulting in substantial damage (see Figure 1.)

Figure 1- View of missing right front window and roof structure. (Photo courtesy of FAA)

The separated window was not located; however, a FAA inspector initially documented the airplane. Before a detailed examination could be completed, repairs were made on the airplane and the original fracture surfaces were not available for examination. No maintenance records were provided. The pilot/owner stated he had ordered replacement windows, but the accident occurred before he could get them installed.
