Aviation Investigation Final Report

Location:	Kalispell, Montana	Accident Number:	WPR22FA169
Date & Time:	April 30, 2022, 08:04 Local	Registration:	N1908A
Aircraft:	Bearhawk LSA	Aircraft Damage:	Substantial
Defining Event:	Abrupt maneuver	Injuries:	2 Fatal
Flight Conducted Under:	Part 91: General aviation - Personal

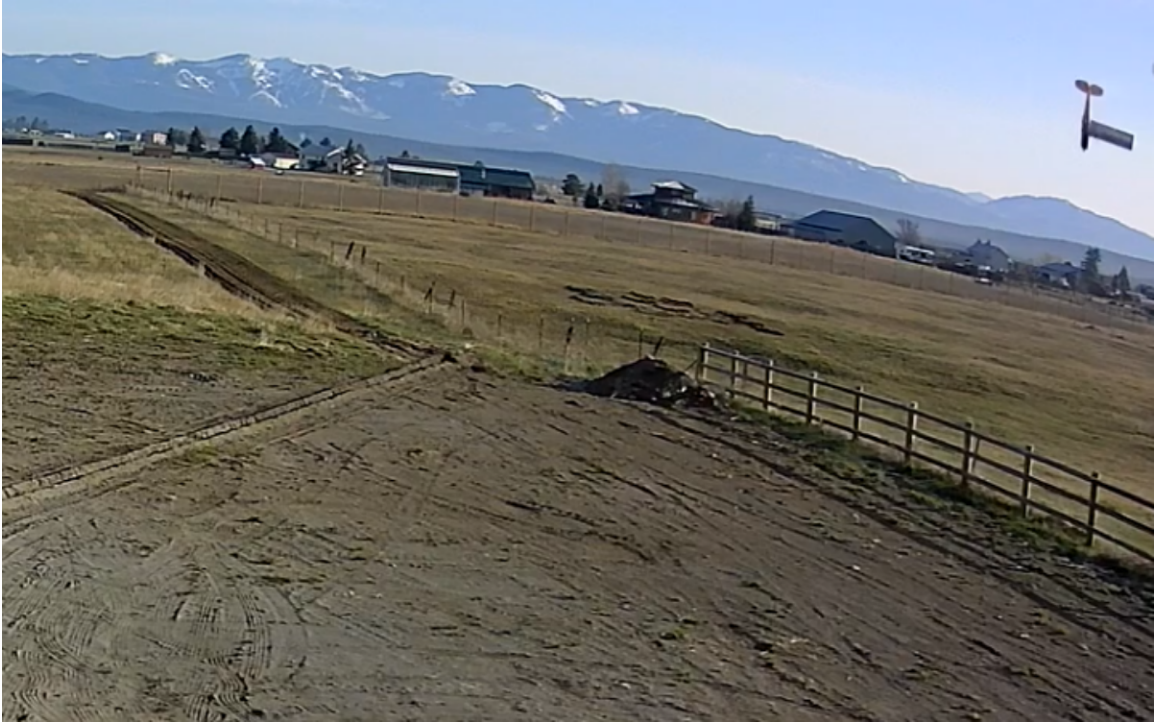
Figure 2 – Airplane just before impact

About that time, a witnesses heard an unusual wind noise followed by a loud bang and observed a wing falling to the ground. No witnesses observed the initial breakup event; however, a north-facing security camera, located on a building about 1,100 ft northwest of the last ADS-B target, captured the airplane about 1 second before ground impact. It was in a direct nose-down attitude and spinning to the right. The right wing was missing, but the left wing and empennage were still attached and intact (figure 2).
