Aviation Investigation Final Report

Location:	Kalispell, Montana	Accident Number:	WPR22FA169
Date & Time:	April 30, 2022, 08:04 Local	Registration:	N1908A
Aircraft:	Bearhawk LSA	Aircraft Damage:	Substantial
Defining Event:	Abrupt maneuver	Injuries:	2 Fatal
Flight Conducted Under:	Part 91: General aviation - Personal

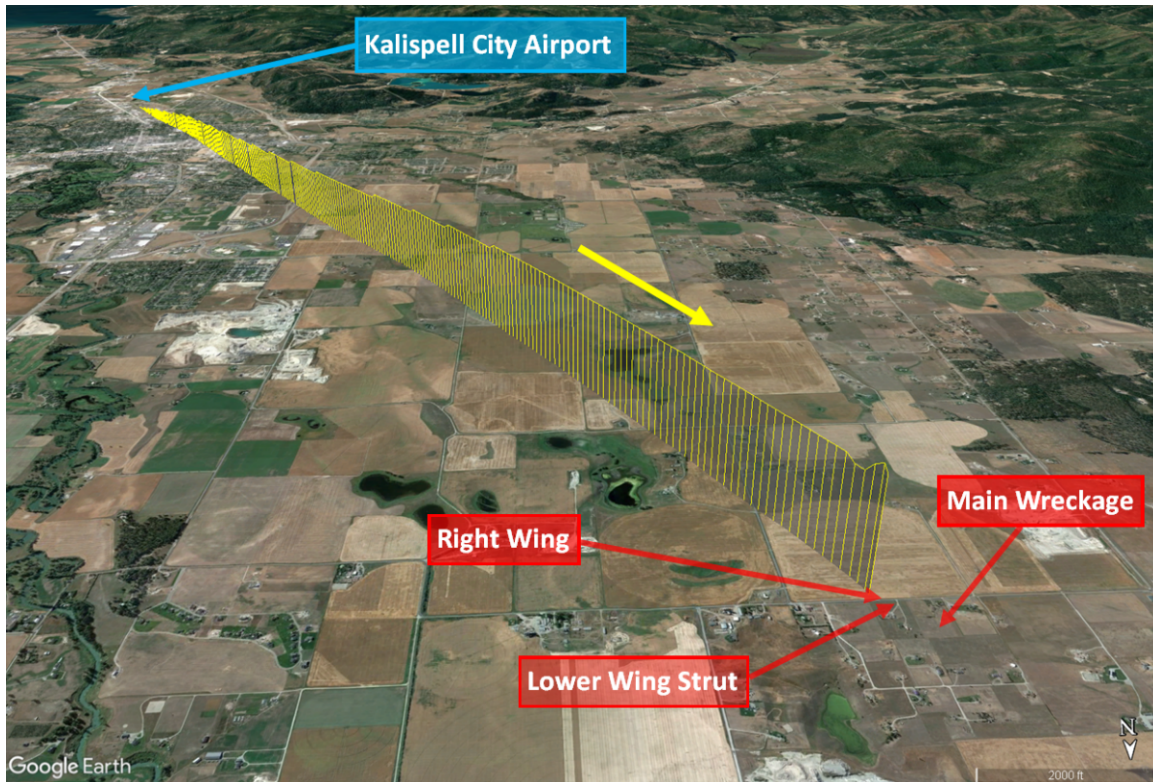
Figure 1 –Flight track and debris field

ADS-B data indicated that after departing from runway 31, the accident airplane climbed on the runway heading for about 4 minutes at a groundspeed of about 88 knots. The airplane then leveled off at a barometric (pressure) altitude of 4,900 ft (about 1,850 ft agl) and for the next 60 seconds accelerated to a ground speed of about 115 knots, after which the data ended. Closer examination of the altitude data, which had a resolution of 100 ft, indicated that for the final 3.5 seconds of flight, and while maintaining the same track, the airplane descended to 4,800 ft, then climbed to 5,100 ft before descending again to 5,000 ft as the data ended (figure 1).

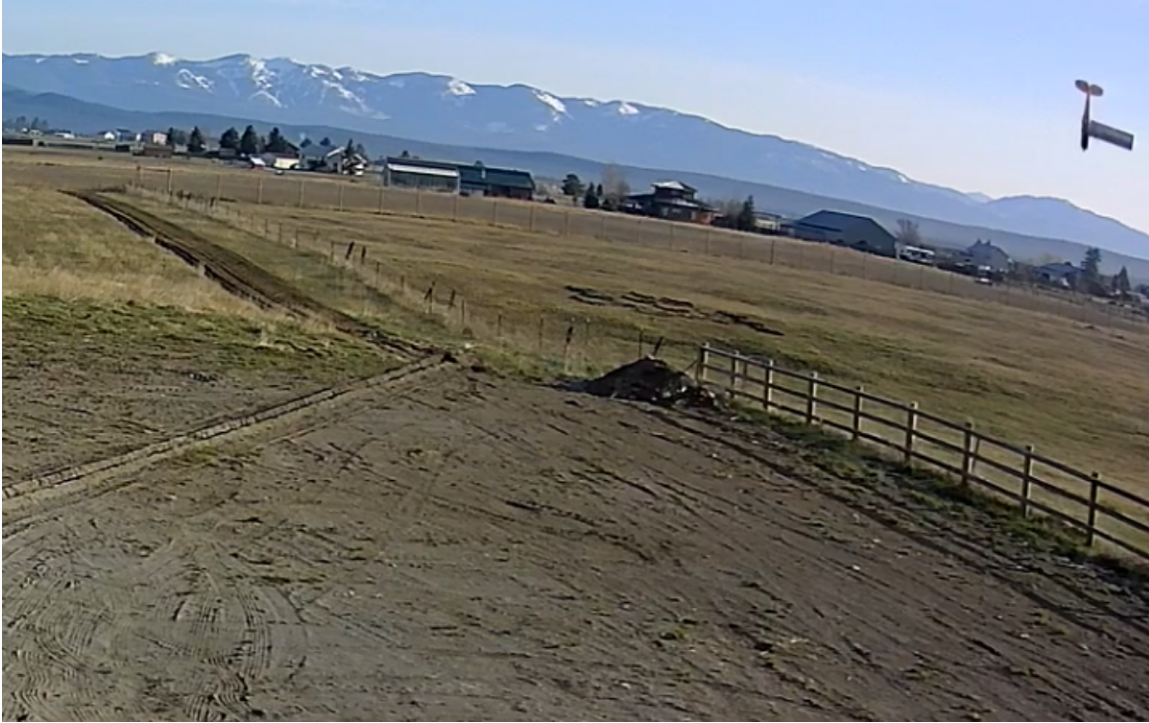
Figure 2 – Airplane just before impact

About that time, a witnesses heard an unusual wind noise followed by a loud bang and observed a wing falling to the ground. No witnesses observed the initial breakup event; however, a north-facing security camera, located on a building about 1,100 ft northwest of the last ADS-B target, captured the airplane about 1 second before ground impact. It was in a direct nose-down attitude and spinning to the right. The right wing was missing, but the left wing and empennage were still attached and intact (figure 2).

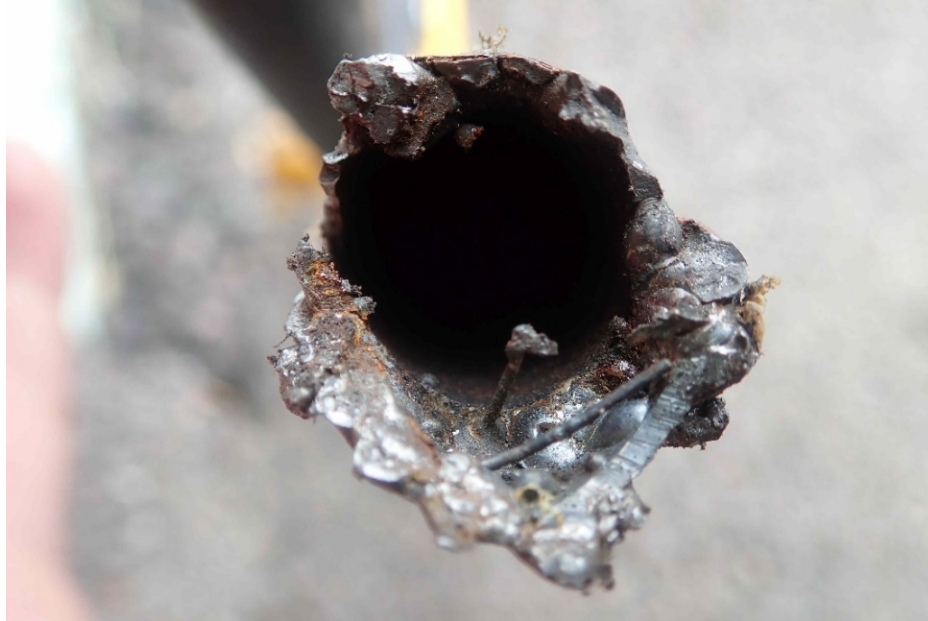
Figure 3 – Incomplete weld of left lower wing box longeron

The pilot built the airplane from plans, and its primary fuselage structure was made of tubular steel covered in fabric. He used an unapproved welding process to construct the airframe and used thicker walled tubing to compensate. Postaccident examination of the wreckage showed the weld quality was generally poor, and a set of structural bracing components in the main wing spar carry-through section was omitted. Even with the poor build quality, the steel airframe structure appeared to be intact before impact. The omission of the braces alone would not have resulted in the failure of the wing as observed: however, the combined effect of the omission and modifications would have affected the overall structural integrity of the airplane.

The weld quality was generally poor throughout, with multiple areas of incomplete fusion, porosity, and burn-through. Of note, the left fore-aft lower wing box longeron exhibited an incomplete weld to the left aft vertical support, with no penetration, and had detached (figure 3). However, the remaining airframe welds in all other locations were correctly oriented, and appeared intact, with any separation failures occurring in overload just beyond the weld fillets.

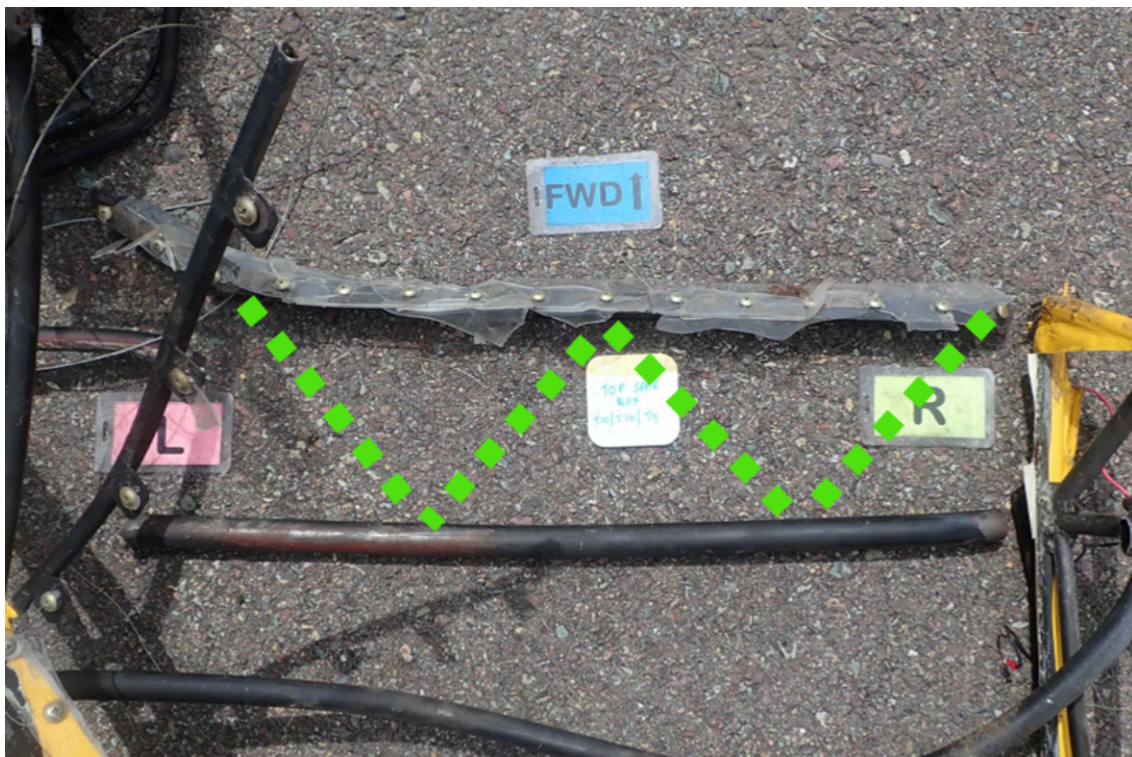
Figure 4 – Omitted wing spar carry-through bracing (in green)

The airplane's plans called for diagonal bracing of the main wing spar carry-through area in the upper cabin. Examination of the airframe revealed that the carry-through structure bracing was missing. Review of the pilot's build logs and airframe remnants indicated that the bracing had never been installed; nothing in the build logs indicated this omission was intentional.

The designer of the airplane performed a structural analysis to calculate how the omission of the bracing would affect the airframe integrity. The results indicated that the carry-through would lose about 20% of its compressive strength, with little change to tensile strength.
