Aviation Investigation Final Report

Location:	Connellsville, Pennsylvania	Accident Number:	ERA22LA215
Date & Time:	May 2, 2022, 15:50 Local	Registration:	N46TA
Aircraft:	Cessna 414	Aircraft Damage:	Substantial
Defining Event:	Flight control sys malf/fail	Injuries:	1 Serious, 1 Minor
Flight Conducted Under:	Part 91: General aviation - Flight test

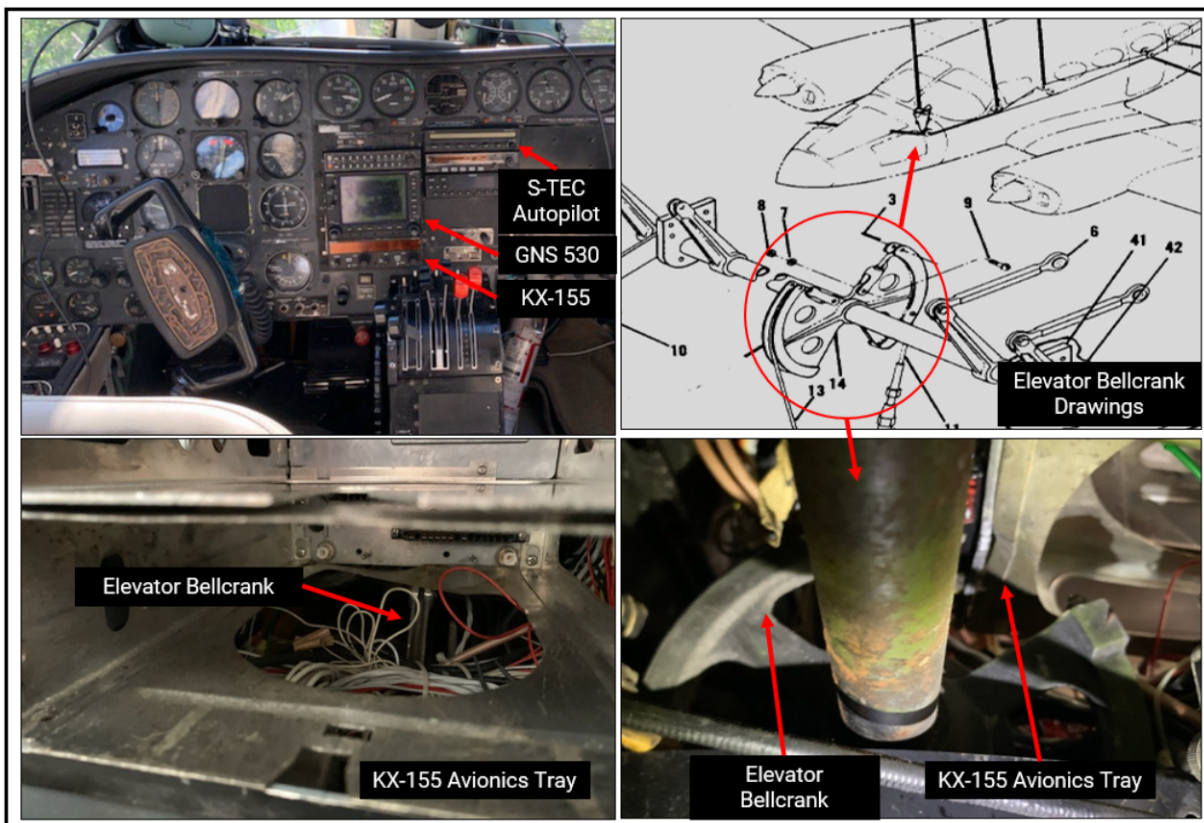
Postaccident examination of the cockpit panel revealed that the left avionics stack included a Garmin GNS 530 GPS and a Bendix-King KX-155 navigation/communication receiver. The avionics tray on the left side that held the KX-155 unit was found stuck within the opening area of the elevator bellcrank. When the flight controls were moved forward or aft, which also moved the elevator bellcrank forward and aft, the controls would not move. The trays in the left avionics stack were found sagging downward, and the avionics units would move downward when the front of the units were pushed by hand.

The avionics trays holding the GNS 530 and KX-155 equipment were secured to the sheet metal on the front of the cockpit panel, but neither avionics tray had metal straps that secured the rear or sides of the tray to the airplane's structure of the airplane. The KX-155 avionics tray had a metal strap on its left side that was not connected to any structure of the airframe. No other avionics trays had straps connected to the airframe structure.

Figure 1. Cockpit, avionics trays, and elevator bellcrank (Source: Federal Aviation Administration).

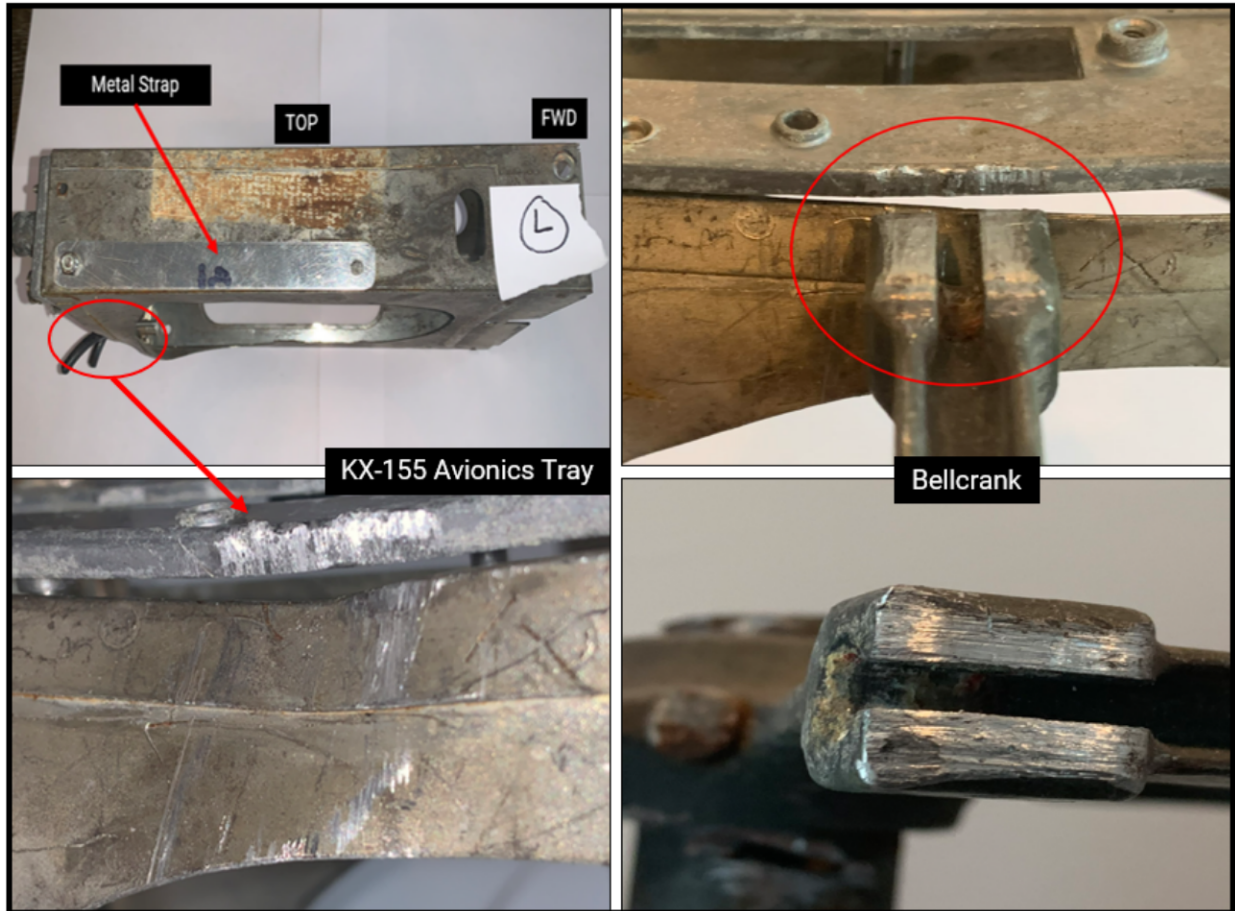
The avionics tray and elevator bellcrank exhibited significant scraping and metal polishing, which indicated that rubbing contact between the sagging avionics tray and the elevator bellcrank had likely been occurring for some time before the accident flight. Neither the pilot nor the passenger (who was also a mechanic) reported observing any anomalies with the flight controls during the preflight run-up but did report that the airplane hit a dip in the runway as the airplane approached its the rotation speed. Thus, this movement likely moved the tray further downward and into the movement area of the elevator bellcrank.

Further examination revealed that the bottom rearward portion of the KX-155 avionics tray was deformed and that the tray and the bellcrank displayed significant scratching and metal polishing. When the avionics tray was removed from the bellcrank movement area, the flight controls operated with a full range of movement.

Figure 2. Scratches found on the elevator bellcrank and KX-155 avionics tray (Source: Federal Aviation Administration). Note: The “FWD” label in the top left photograph shows where the face of the KX-155 unit was located.
