Aviation Investigation Final Report

Location:	Sausalito, California	Accident Number:	WPR22FA172
Date & Time:	May 6, 2022, 12:10 Local	Registration:	N54MG
Aircraft:	Vans RV10	Aircraft Damage:	Substantial
Defining Event:	VFR encounter with IMC	Injuries:	2 Fatal
Flight Conducted Under:	Part 91: General aviation - Personal

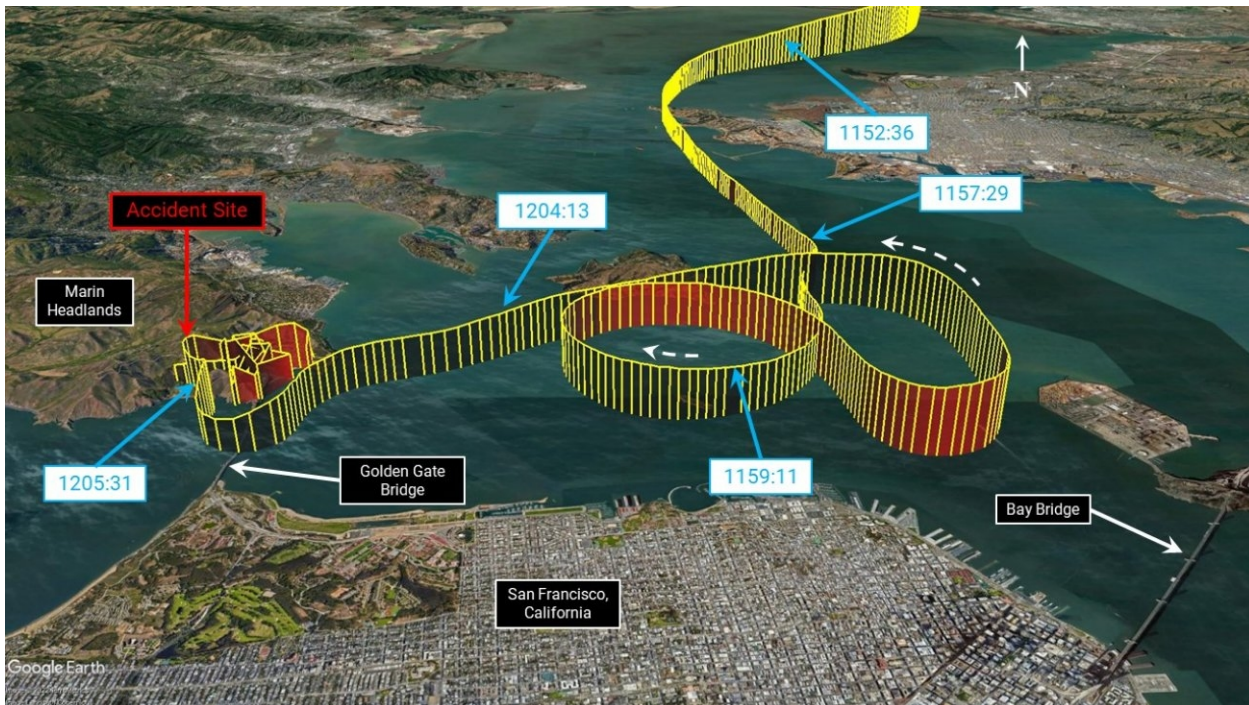
Figure 1: Airplane's route of flight

Over the next five minutes, the airplane made a series of turns at various altitudes below 2,100 ft msl near the north end of the Golden Gate Bridge. In the final 40 seconds of flight, at 1209:07, the airplane began a descent while on a westerly heading from 1,332 ft msl. At 1209:28, the airplane began a right turn to a northerly heading as it continued its descent from 980 ft msl. The track ended at 1209:47, about 300 ft south of the accident site at an altitude

about 821 ft msl. In the final 10 seconds of flight, the airspeed decreased from 79 knots (kts) to 63 kts. Figure 1 depicts the airplane's flight track during the minutes before the accident.
