Aviation Investigation Final Report

Location:	Livermore, California	Accident Number:	WPR22LA174
Date & Time:	May 11, 2022, 09:30 Local	Registration:	N999GH
Aircraft:	BELL HELICOPTER TEXTRON CANADA 407	Aircraft Damage:	Substantial
Defining Event:	Miscellaneous/other	Injuries:	1 Serious, 1 Minor
Flight Conducted Under:	Part 133: Rotorcraft ext. load

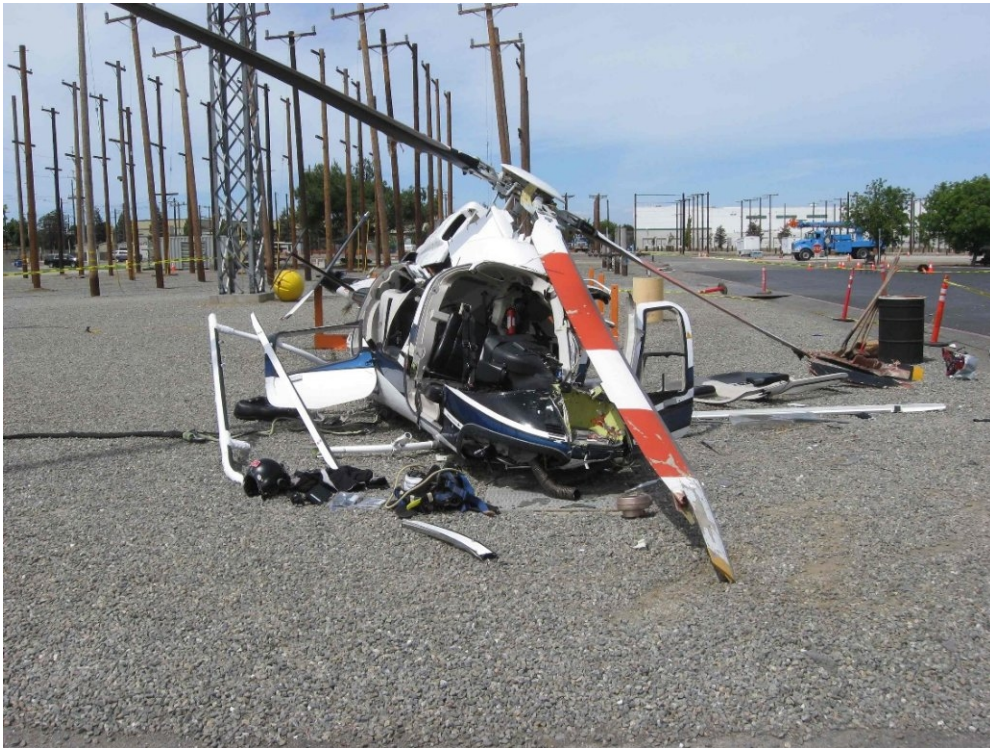
The helicopter came to rest on its belly and was tilted slightly to the left (see Figures 1 and 2). The landing skids had spread outwards on both sides. The primary airframe structure was largely intact but had buckled in the roof area below the main transmission, which had moved out of position and was tilted slightly down. All four main rotor blades remained attached to the hub assembly; one blade was essentially undamaged and the remaining three had sustained delamination, aft bending, and buckling damage from midspan outwards. The tailboom remained attached to the aft bulkhead, and both tail rotor blades had detached with their roots remaining on the hub.

Figure 1– Helicopter at the accident site (photo courtesy of the FAA).

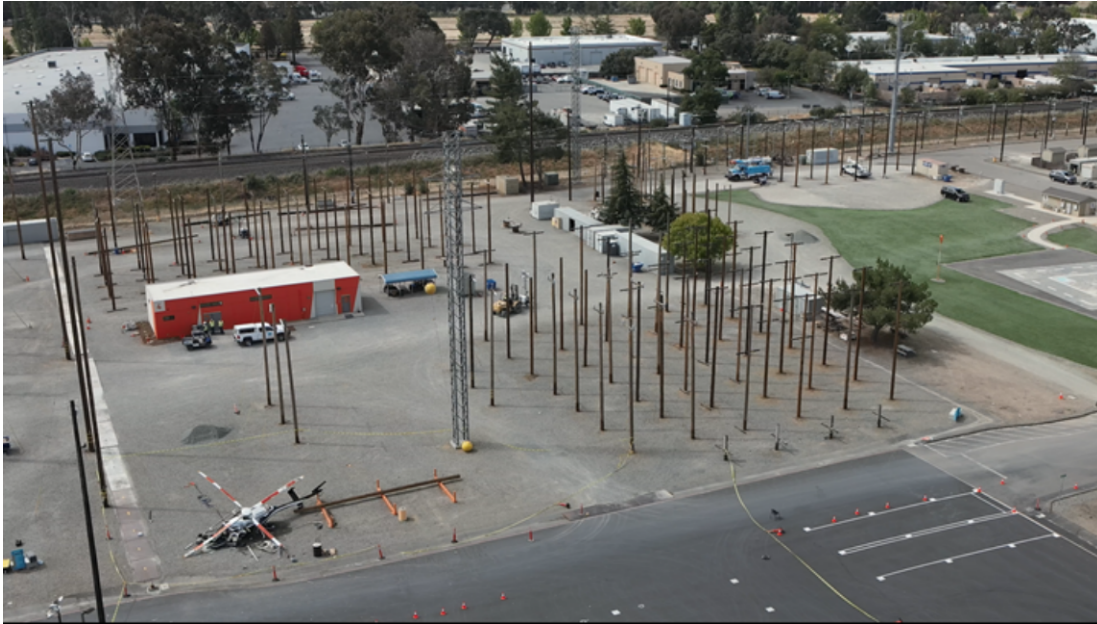
Figure 2 - Accident location within training facility (photo courtesy of PG&E).
