# Aviation Investigation Final Report

<b>Location:</b>	Livermore, California	<b>Accident Number:</b>	WPR22LA174
<b>Date &amp; Time:</b>	May 11, 2022, 09:30 Local	<b>Registration:</b>	N999GH
<b>Aircraft:</b>	BELL HELICOPTER TEXTRON CANADA 407	<b>Aircraft Damage:</b>	Substantial
<b>Defining Event:</b>	Miscellaneous/other	<b>Injuries:</b>	1 Serious, 1 Minor
<b>Flight Conducted Under:</b>	Part 133: Rotorcraft ext. load

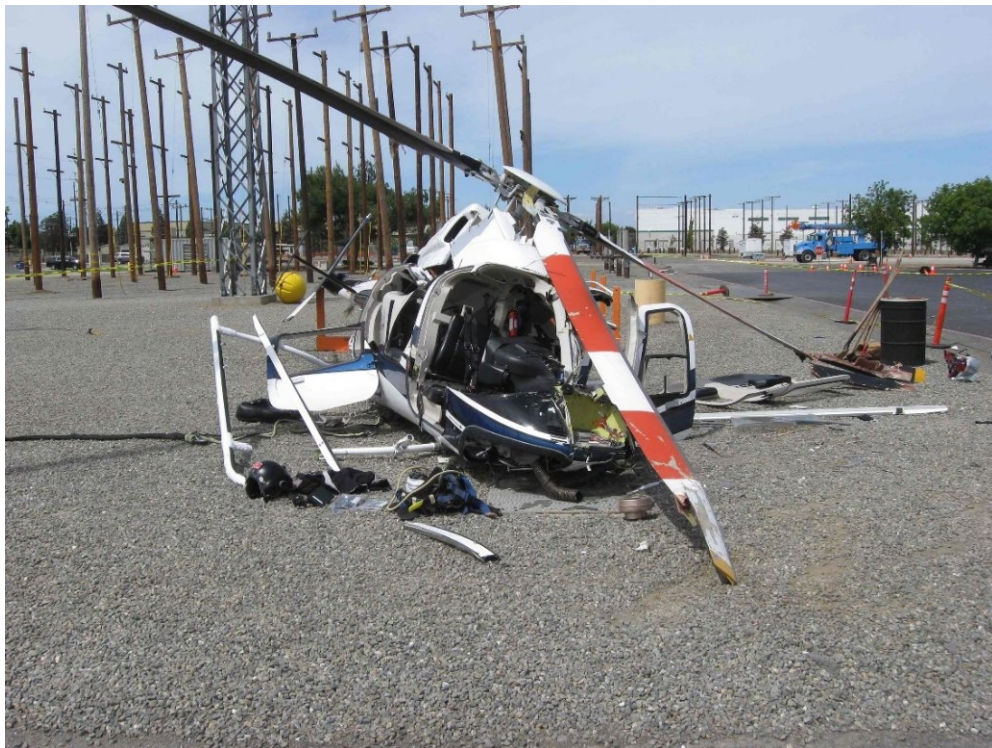
The helicopter came to rest on its belly and was tilted slightly to the left (see Figures 1 and 2). The landing skids had spread outwards on both sides. The primary airframe structure was largely intact but had buckled in the roof area below the main transmission, which had moved out of position and was tilted slightly down. All four main rotor blades remained attached to the hub assembly; one blade was essentially undamaged and the remaining three had sustained delamination, aft bending, and buckling damage from midspan outwards. The tailboom remained attached to the aft bulkhead, and both tail rotor blades had detached with their roots remaining on the hub.

Figure 1– Helicopter at the accident site (photo courtesy of the FAA).

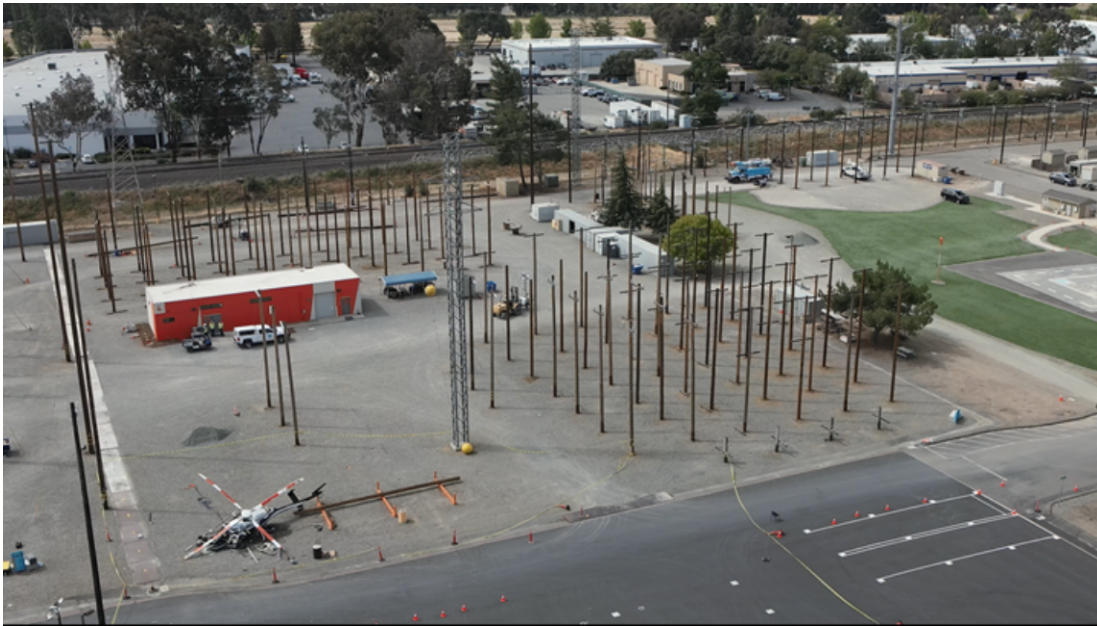
Figure 2 - Accident location within training facility (photo courtesy of PG&E).
