Aviation Investigation Final Report

Location:	Broomfield, Colorado	Accident Number:	CEN22FA208
Date & Time:	May 22, 2022, 11:49 Local	Registration:	N85CT
Aircraft:	Piper PA-32-260	Aircraft Damage:	Substantial
Defining Event:	Unknown or undetermined	Injuries:	2 Fatal
Flight Conducted Under:	Part 91: General aviation - Personal

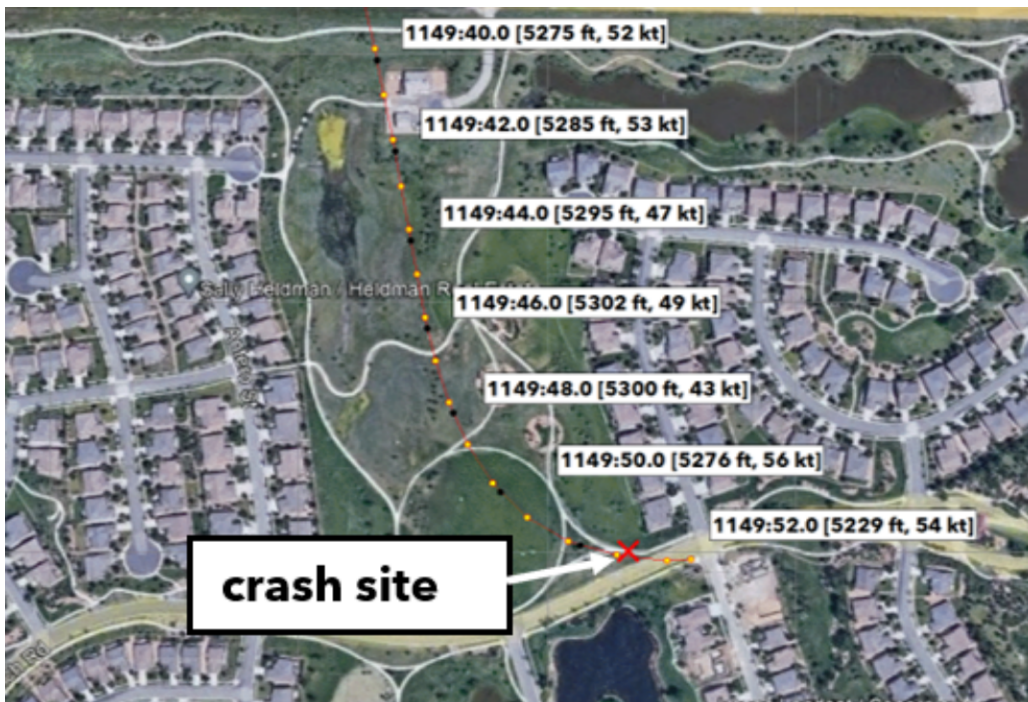
Figure 1. Accident Flight Track with Recorded Altitude and Indicated Airspeed

According to automatic dependent surveillance-broadcast (ADS-B) information, the airplane departed Erie Municipal Airport (EIK) on Runway 16. About 3,000 ft from the departure end of the runway, the airplane made a left turn, descended, and impacted terrain.

On the accident takeoff roll, engine power was slow to increase relative to the previous flight, and the airplane did not accelerate much beyond the rotation speed. The accident takeoff rate of climb was 200-300 feet per minute less than the previous flight.

The airplane pitched up to over 20° during the accident takeoff, about twice the pitch attitude obtained during the previous takeoff. The airplane reached a maximum altitude of about 230 ft above ground level before pitching down, descending, and impacting the ground.

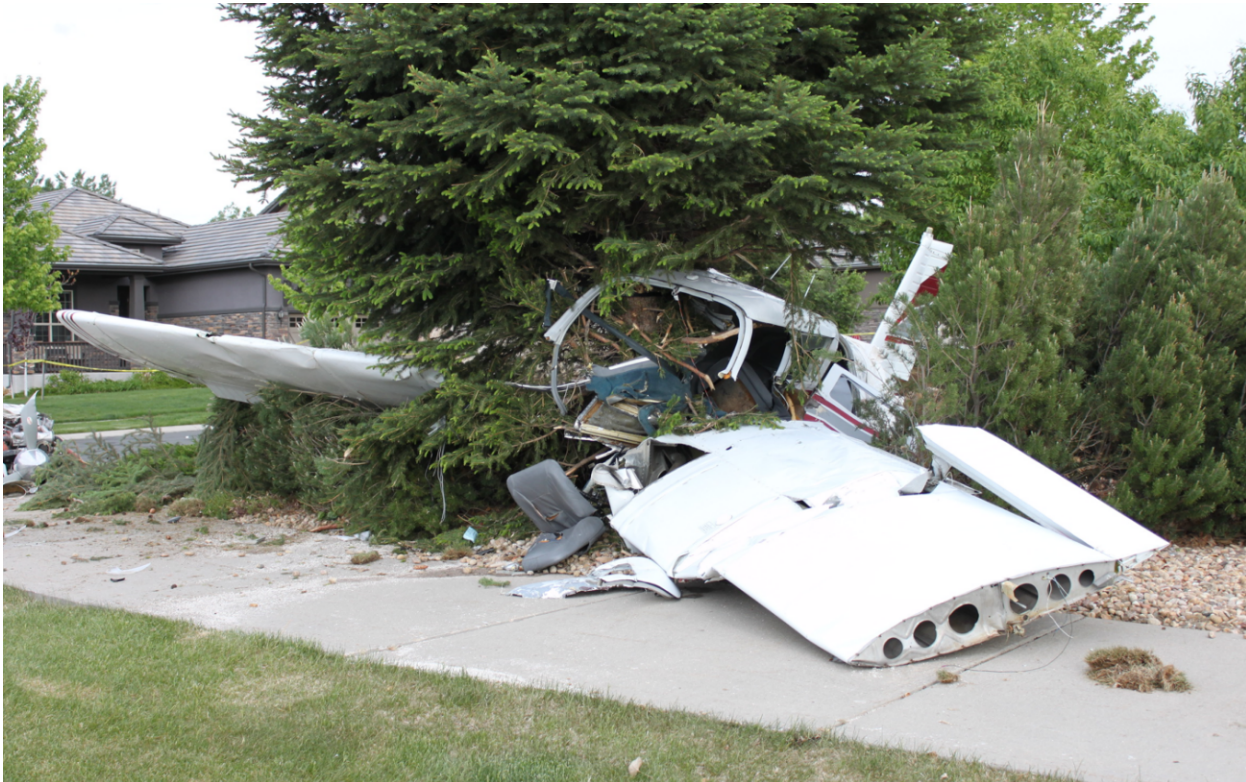
Figure 2. Airplane at Accident Site

The airplane impacted a grassy area in a residential community. About 35 ft beyond the point of initial impact, six propeller strike marks spaced about 1 ft apart were located on a paved road. The airplane bounced and subsequently impacted a large tree about 100 ft from the propeller strike marks, which resulted in the engine and cockpit area separating from the remainder of the fuselage.
