Aviation Investigation Final Report

Location:	Galice, Oregon	Accident Number:	WPR22LA193
Date & Time:	May 31, 2022, 09:40 Local	Registration:	N298DM
Aircraft:	Vans RV-8	Aircraft Damage:	Substantial
Defining Event:	Loss of engine power (total)	Injuries:	2 None
Flight Conducted Under:	Part 91: General aviation - Personal

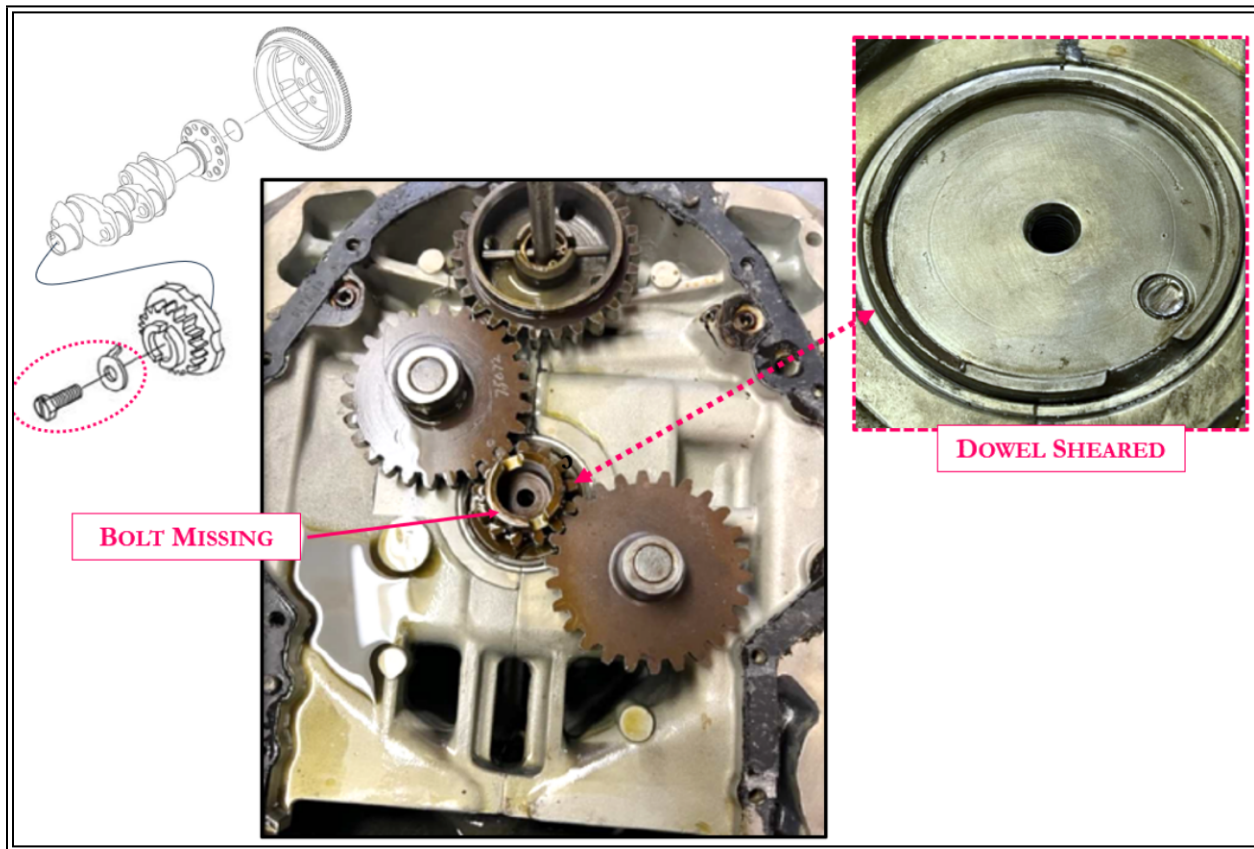
Figure 1: Accessory Housing Removed (pictures provided by mechanic)

A postaccident examination revealed that the crankshaft gear was missing its retaining bolt and lock-plate. The alignment dowel was sheared off and the crankshaft gear’s mounting flange was damaged. Mounting flange material was found in the sump, but the missing bolt and lock-plate were not found, likely because it was never installed at the last overhaul (98.9 hours before the accident).

The in-flight failure of the crankshaft gear’s alignment dowel as a result of the retaining bolt not being installed, which lead to a total loss of engine power.

crankshaft gear was missing its retaining bolt and lock-plate (see Figure 1 below). After removing the gear, he noted the alignment dowel was sheared off and the crankshaft gear's mounting flange was damaged. He removed the oil sump and found debris consistent with the mounting flange material but was unable to locate the missing bolt.
