# Aviation Investigation Final Report

<b>Location:</b>	Galice, Oregon	<b>Accident Number:</b>	WPR22LA193
<b>Date &amp; Time:</b>	May 31, 2022, 09:40 Local	<b>Registration:</b>	N298DM
<b>Aircraft:</b>	Vans RV-8	<b>Aircraft Damage:</b>	Substantial
<b>Defining Event:</b>	Loss of engine power (total)	<b>Injuries:</b>	2 None
<b>Flight Conducted Under:</b>	Part 91: General aviation - Personal

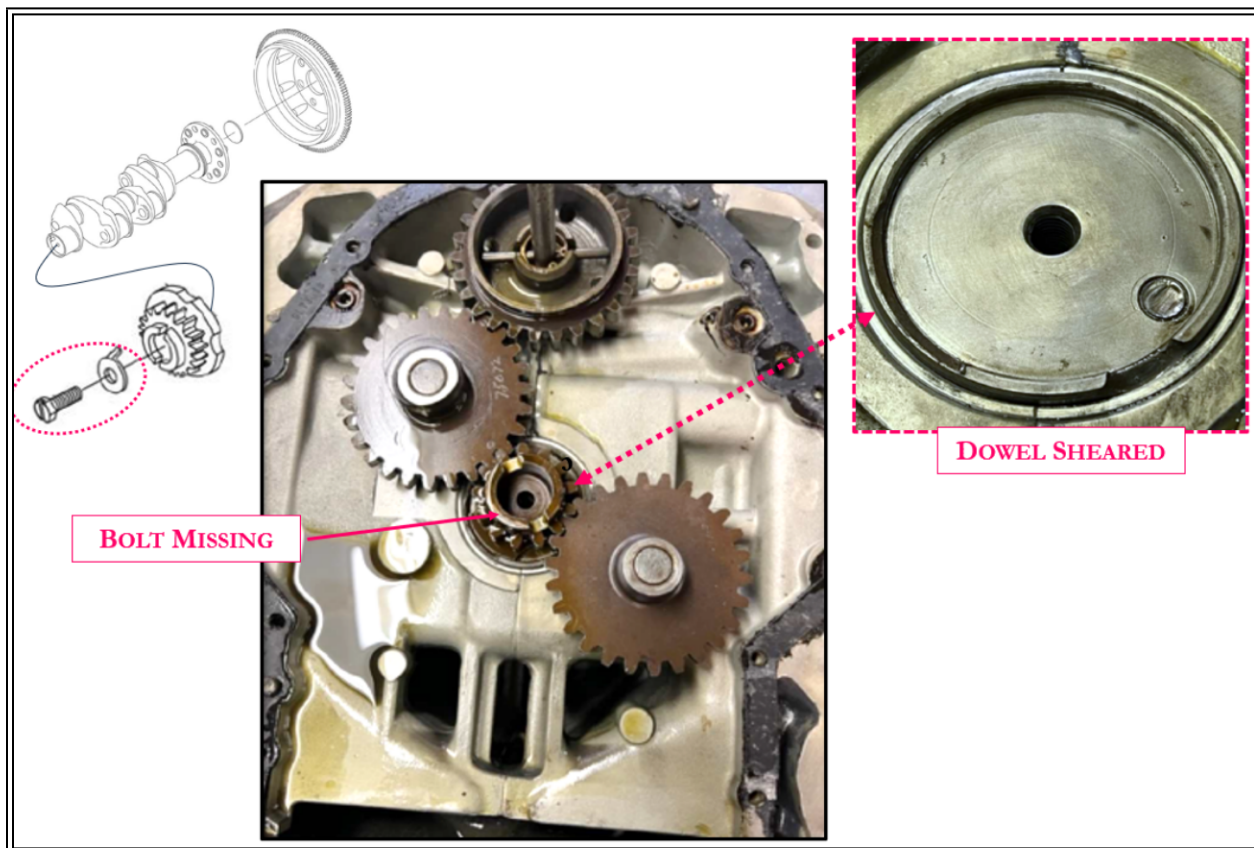
A postaccident examination revealed that the crankshaft gear was missing its retaining bolt and lock-plate. The alignment dowel was sheared off and the crankshaft gear’s mounting flange was damaged. Mounting flange material was found in the sump, but the missing bolt and lock-plate were not found, likely because it was never installed at the last overhaul (98.9 hours before the accident).

The in-flight failure of the crankshaft gear’s alignment dowel as a result of the retaining bolt not being installed, which lead to a total loss of engine power.

crankshaft gear was missing its retaining bolt and lock-plate (see Figure 1 below). After removing the gear, he noted the alignment dowel was sheared off and the crankshaft gear's mounting flange was damaged. He removed the oil sump and found debris consistent with the mounting flange material but was unable to locate the missing bolt.

Figure 1: Accessory Housing Removed (pictures provided by mechanic)
