# Aviation Investigation Final Report

<b>Location:</b>	Fairfield, New Jersey	<b>Accident Number:</b>	ERA22FA257
<b>Date &amp; Time:</b>	June 4, 2022, 12:01 Local	<b>Registration:</b>	N98ZA
<b>Aircraft:</b>	BELL HELICOPTER TEXTRON CANADA 407	<b>Aircraft Damage:</b>	Substantial
<b>Defining Event:</b>	Loss of control in flight	<b>Injuries:</b>	1 Serious
<b>Flight Conducted Under:</b>	Part 91: General aviation - Positioning

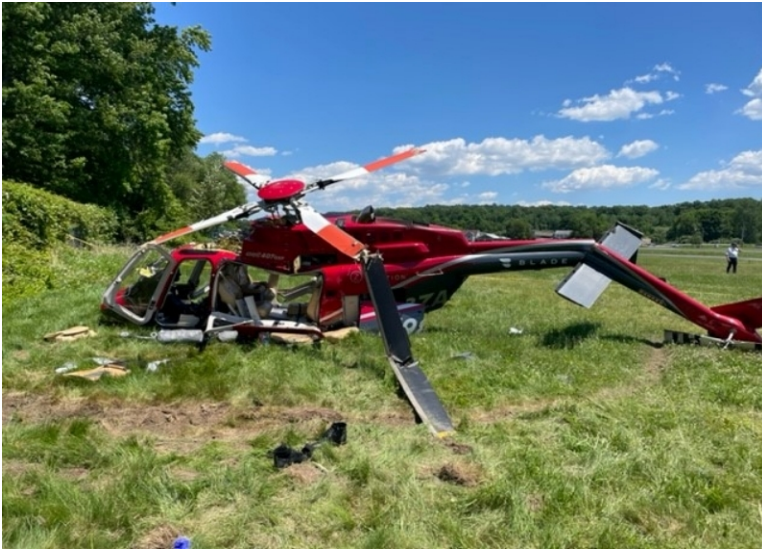
descend as the helicopter rotated right around the main rotor mast. The helicopter completed several 360° rotations before impacting terrain north of runway 28, which caused substantial damage to the fuselage and tailboom, as shown in figure 1.

Figure 1. Helicopter after ground impact (Source: FAA).

Airport surveillance video captured the helicopter's approach, its alignment with the runway, and its decreasing airspeed as the nose pitched upward. The video showed that, as the helicopter slowed, its nose yawed to the right, and the helicopter became unstable and started to descend vertically while rotating around the main rotor mast. About 3 seconds into the vertical descent, the right yaw slowed and then stopped, and the helicopter rotated to its left as it descended and contacted the ground. After ground contact, the main rotor continued to turn, and the main rotor blades continued to strike the ground, shedding about 50% of the span of each blade.

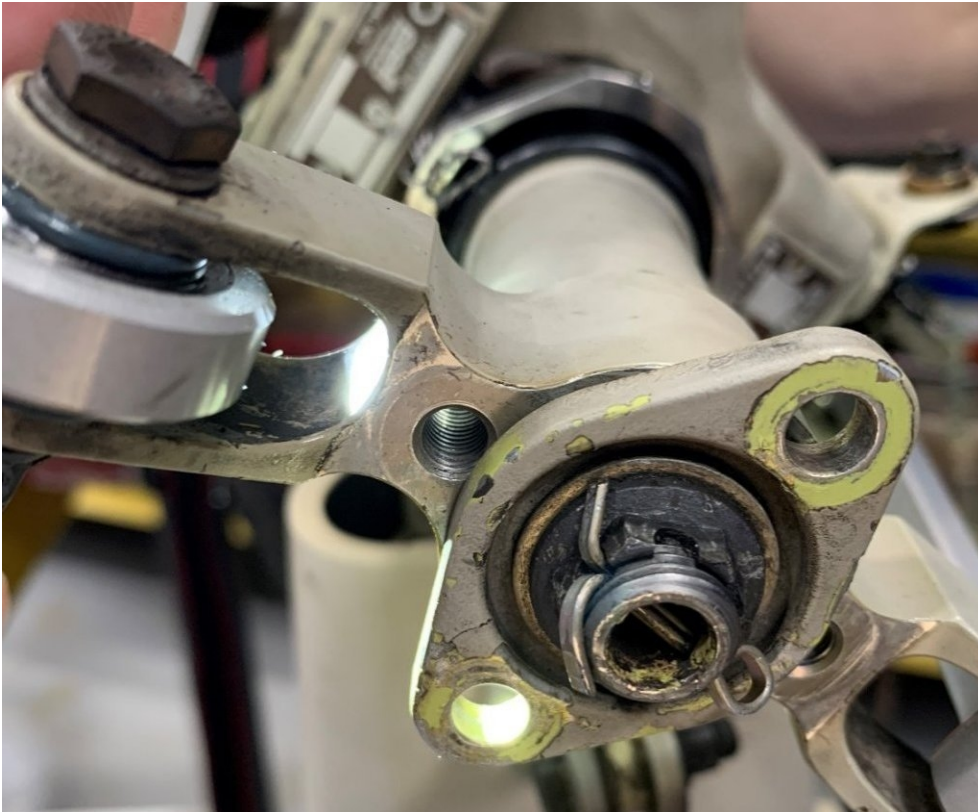
Postaccident examination of the helicopter revealed that the tail rotor crosshead drive plate, which was positioned behind the pitch change rod attachment nut, was not bolted to the tail rotor crosshead. The two attachment bolts were not present, and no remnants of any bolts were found in the threaded receptacles in the crosshead. The threads were undamaged and showed no signs of corrosion, deformation, smearing, or cross-threading, indicating that the attachment bolts were likely not installed.

The failure of maintenance personnel to properly secure the tail rotor crosshead drive plate and the failure of maintenance personnel, the maintenance pilot, and the accident pilot to detect the error, which led to the helicopter’s loss of tail rotor antitorque. Also causal was the pilot’s failure to maintain the helicopter’s airspeed at or above effective translational lift and perform a run-on landing, which resulted in a loss of control.

Postaccident examination revealed that the tail rotor crosshead drive plate, which was positioned behind the pitch change rod attachment nut, was not bolted to the tail rotor crosshead, as prescribed in the maintenance manual. The two attachment bolts were not present, and no remnants of any bolts were found in their threaded receptacles in the

crosshead drive plate, as shown in figure 2. The threads were undamaged and showed no signs of corrosion, deformation, smearing, or cross-threading.

Figure 2. Tail rotor crosshead/drive plate attachment bolt bore threads (Source: Bell Helicopters).

As a result of this investigation, the operator developed a required inspection program, which was published and amended to the *General Operating Manual*. The program was submitted to the appropriate FAA Certificate Holder District Office, and the manual revisions were accepted.
