Aviation Investigation Final Report

Location:	Panama City, Florida	Accident Number:	ERA22FA261
Date & Time:	June 6, 2022, 16:10 Local	Registration:	N160LL
Aircraft:	Piper PA-28RT-201	Aircraft Damage:	Substantial
Defining Event:	Loss of engine power (partial)	Injuries:	2 Fatal, 1 Serious
Flight Conducted Under:	Part 91: General aviation - Personal

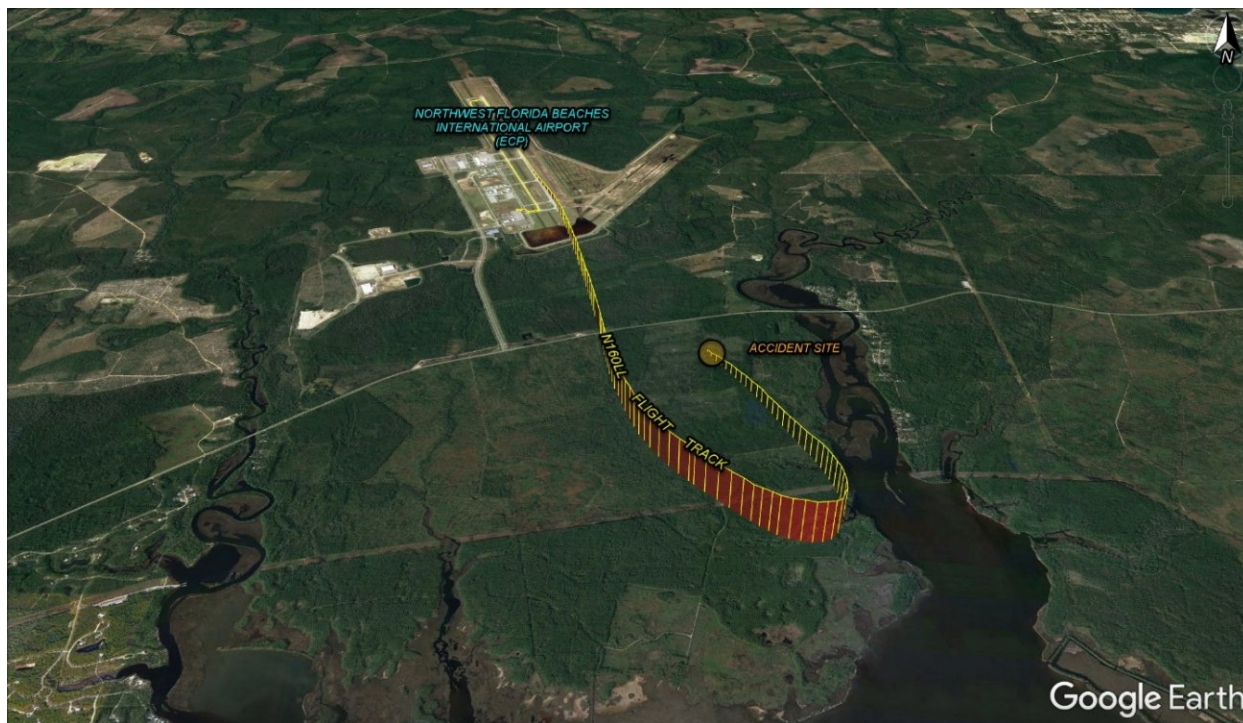
about 1609. ADS-B data showed that the airplane began to descend, made a 180° left turn, and then continued to descend until it impacted trees and terrain about 1.7 miles from the runway threshold. The ADS-B data ended about 190 ft before the main wreckage; figure 1 shows the airplane's flight track.

Figure 1 - ADS-B data showing the accident flight track.

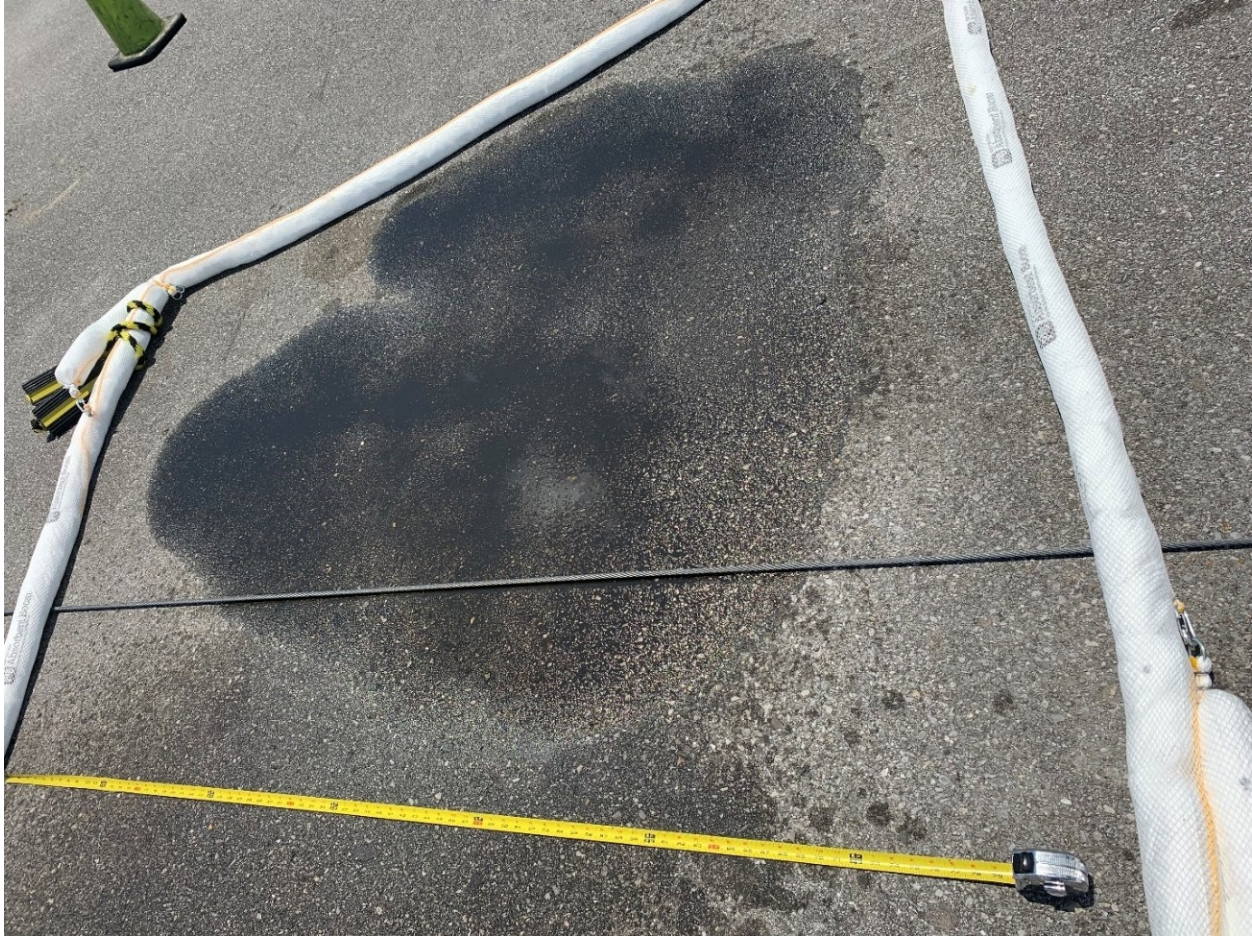
Oil staining observed on the ramp area where the airplane was parked before the flight, a trail of oil leading from the parking area to the runway, and the oil observed on the airframe exterior at the accident site all suggest that the airplane was actively leaking oil both before and during the accident flight. Based on all available information, it is likely that the oil pressure sensor line fractured during the flight before the accident flight, which resulted in oil leaking from the engine. This oil leak ultimately resulted in oil starvation and loss of engine power during the departure from, and the pilot's attempted return to the airport. Had the pilot noted and investigated the source of the oil leakage during the preflight inspection, he might have taken appropriate corrective action and avoided the accident.

Postaccident examination of the pavement in the parking area of the FBO revealed a trail of oil drops that led to a small puddle of oil where the airplane was initially parked. A second larger area of oil staining, measuring about 6 ft by 6 ft (as shown in figure 2), was found at the airplane’s second parking location (where the airplane had been moved by FBO personnel), which was where the pilot conducted his walk-around and loaded passengers before he started the engine for taxi and takeoff. Furthermore, there was a trail of oil leading from the spot pictured in Figure 2 toward the runway that aligned with the airplane taxiing to the runway.

Figure 2 - Large oil stain on the pavement where airplane was located at engine start.

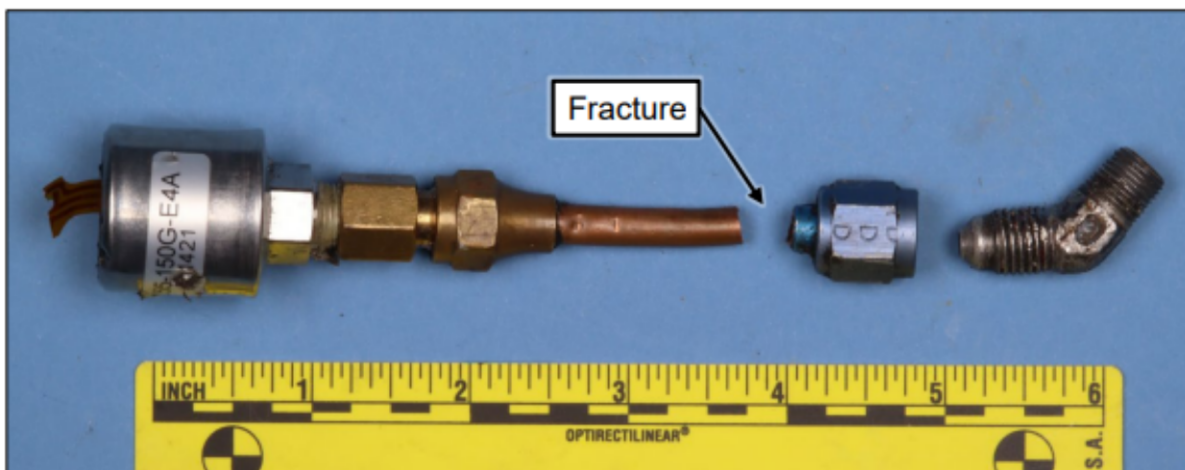
Examination of the rigid oil pressure line revealed that it fractured due to high-cycle fatigue. This was likely from excessive vibration due to insufficient support of the oil pressure sensor and rigid line. The oil pressure sensor, which was part of the avionics system, was installed about 3 flight hours before the accident. The installation manual for the avionics system stated that a flexible line should be used to install the oil pressure sensor in order to minimize vibration effects. Instead, a rigid line was installed, which would have been more susceptible to the effects of vibration, including high-cycle fatigue failure.

Postaccident examination of the engine revealed a breach of the crankcase near the No. 4 cylinder. The engine was disassembled, and continuity of the crankshaft was confirmed. No anomalies were noted on the main journals of the crankshaft. The No. 4 connecting rod journal exhibited thermal damage, and bearing material was found welded/smeared to the crankshaft journal. The No. 4 connecting rod cap, connecting rod bolts, and bearing pieces were found in the oil sump along with other metallic debris and a trace amount of oil. The oil drain plug remained seated and safety wired to the oil sump. The oil pump rotated freely by hand. The oil pump was disassembled, and no scoring was noted on the oil pump gears or the housing. The oil pressure sensor was separated from the engine. The sensor's rigid copper line was fractured at the fitting to the accessory section of the crankcase, as shown in figure 3.

Figure 3. Fractured oil pressure sensor line.

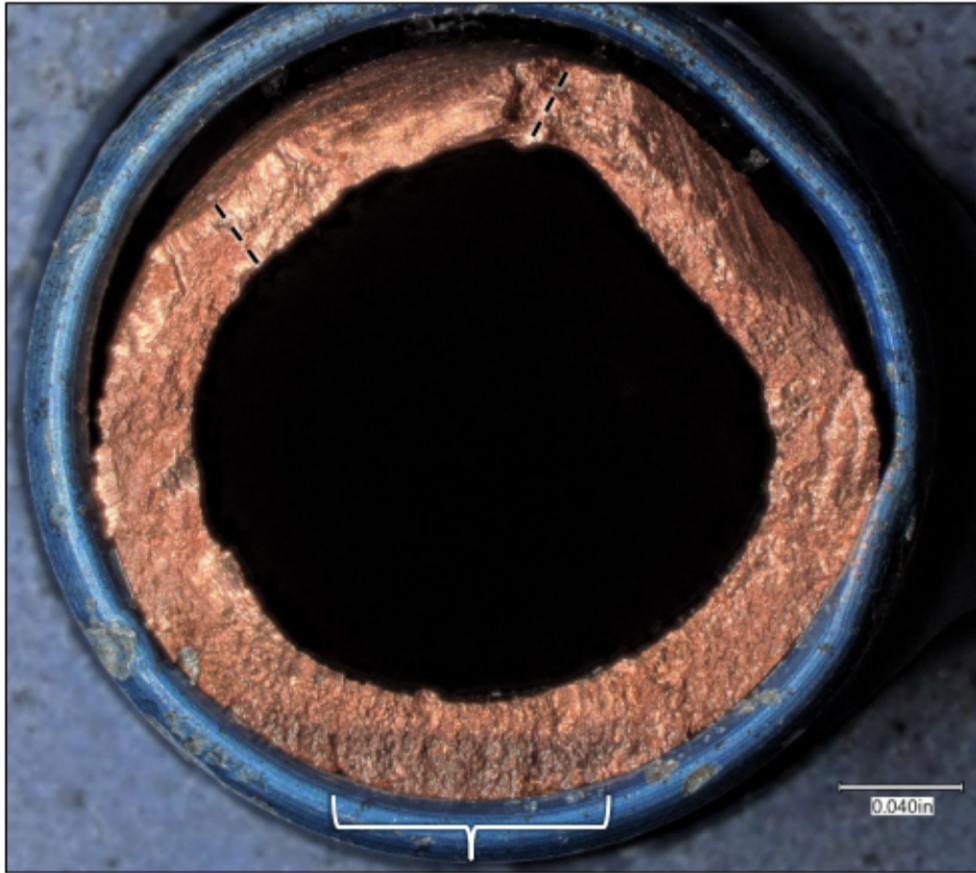
The rigid copper line and oil pressure sensor were examined by the National Transportation Safety Board Materials Laboratory. The examination revealed that most of the fracture occurred on a flat plane perpendicular to the tube axis, and a darker region with a smooth curving boundary was observed at one side identified as the origin area, as shown in figure 4. The figure also shows that fatigue features emanated from the origin area and extended to the boundary approximately indicated with dashed lines. The remainder of the fracture surface showed a change in fracture plane with dimple features on the fracture surface; those features were consistent with ductile overstress fracture of the remaining ligament of the tube wall.

Figure 4. Oil pressure sensor line fracture surface after cleaning. The dashed lines indicate the approximate fatigue boundary from the origin area, which is indicated with a bracket.
