Aviation Investigation Final Report

Location:	Kalea, Hawaii	Accident Number:	ANC22FA041
Date & Time:	June 8, 2022, 17:26 Local	Registration:	N402SH
Aircraft:	Bell 407	Aircraft Damage:	Substantial
Defining Event:	Part(s) separation from AC	Injuries:	3 Serious, 3 Minor
Flight Conducted Under:	Part 135: Air taxi & commuter - Non-scheduled - Sightseeing

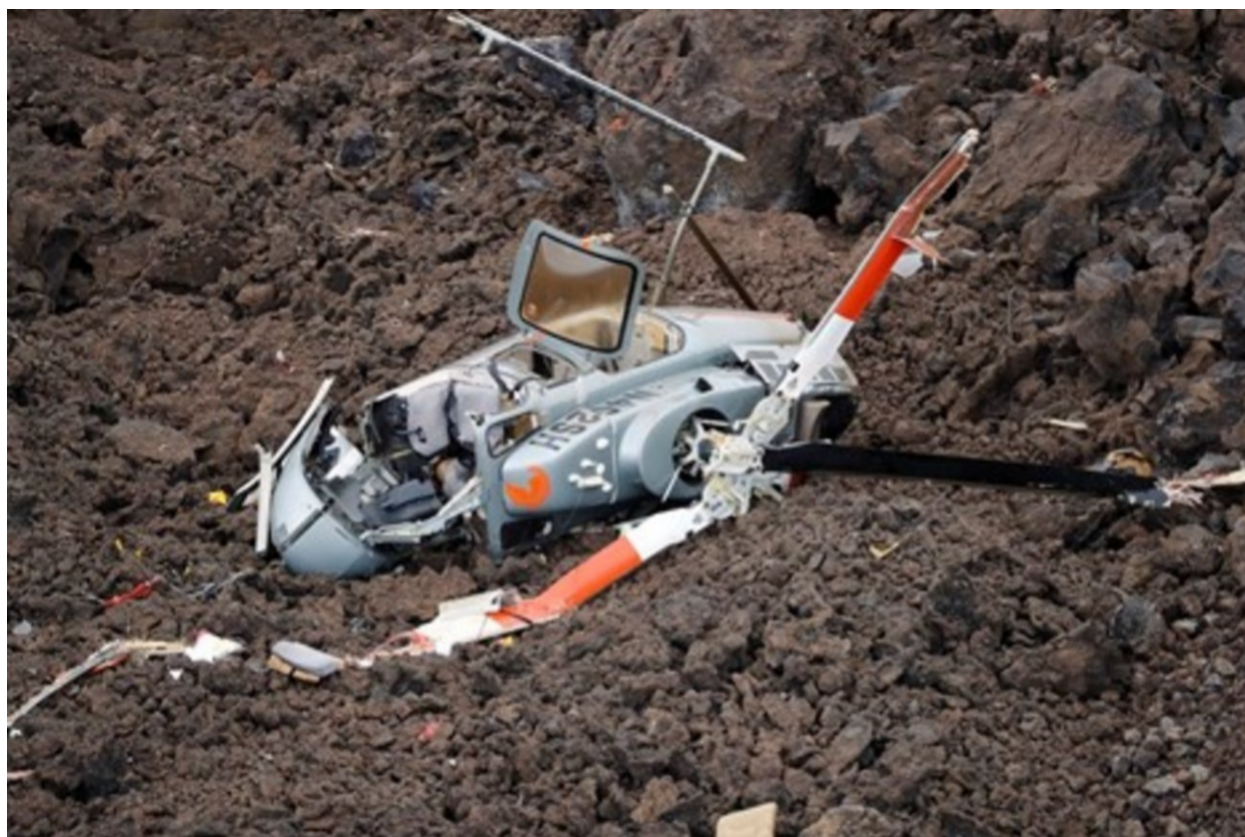
The pilot stated that the first part of the flight was normal. About 35 minutes into the flight, at an altitude of 1,500 ft agl and an airspeed of 130 knots, the helicopter experienced a violent upset, followed by an uncontrolled spin (yaw) to the right. A passenger, seated in the aft-left forward-facing seat, reported that as the helicopter continued to spin she observed something fall off the helicopter; however, she was not able to identify the specific part. The pilot communicated two mayday calls and attempted to recover helicopter control as it continued to spin uncontrollably and rapidly descend. The helicopter subsequently impacted a lava field and came to rest on its left side (see figure 1).

Figure 1. Main wreckage in a lava field.

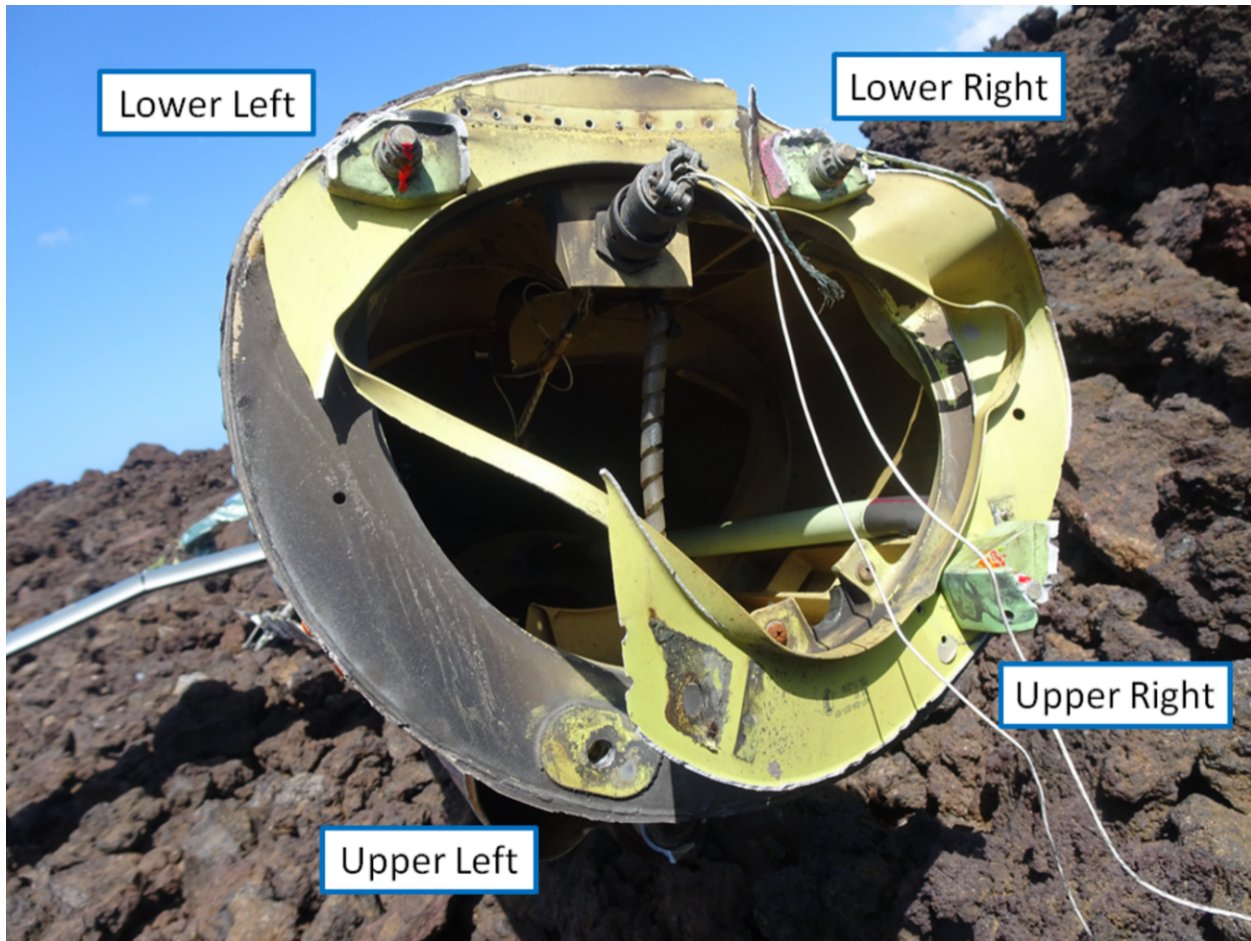
A National Transportation Safety Board (NTSB) examination of the accident site revealed the tail boom came to rest about 762 ft northeast of the main wreckage, which consisted of the fuselage, engine, and main rotor system. The tail boom separated from the aft fuselage at the tail boom attach point (see figures 2 and 3). The upper-left attachment fitting fastener was not present and the lower-left attachment fitting was fractured and displayed fatigue signatures. The fasteners for the lower-left, lower-right, and upper-right attachment fittings were present.

Figure 2. Tail boom at accident site with the four attachment fittings annotated.

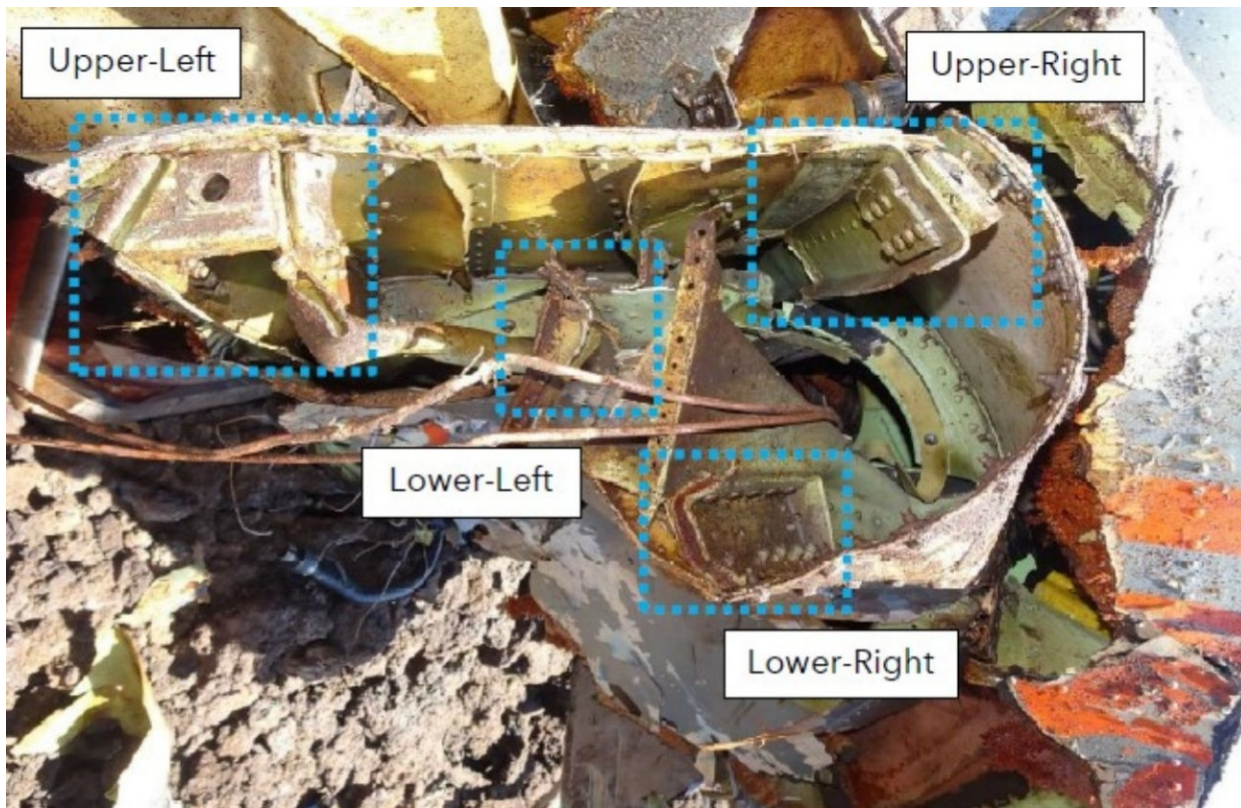
Figure 3. Aft fuselage at the accident site with the four longeron locations annotated.
