Aviation Investigation Final Report

Location:	Kalea, Hawaii	Accident Number:	ANC22FA041
Date & Time:	June 8, 2022, 17:26 Local	Registration:	N402SH
Aircraft:	Bell 407	Aircraft Damage:	Substantial
Defining Event:	Part(s) separation from AC	Injuries:	3 Serious, 3 Minor
Flight Conducted Under:	Part 135: Air taxi & commuter - Non-scheduled - Sightseeing

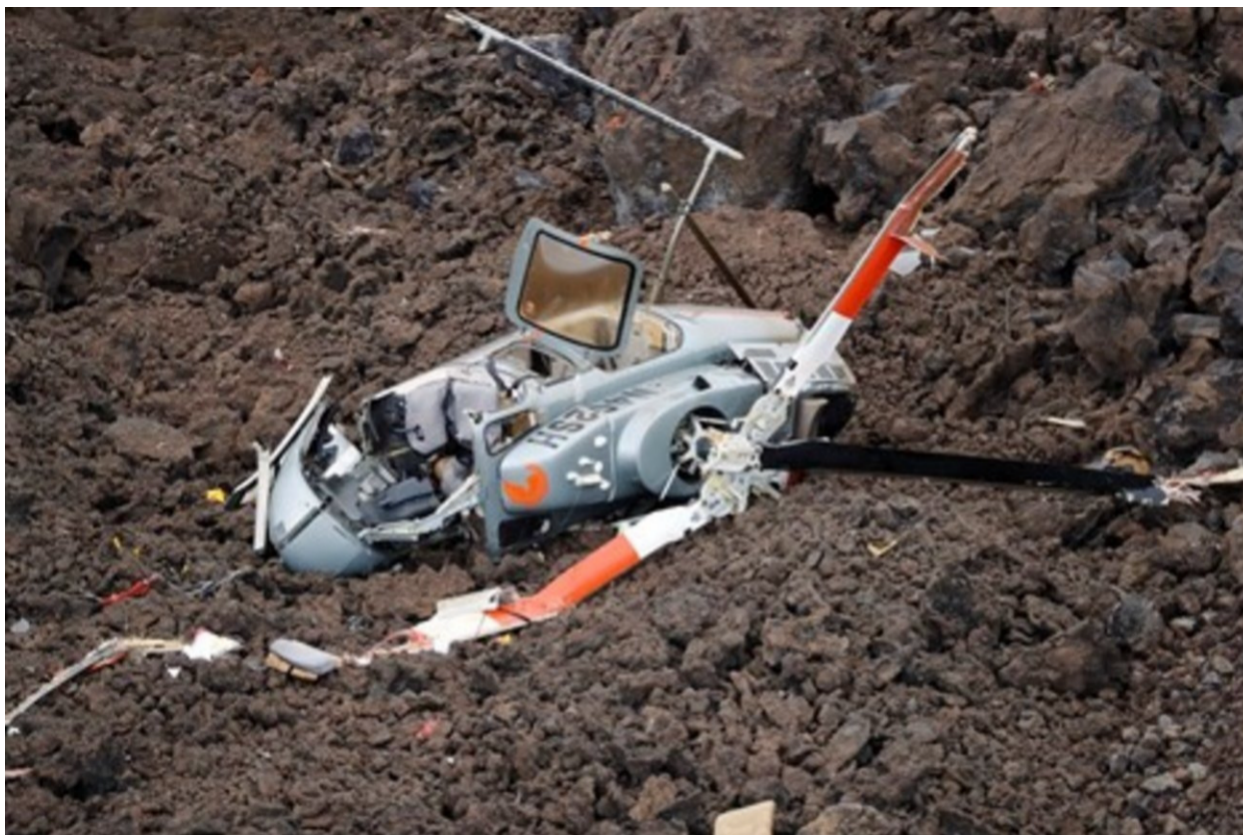
The pilot stated that the first part of the flight was normal. About 35 minutes into the flight, at an altitude of 1,500 ft agl and an airspeed of 130 knots, the helicopter experienced a violent upset, followed by an uncontrolled spin (yaw) to the right. A passenger, seated in the aft-left forward-facing seat, reported that as the helicopter continued to spin she observed something fall off the helicopter; however, she was not able to identify the specific part. The pilot communicated two mayday calls and attempted to recover helicopter control as it continued to spin uncontrollably and rapidly descend. The helicopter subsequently impacted a lava field and came to rest on its left side (see figure 1).

Figure 1. Main wreckage in a lava field.

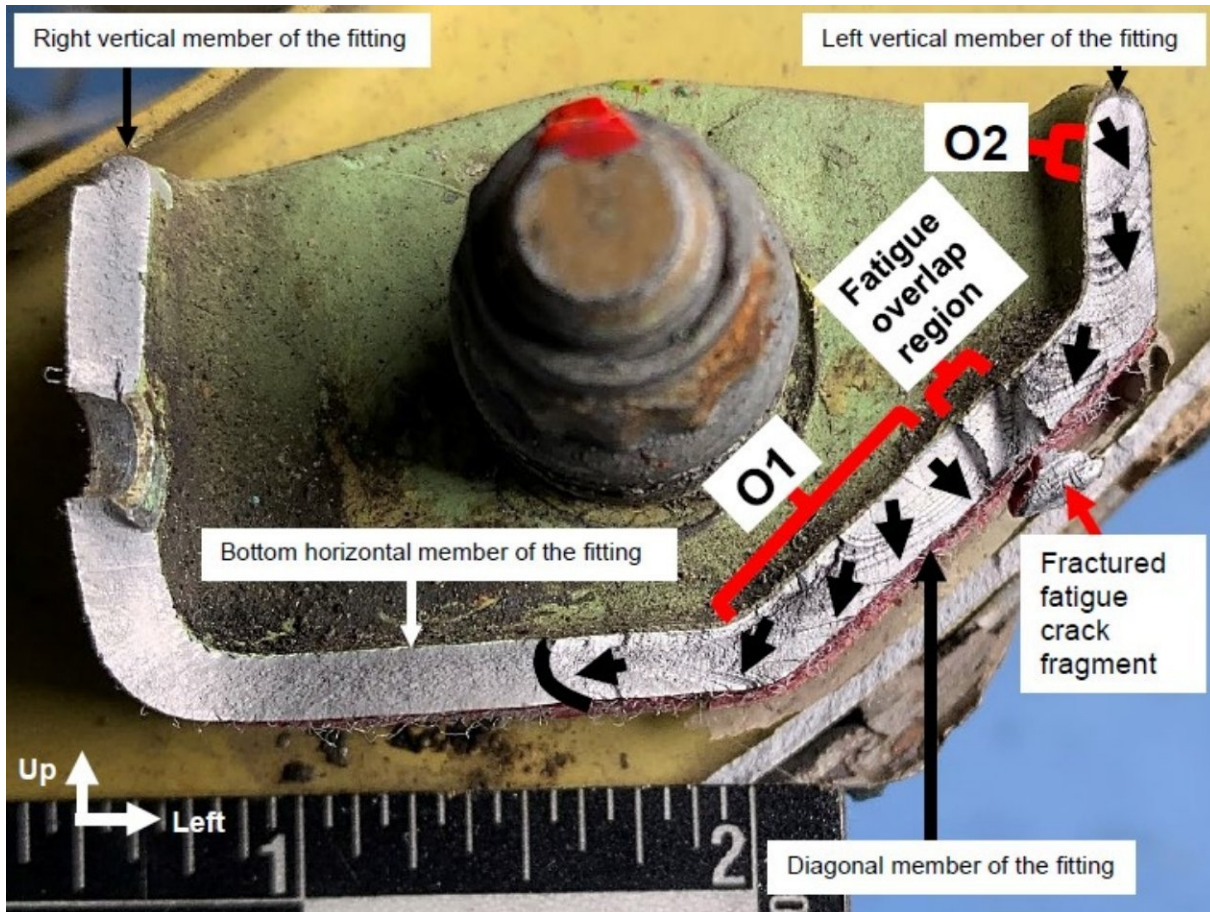
Examination of the lower-left fitting revealed the fracture face contained evidence of crack arrest marks typical of fatigue cracking that emanated from two separate areas, identified as O1 and O2 (see figure 4). Scanning electron microscope examination revealed that fatigue crack O1 emanated from multiple origins at the outer surface at an area that was located slightly forward of the inner transition radius of the diagonal wall member portion of the fitting. The fatigue origin contained no evidence of pitting corrosion. Fatigue propagation was down and through the wall then extended to the right of the fitting. The 1-inch fatigue crack contained alternating fatigue crack and overstress features.

Figure 4. Fractured lower left fitting showing fatigue cracking indicated by brackets "O1" and "O2".

Fatigue crack O2 emanated from a corrosion pit at the outer surface in an area slightly forward of the inner transition radius near the upper right end of the fitting. The fatigue crack propagated through the wall and then extended down where it intersected the left edge of fatigue crack O1. The 0.75-inch fatigue crack region contained alternating fatigue crack and overstress features. The bolt hole showed evidence of severe spiral gouge marks and fine spiral scratches. The spiral gouge marks did not extend all around the bore.
