Aviation Investigation Final Report

Location:	Camarillo, California	Accident Number:	WPR22FA210
Date & Time:	June 10, 2022, 08:00 Local	Registration:	N305L
Aircraft:	MOONEY AIRCRAFT CORP. M20K	Aircraft Damage:	Destroyed
Defining Event:	Loss of control in flight	Injuries:	1 Fatal
Flight Conducted Under:	Part 91: General aviation - Personal

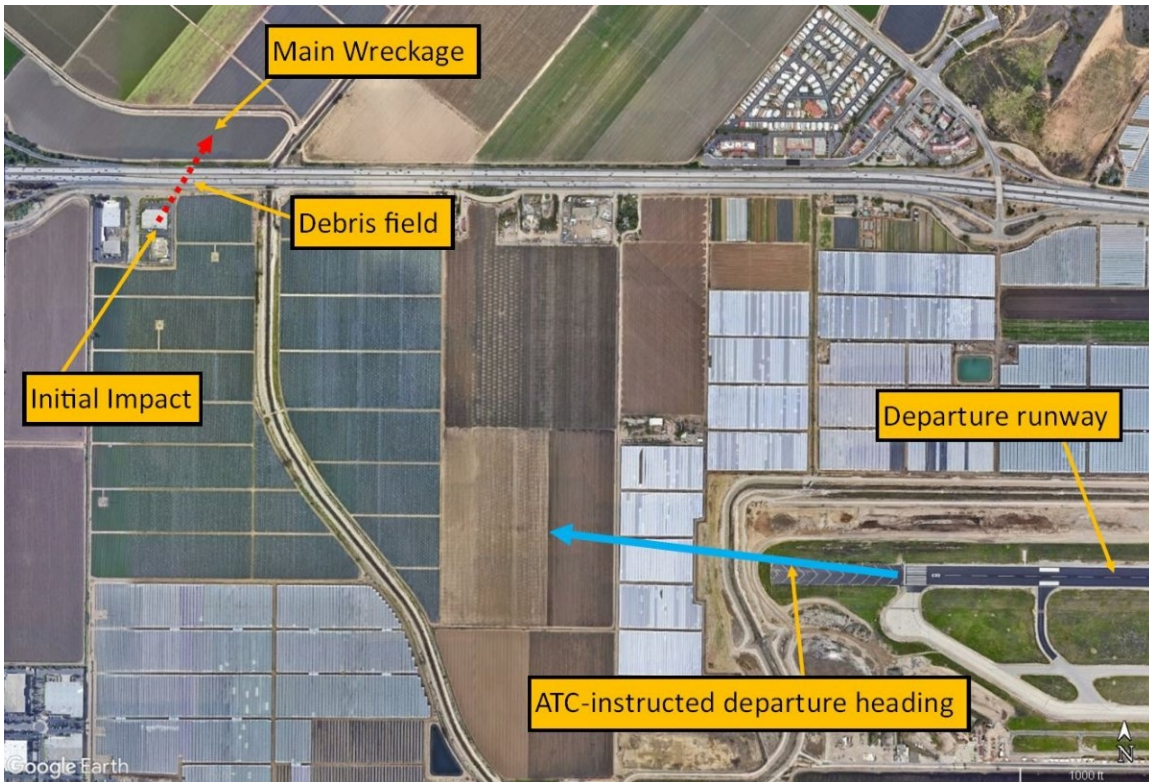
The first point of impact was identified by a wing-shaped imprint at the top wall of a building located south of the freeway, 1 mile west-northwest of the departure end of runway 26. The imprint was about 50 ft agl, and its shape corresponded to a 15° right-wing-low impact attitude. The outboard section of the right wing and aileron were located on the building's flat roof. A trail of debris consisting of wing skin fragments and the right flap continued on a heading of about 035° and across the freeway to a secondary impact point in a strawberry field that was 750 ft beyond the first impact point (as shown in figures 1 and 2).

Figure 1. Location of the wreckage and debris field in relation to the departure runway.

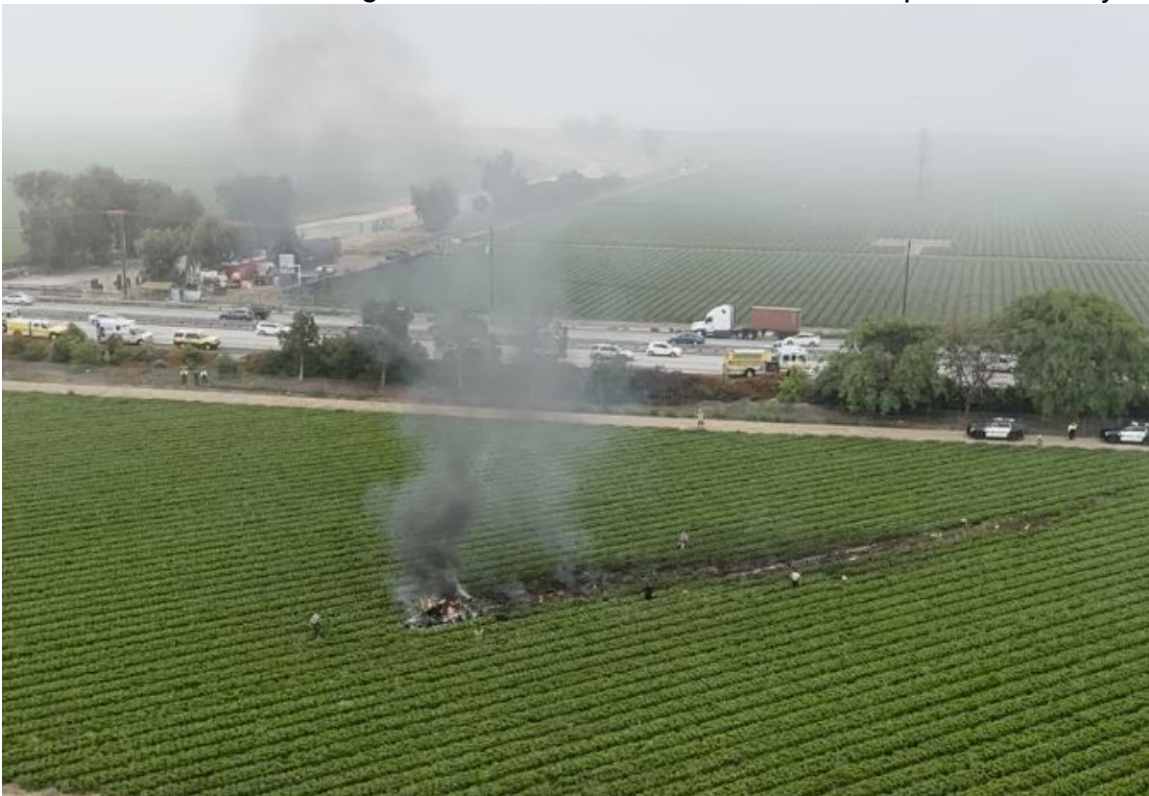
Figure 2. Debris field facing southeast.

Note: The debris field travels from right to left, with the initial impact point to the right on the other side of the freeway. The departure end of runway 8 is 1 mile in the background beyond the clouds.

The debris beyond the secondary impact point consisted of the propeller assembly, cabin skin fragments, and flight instruments, all of which led to the main wreckage, which was on the same heading about 250 ft downrange.
