# Aviation Investigation Final Report

<b>Location:</b>	Camarillo, California	<b>Accident Number:</b>	WPR22FA210
<b>Date &amp; Time:</b>	June 10, 2022, 08:00 Local	<b>Registration:</b>	N305L
<b>Aircraft:</b>	MOONEY AIRCRAFT CORP. M20K	<b>Aircraft Damage:</b>	Destroyed
<b>Defining Event:</b>	Loss of control in flight	<b>Injuries:</b>	1 Fatal
<b>Flight Conducted Under:</b>	Part 91: General aviation - Personal

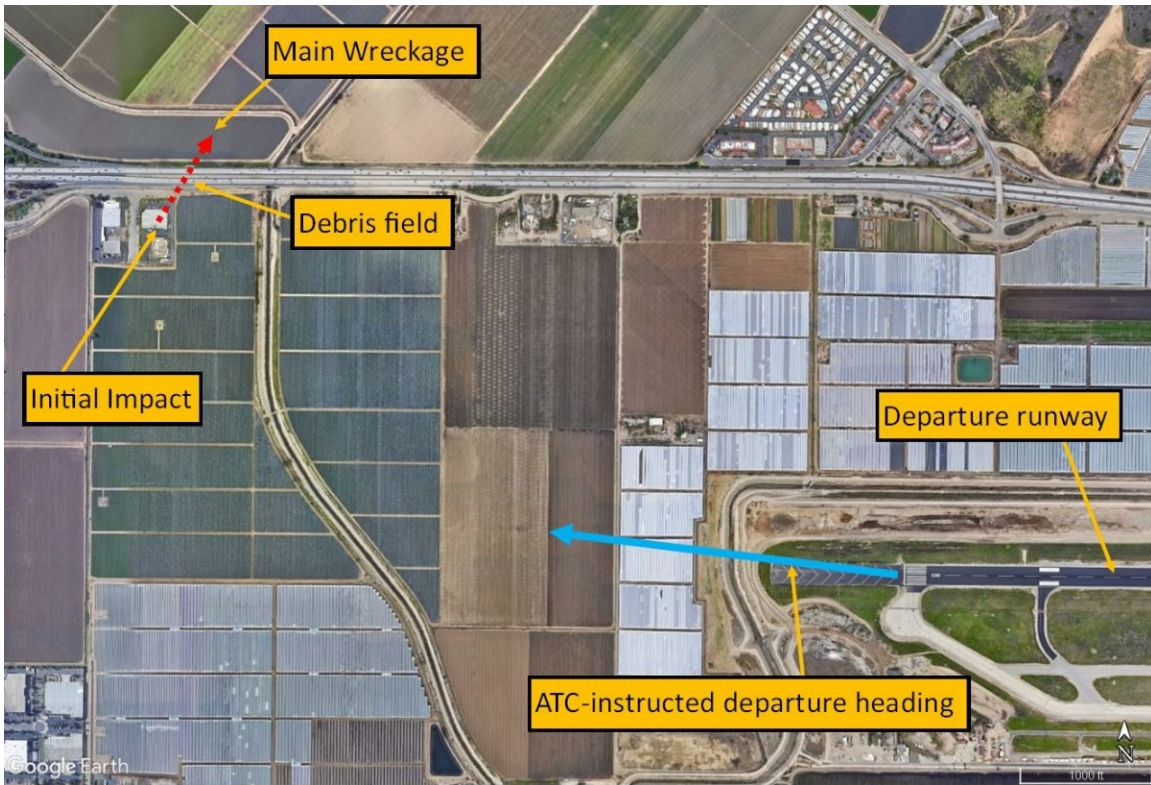
The first point of impact was identified by a wing-shaped imprint at the top wall of a building located south of the freeway, 1 mile west-northwest of the departure end of runway 26. The imprint was about 50 ft agl, and its shape corresponded to a 15° right-wing-low impact attitude. The outboard section of the right wing and aileron were located on the building's flat roof. A trail of debris consisting of wing skin fragments and the right flap continued on a heading of about 035° and across the freeway to a secondary impact point in a strawberry field that was 750 ft beyond the first impact point (as shown in figures 1 and 2).

Figure 1. Location of the wreckage and debris field in relation to the departure runway.

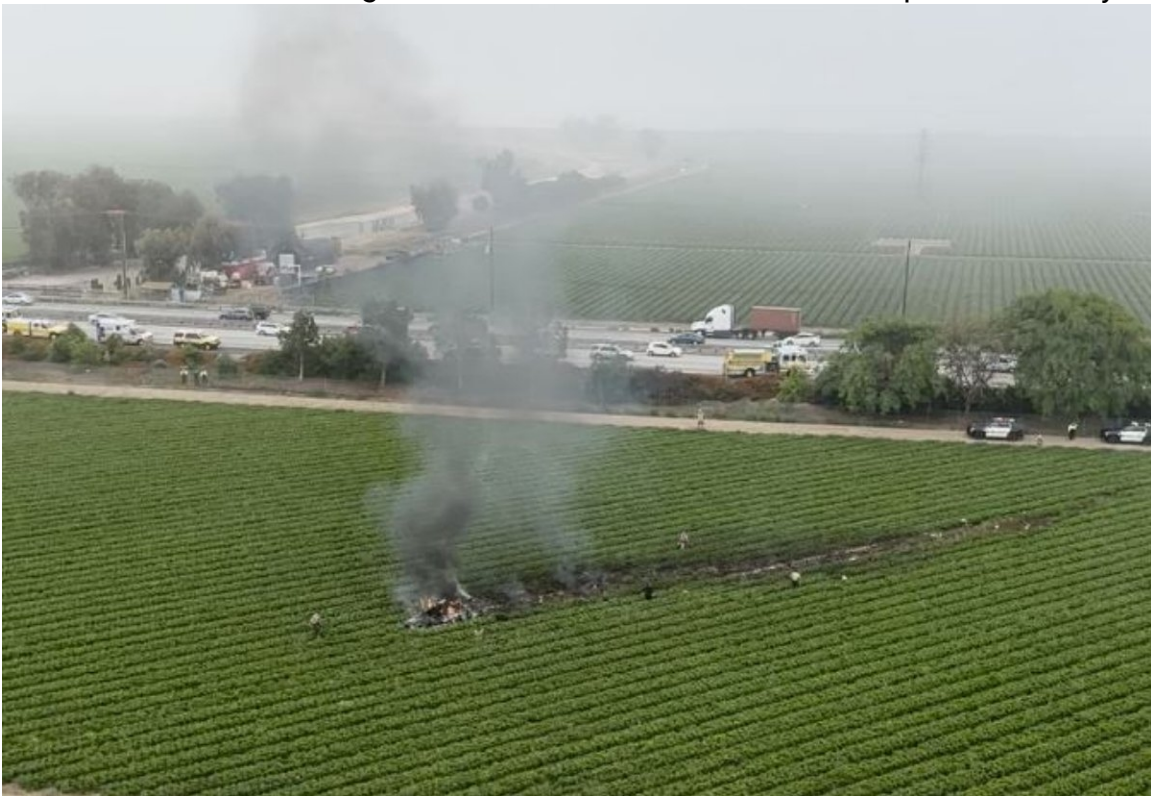
Figure 2. Debris field facing southeast.

Note: The debris field travels from right to left, with the initial impact point to the right on the other side of the freeway. The departure end of runway 8 is 1 mile in the background beyond the clouds.

The debris beyond the secondary impact point consisted of the propeller assembly, cabin skin fragments, and flight instruments, all of which led to the main wreckage, which was on the same heading about 250 ft downrange.
